During the westward push of the Union Pacific Railroad to complete the transcontinental "Pacific Railroad," construction slowed in 1867 when the line reached Crow Creek at the eastern base of the north-south-trending Laramie Mountains, the UP route's most formidable obstacle. The "hell on wheels" town of Cheyenne grew as work progressed slowly over 8,247-foot Evans Pass (also called Sherman Pass) through the Laramie Mountains. Evans Pass is about 20 miles west of Cheyenne and was discovered by the UP-employed English surveyor and engineer, James Evans, in 1864. The new route surveyed across Wyoming was over 150 miles shorter and had a flatter profile than the emigrant wagon route over South Pass, and also went closer to Denver and to the coalfields in the Wasatch and Laramie Ranges. The line over Evans Pass and down to the next hell on wheels town, Laramie, was completed in 1868.

The Hermosa Tunnel was the key element of the 1901 re-alignment of the UP mainline over Evans Pass. The new alignment involved about 10 miles of new grade located south of Evan's Pass; the new grade leaves the 1868 grade about 5 miles east of Evan's Pass, crosses the crest of the Laramie Mountains at the

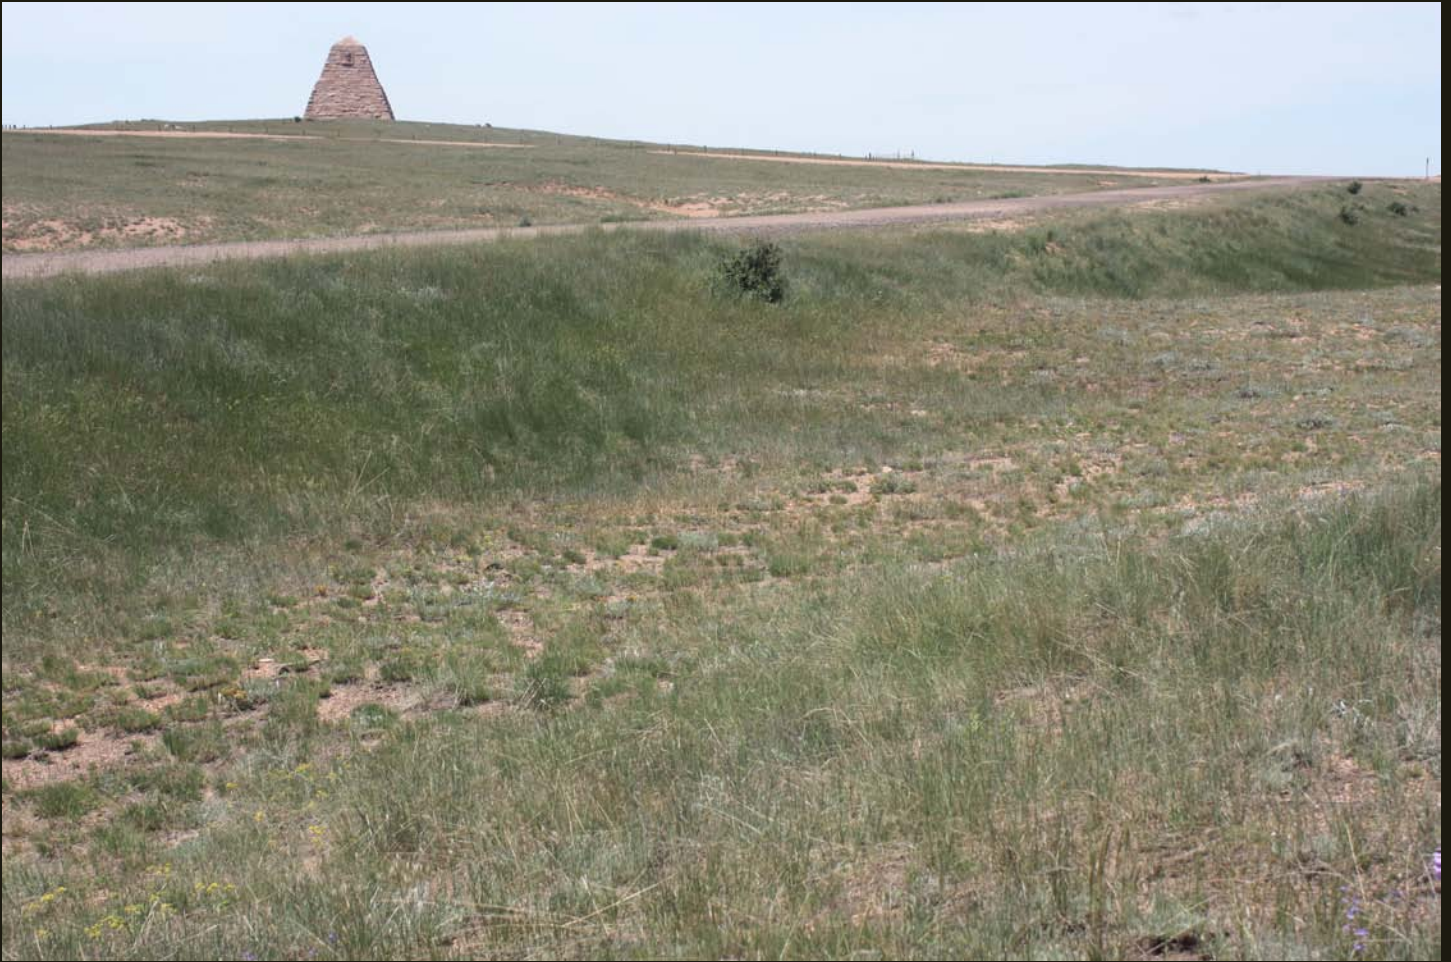
This photograph is the general location of the original town of Sherman on Evan's Pass. The fill grade in the middle-ground is the original 1868 UP grade over Evans Pass and is now Ironhorse Road. Harder to see, the flat area in the right foreground is the east branch of the Evans Pass wye. The wye is visible on the ground and in satellite imagery on the north side of the east-west UP mainline and was used to turn helper engines once they were done helping a train up the grade.

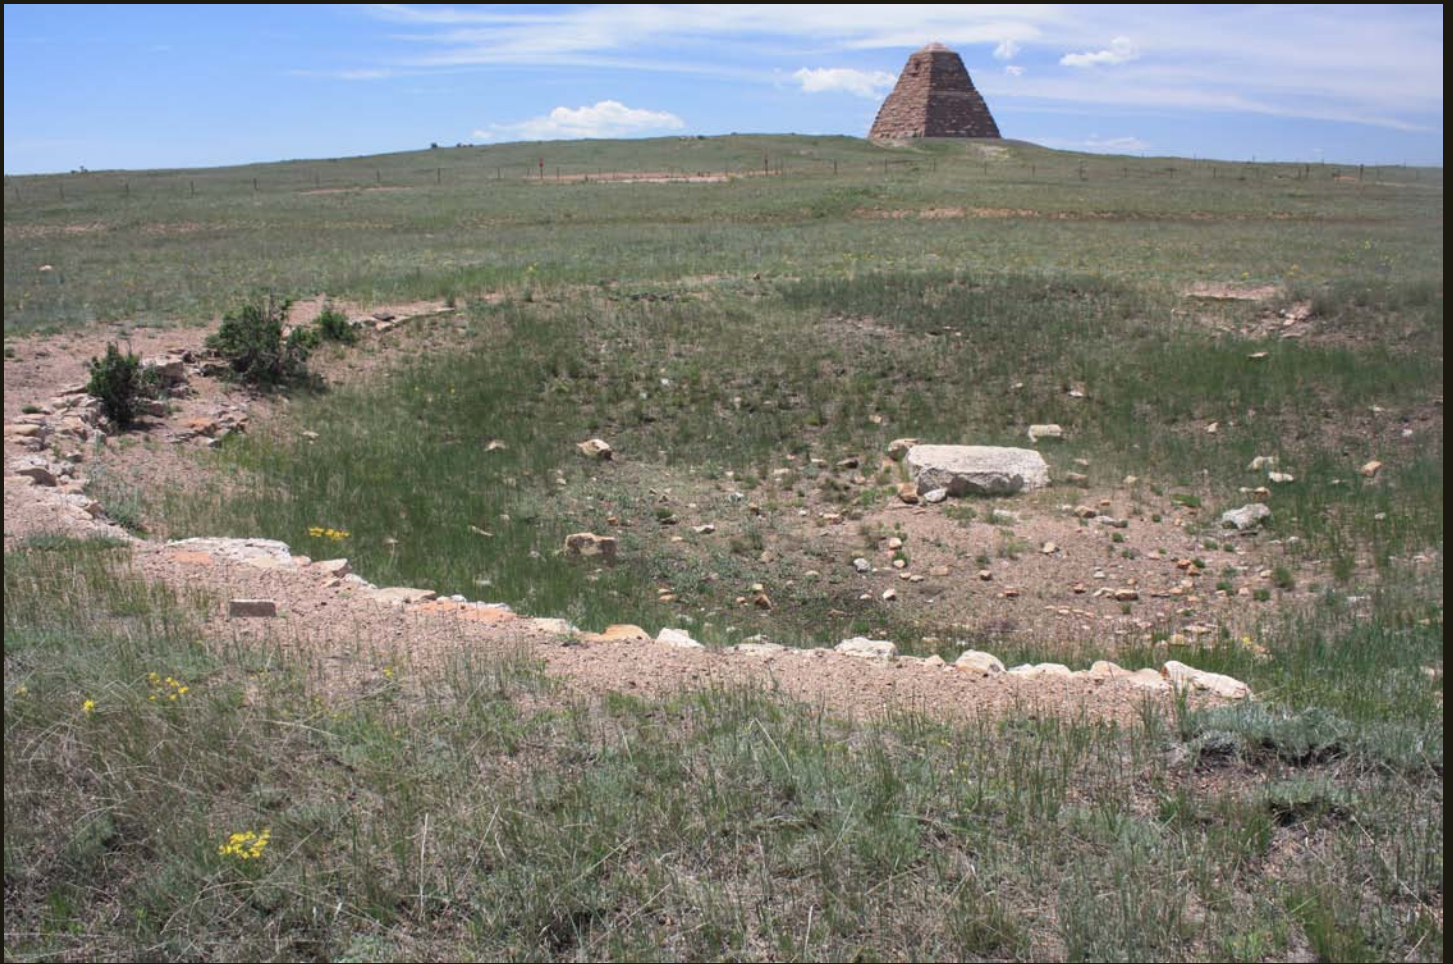
Beside the UP grade, wye, and monument, the only other railroad feature I could find on Evan's pass is this circular foundation. This foundation is within the wye, and satellite imagery shows grades fanning out from it, just like the fanned tracks between the turntable and roundhouse in the below photo. I believe this foundation was a turntable for the Sherman roundhouse, similar to the one pictured below at Jamestown, California, on the Sierra Railway.

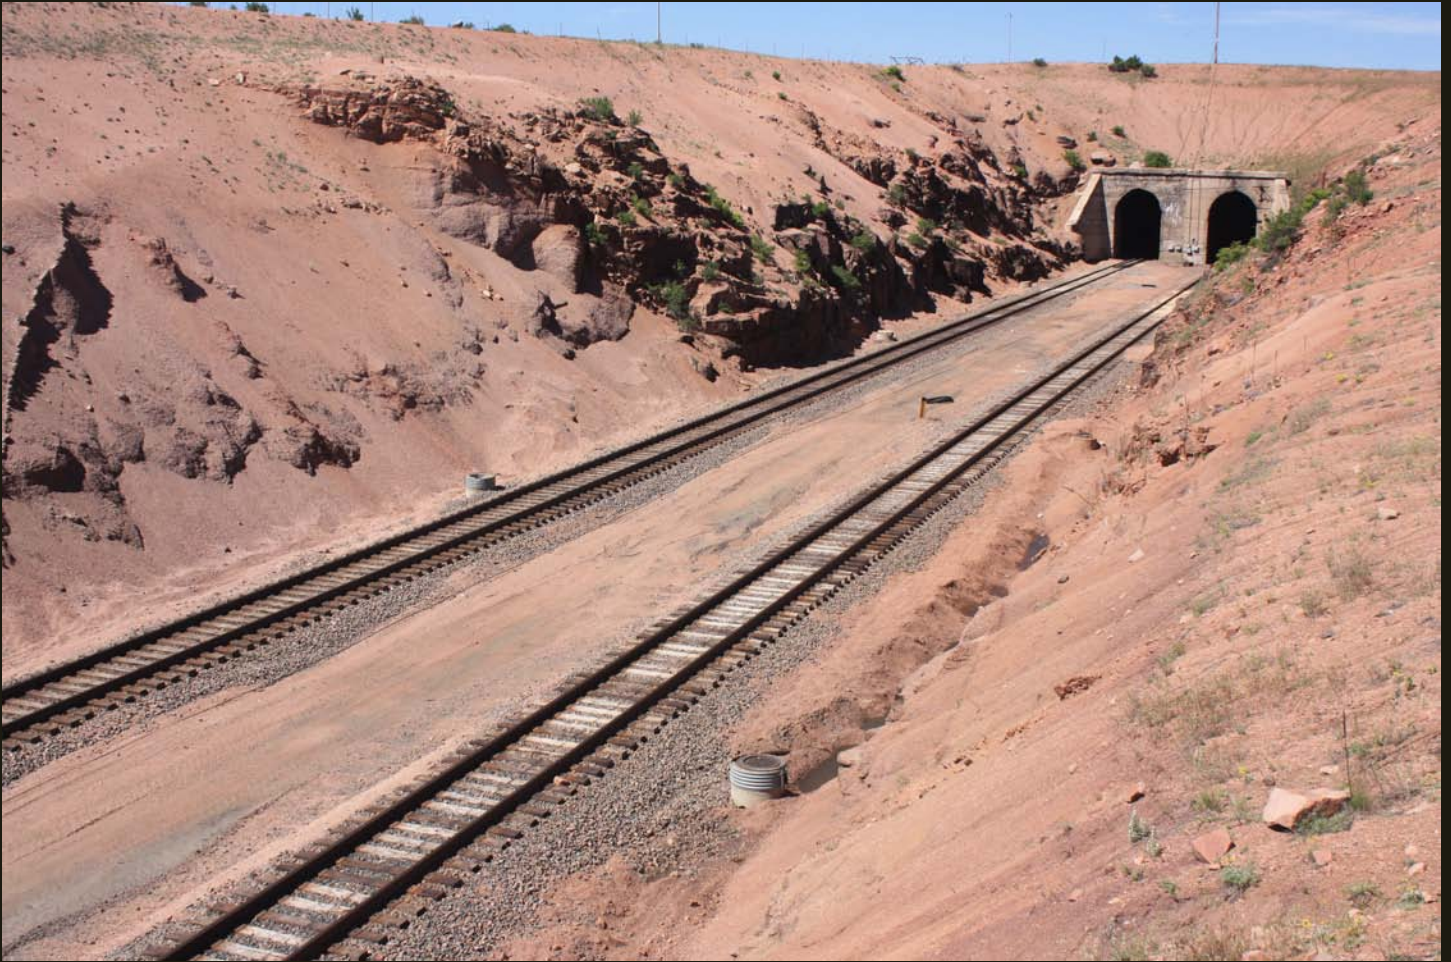
The 1901 Hermosa Tunnel is the "first" Hermosa Tunnel; the second tunnel was added in 1918 along with new grades on both sides of the tunnel and completion of double-tracking of the entire UP mainline. Both the 1901 and 1918 Hermosa Tunnels are represented in this view of the east portal.

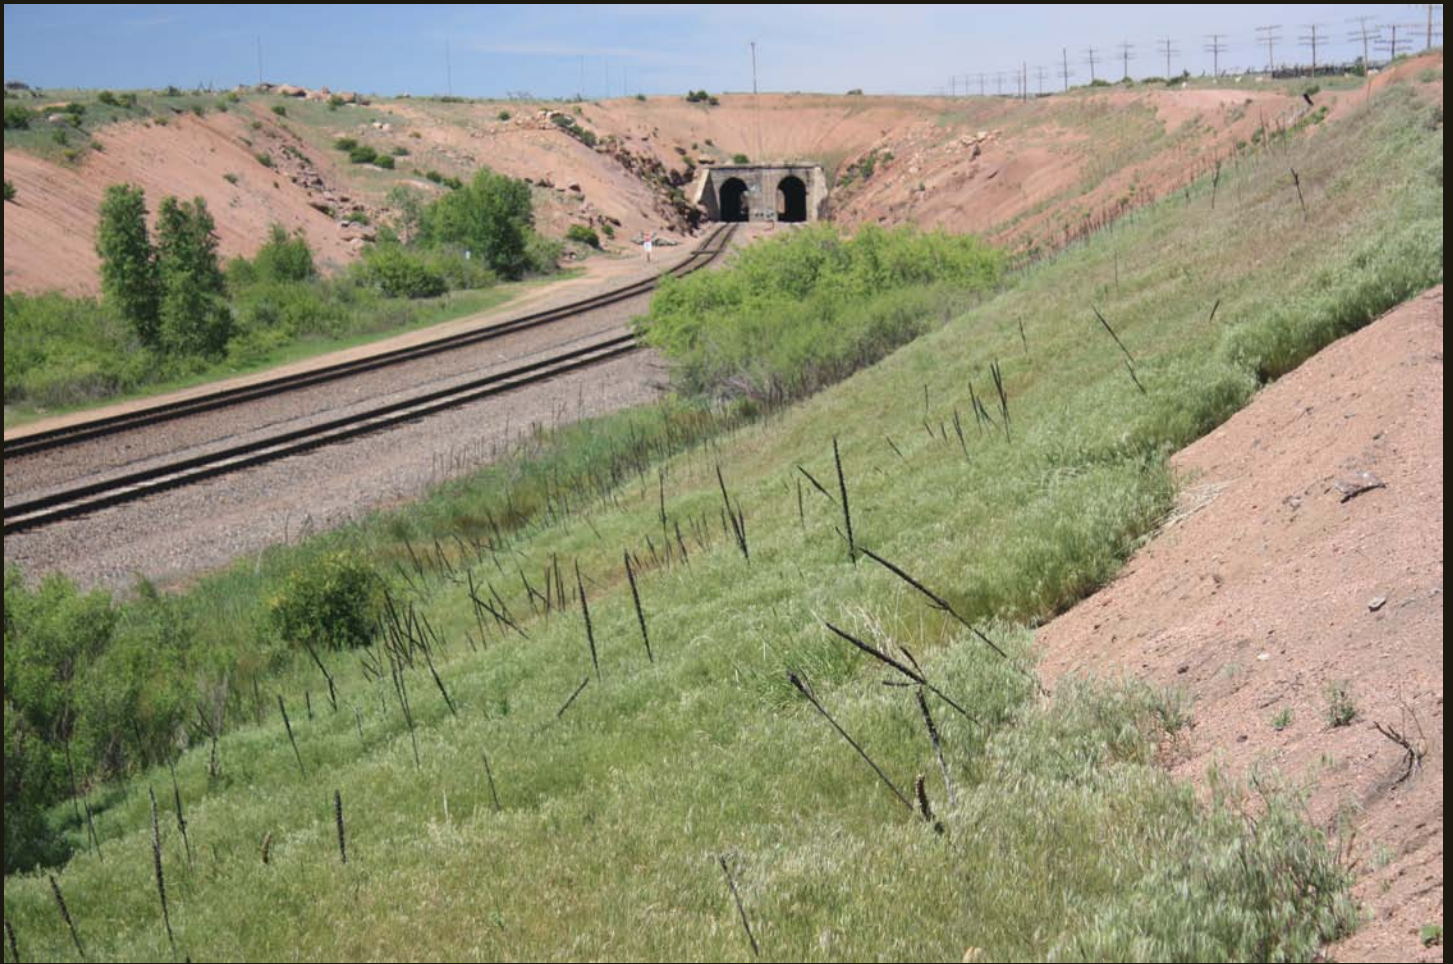
Another view of the east portal of the Hermosa Tunnel, which crosses the summit of the Laramie Mountains in an area of subdued topography. I'm not a railroad engineer, but it sure looks like this crossing could have been a cut like that in the foreground instead of a tunnel, but I have not heard of any plans to daylight the Hermosa Tunnel.

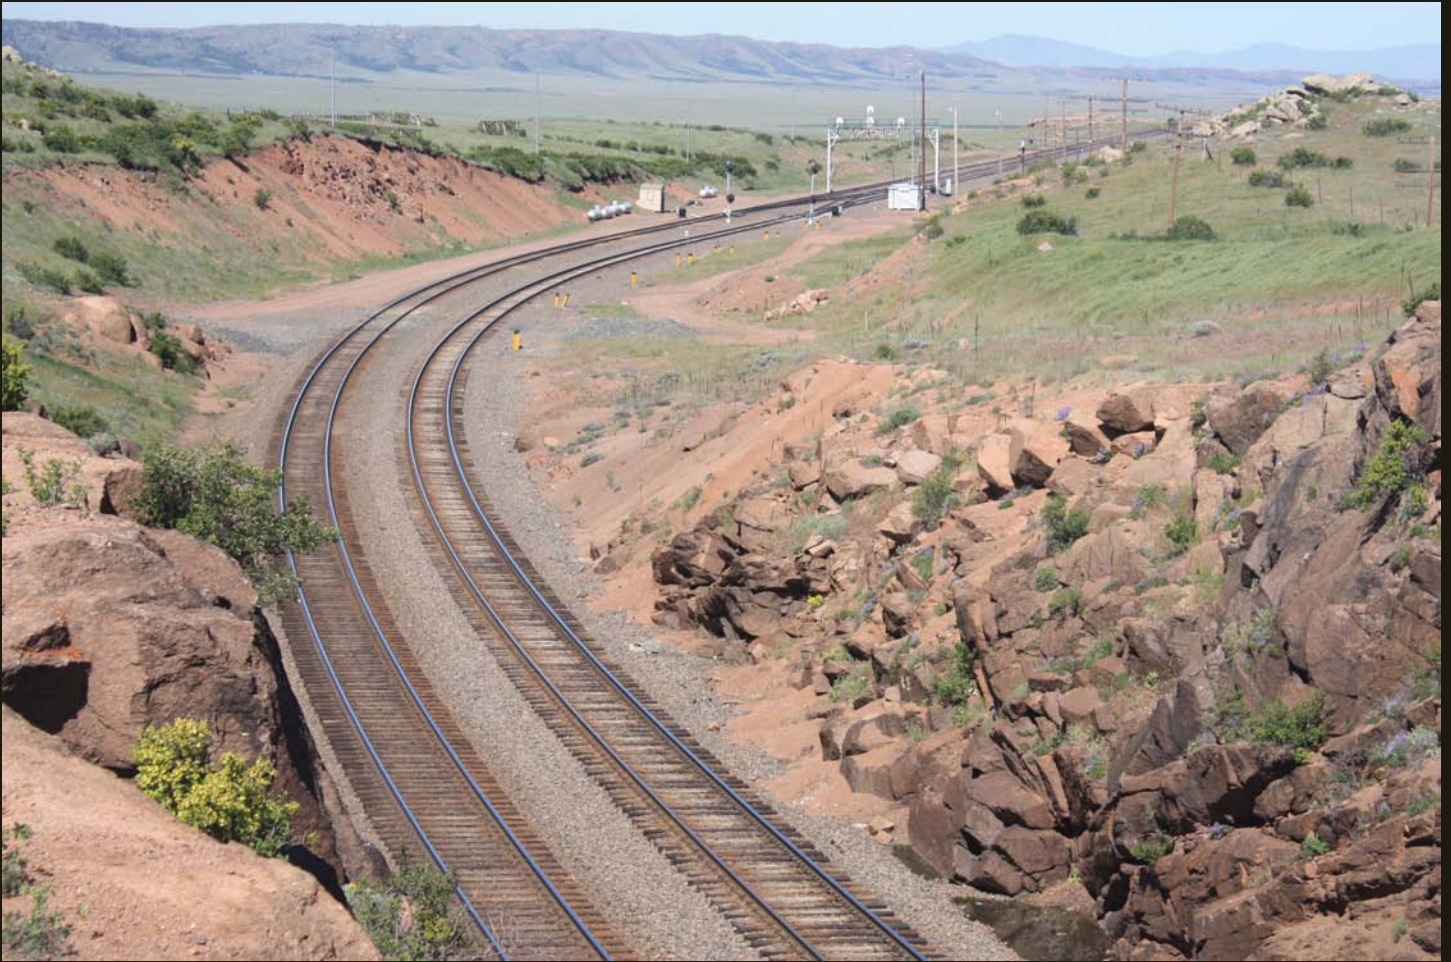
Eastward view near east portal of the Hermosa Tunnel on the 1901 grade. Note that beneath the signal, there are switches from each track to a third track in the middle.

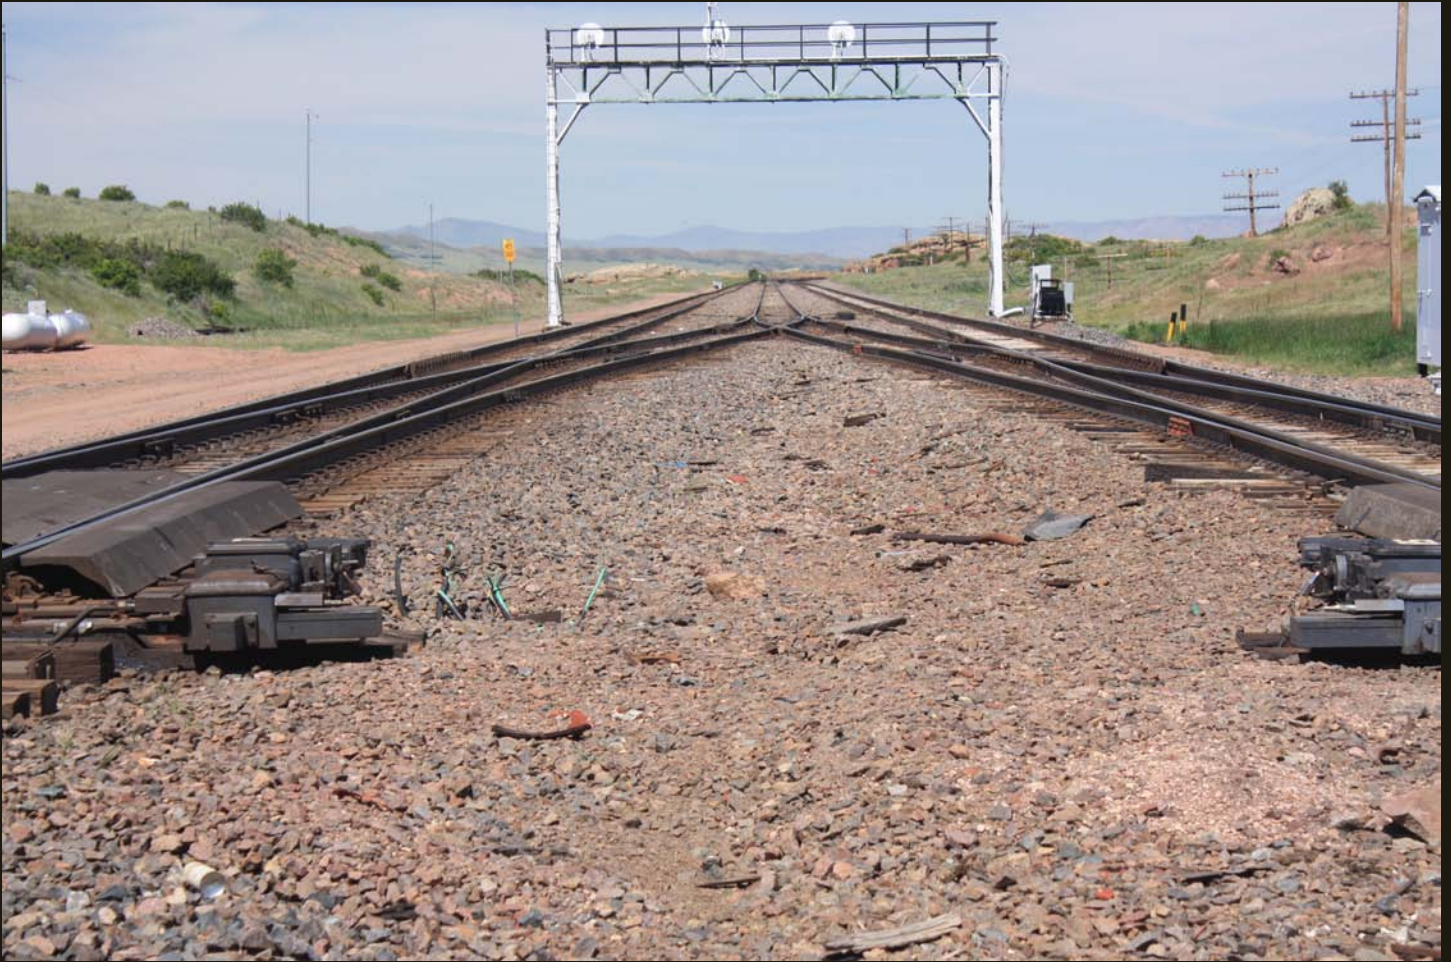
Eastward close-up view of the addition of a third track east the Hermosa Tunnel.

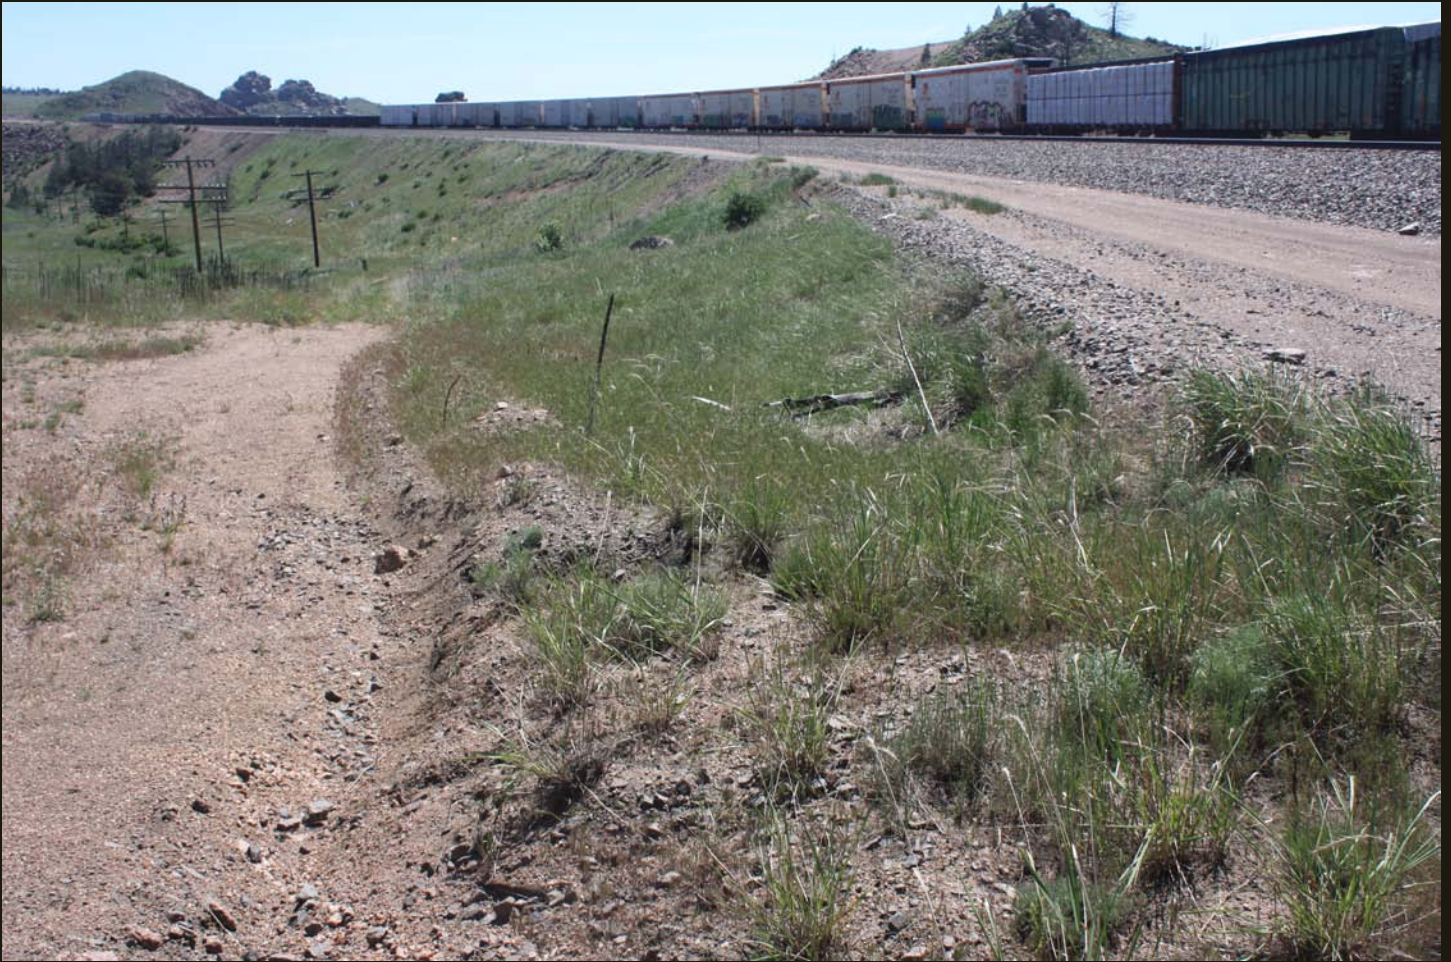
A UP consist crosses a significant fill on the 1901 grade over Dale Creek east of the Hermosa Tunnel, about two miles downstream (south) of the huge trestle crossing of Dale Creek on the 1868 grade.

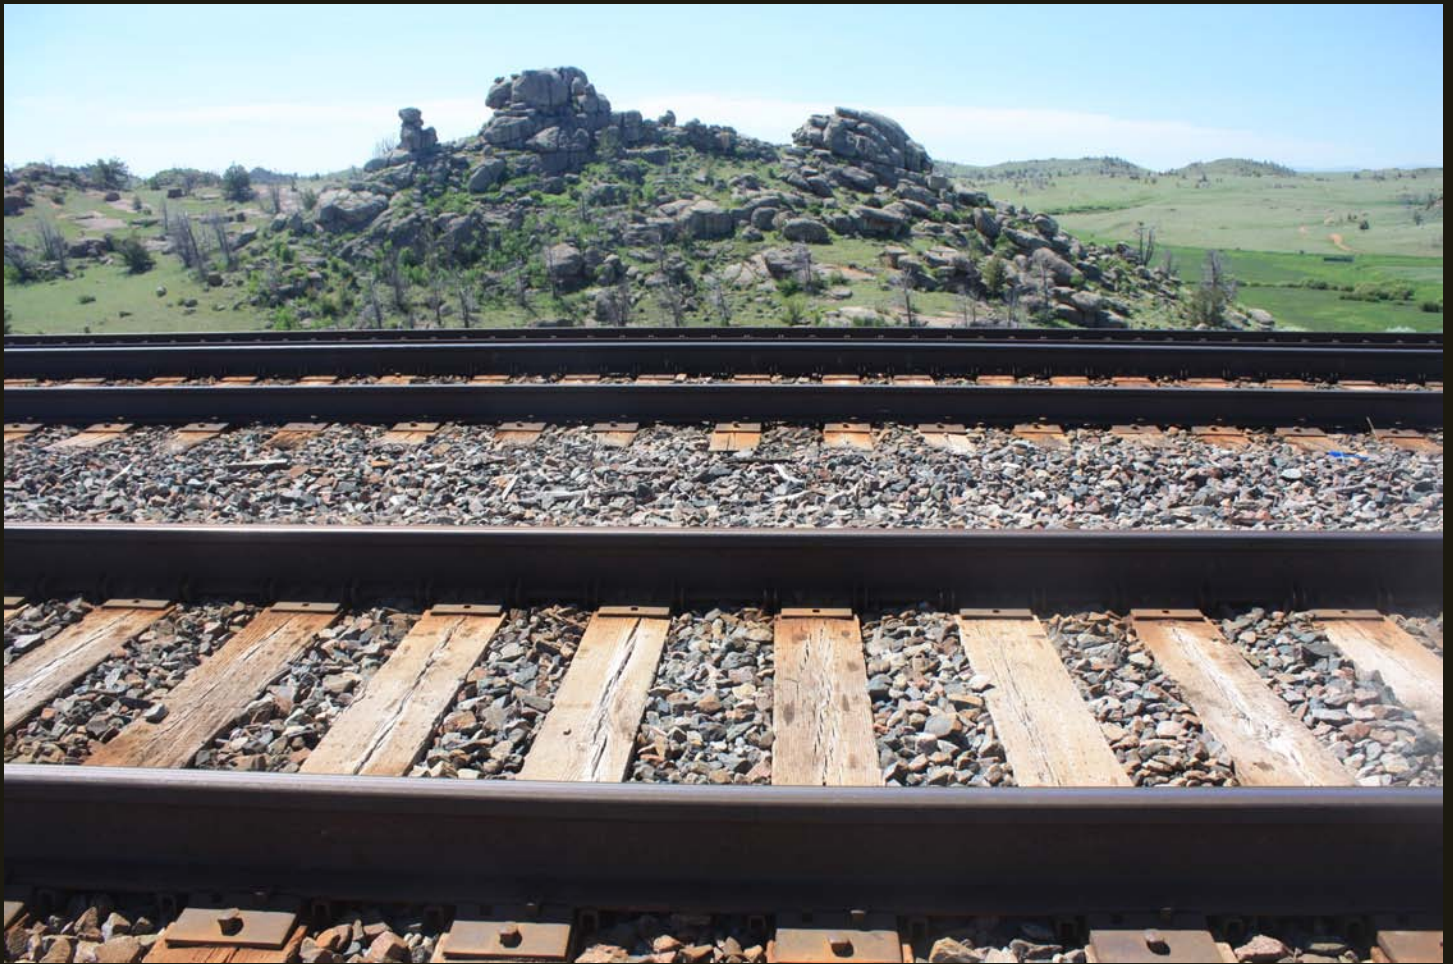
The Evan's Pass area is topographically subdued because it is an "old" surface, meaning it developed prior to the uplift of the Laramie Mountains. The rock outcrops are granite, which in the geologic past weathered under the soil along fractures and then was partially stripped of the soil by the weak erosion at the top of the Laramie Mountains. Note triple track east of the Hermosa Tunnel.

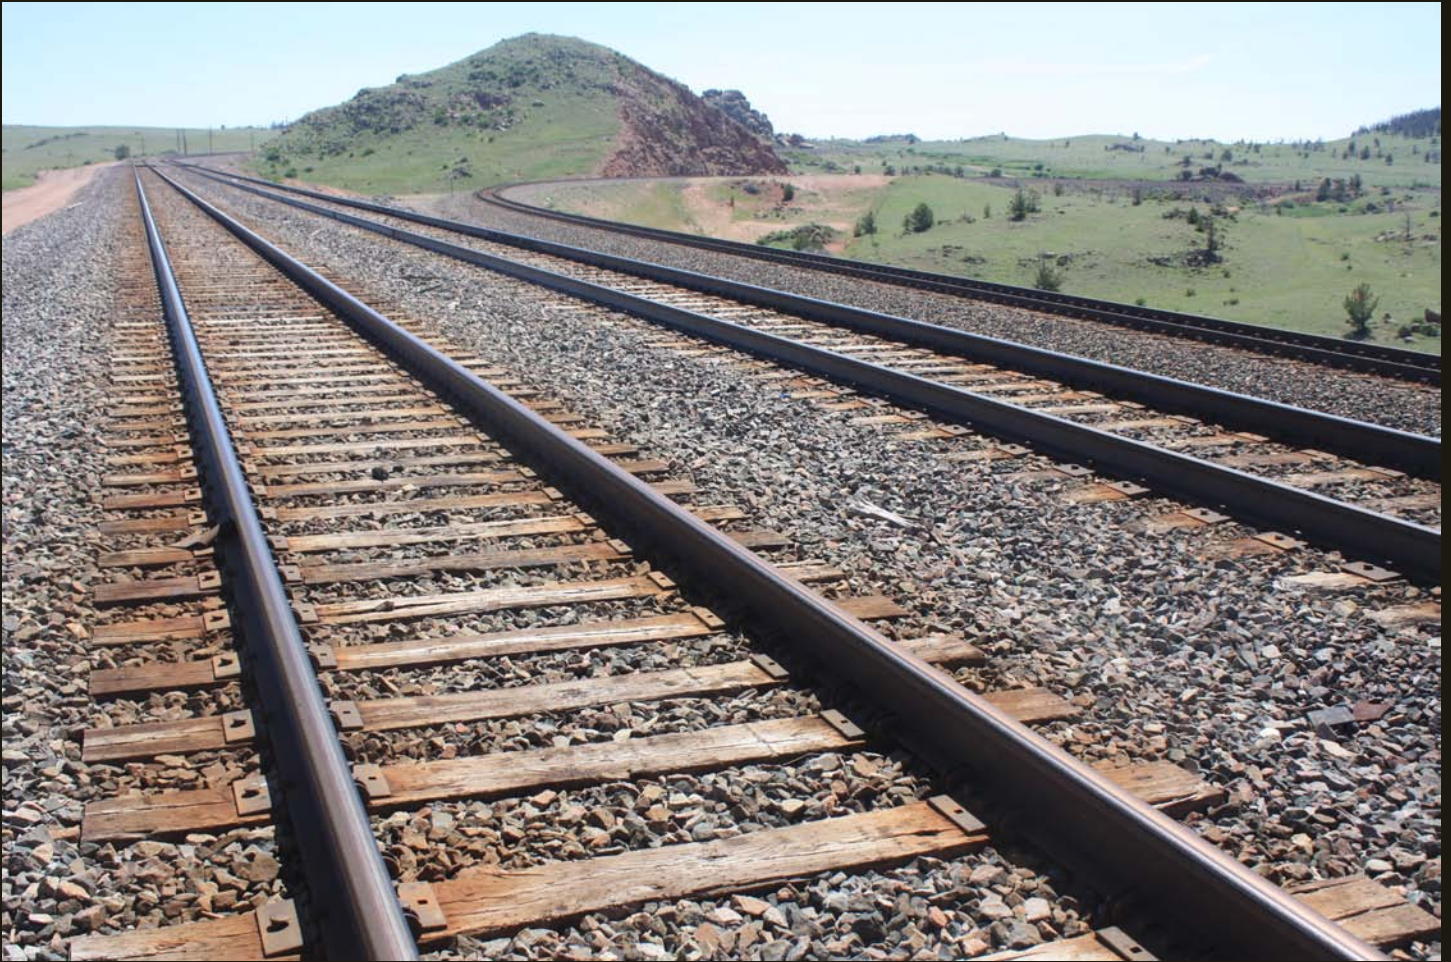
Eastward view of the UP mainline 2 miles east of the Hermosa Tunnel and immediately east of the 1901 Dale Creek crossing. The three tracks in the foreground and the two tracks that continue eastward to the left are on the 1901 grade that bypassed the original line over Evan's Pass. The double track to the left (north) joins the 1868 grade about 3 miles further east. The single track to the right was a new grade built around 1917 as part of the upgrade work; the single track extends from this point eastward all the way to Cheyenne, deviating up to 6 miles south of the 1868 grade and joining the Denver & Pacific route southwest of Cheyenne, which together enter Cheyenne alongside the 1868 double-track route.

Double-tracking east of the Hermosa Tunnel to Cheyenne began in 1900 and was completed to the First Hermosa Tunnel in 1917, followed by completion of the Second Hermosa Tunnel and double-tracking in 1918.

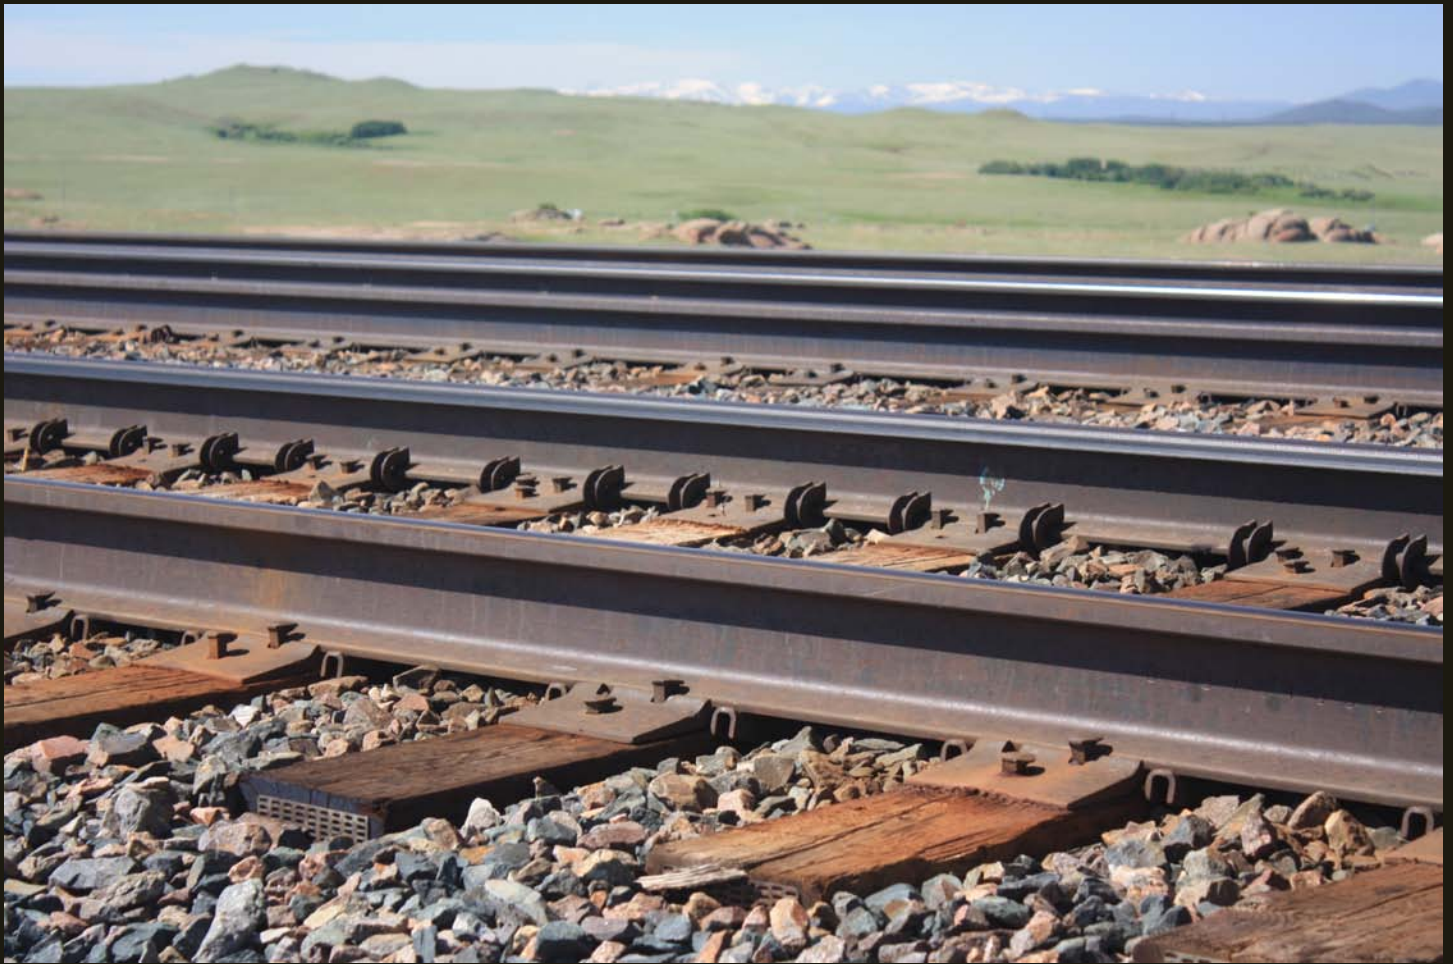
West of the Hermosa Tunnel, the double track becomes triple track as it does east of the tunnel. Note the subdued topography with outcrops of weathered granite and the snow-capped Medicine Bow Mountains in the distance.

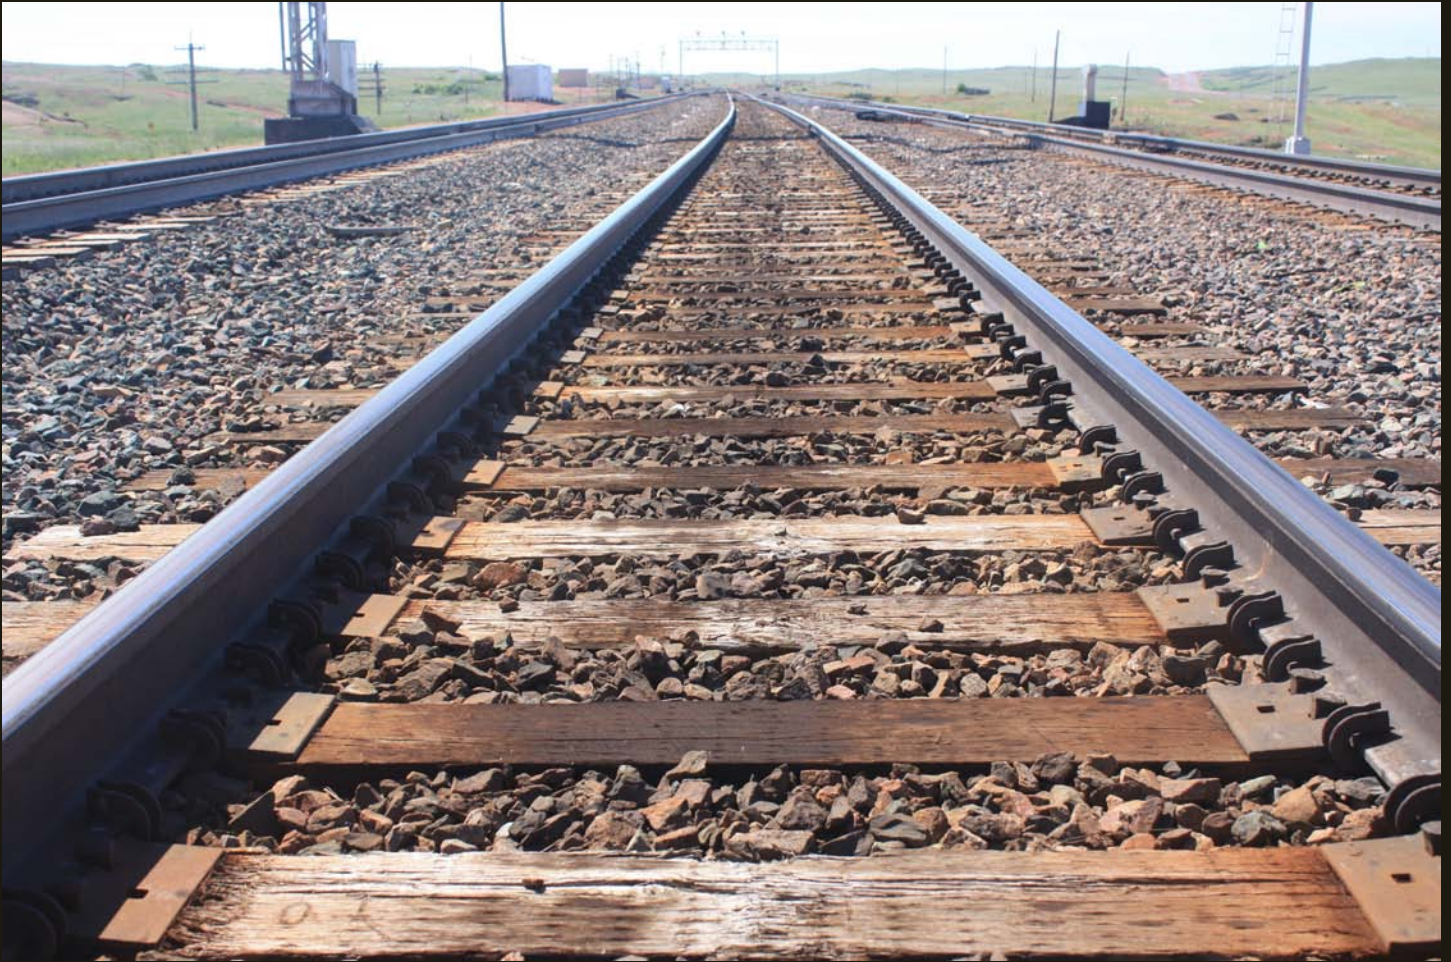
West of the Hermosa Tunnel, the double track through the tunnel (out of sight in the distance to the east) becomes triple track as it does east of the tunnel.

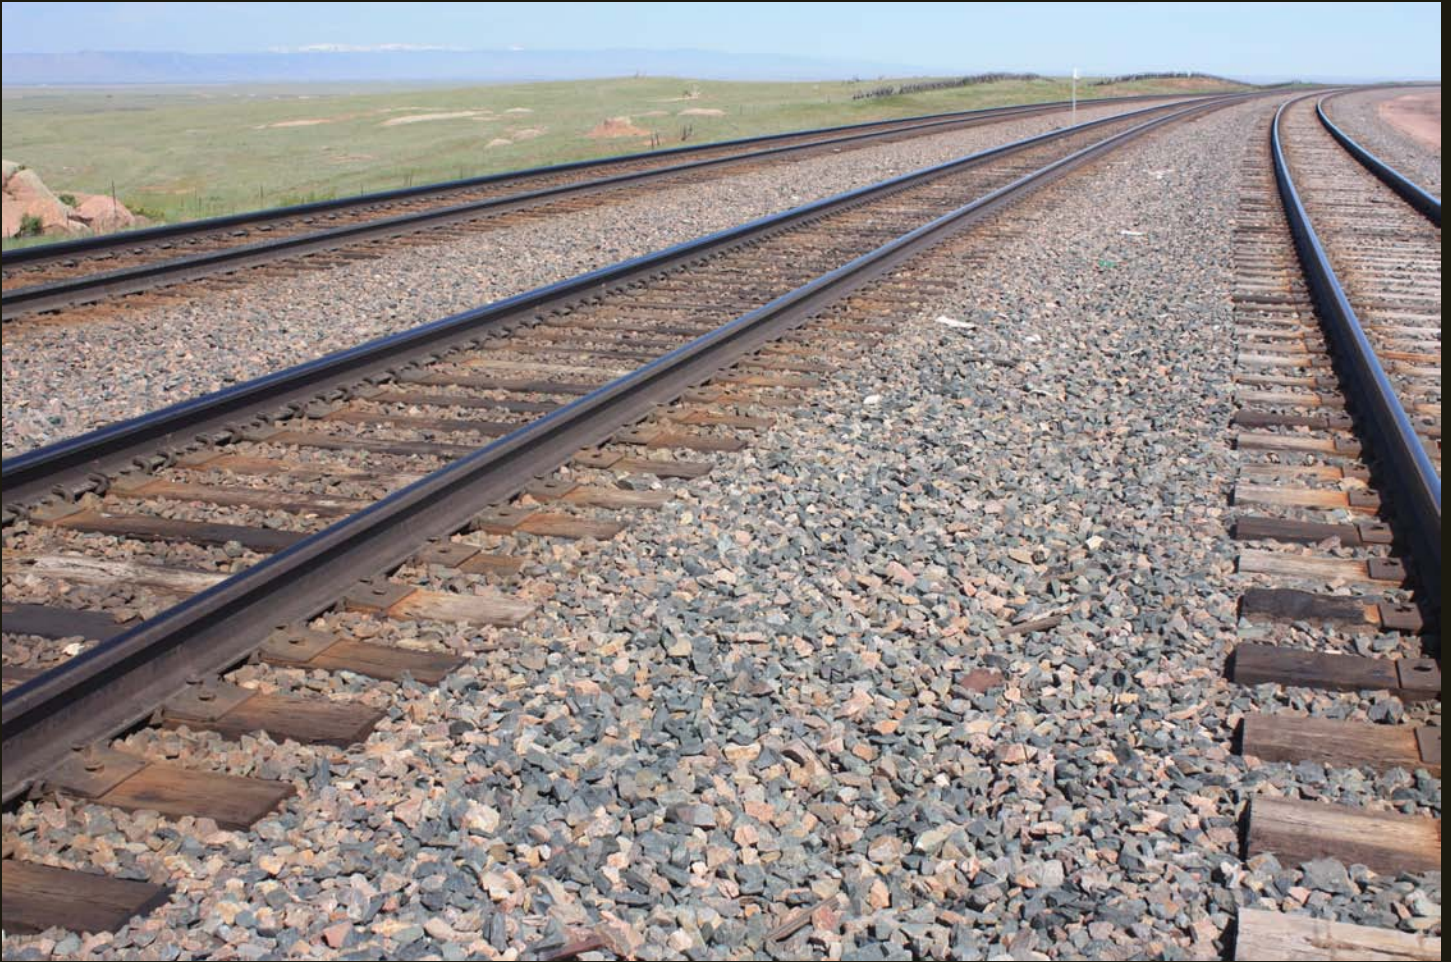
Westward view at about the same location as previous photo. The left (south) track starts to descend in the distance and follows the 1868 grade to Laramie. The two tracks on the right follow a new grade completed in 1917 from this point to Laramie.

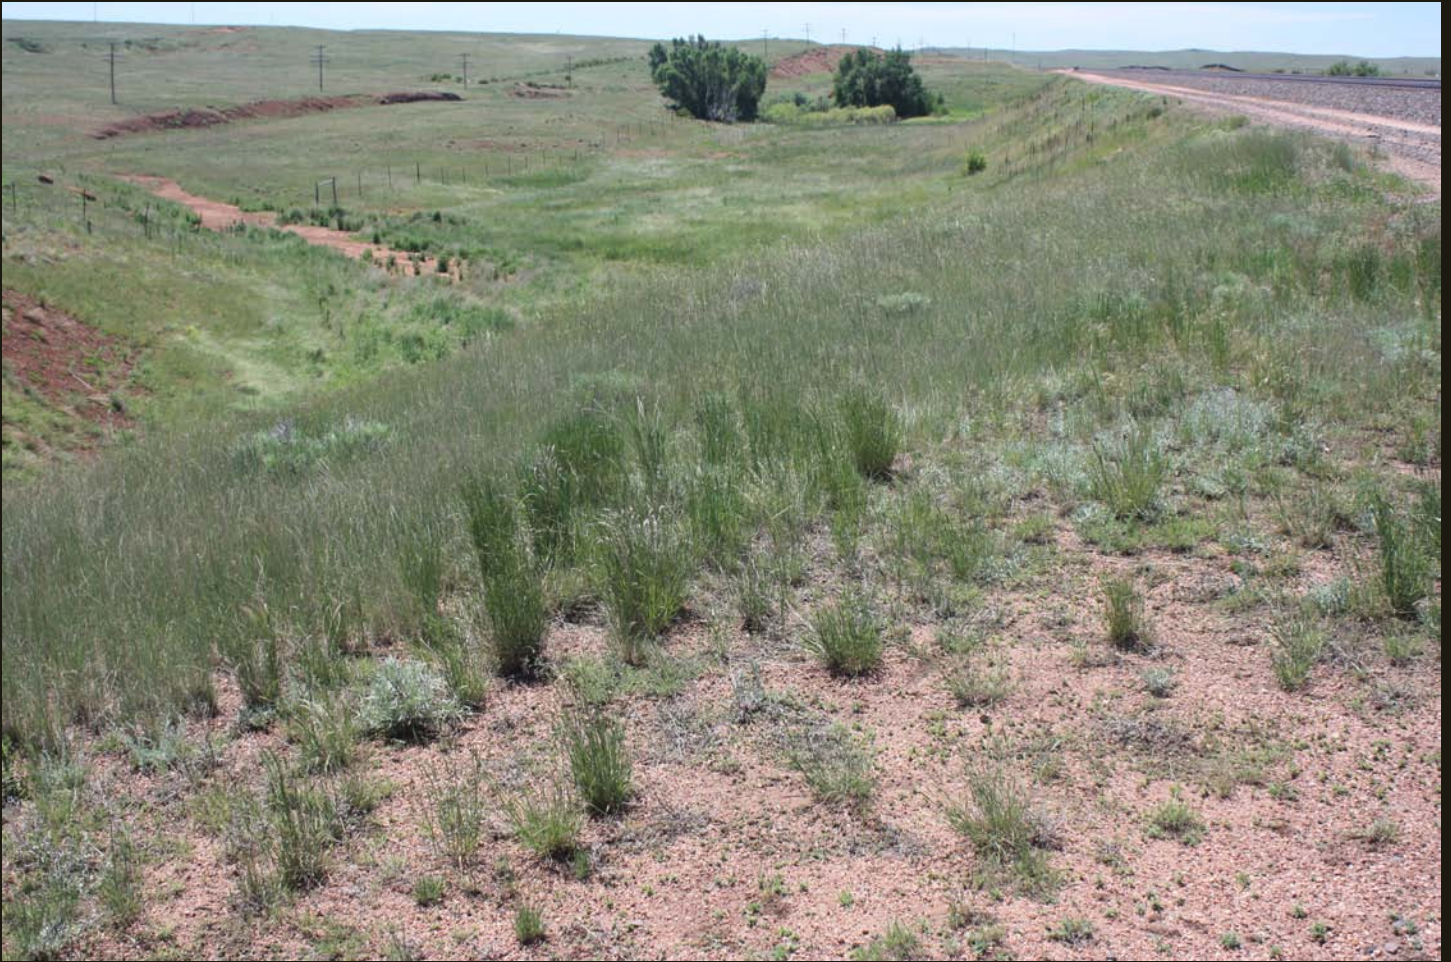
Near the same location as the previous photo, abandoned grades are visible north and east of current tracks. In this southeastward view, the active triple track is on the right, and an abandoned grade for a siding on the left is marked by a cut slope.

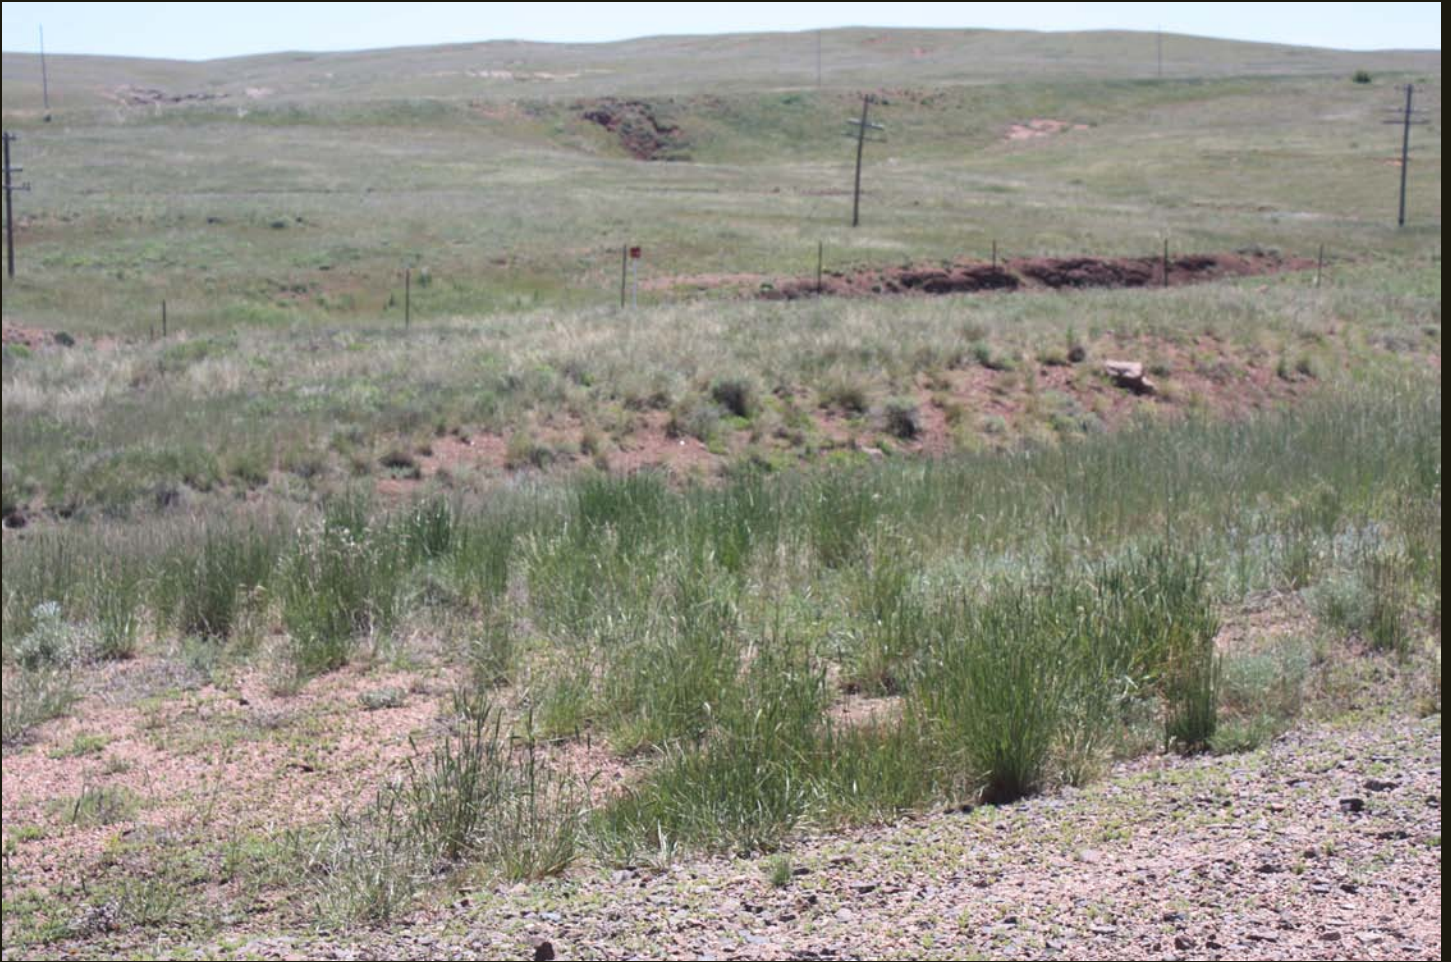
Abandoned fill grade, photo taken from active UP triple track west of Hermosa Tunnel; this is the 1868 mainline near where it intersects the 1901 re-alignment.

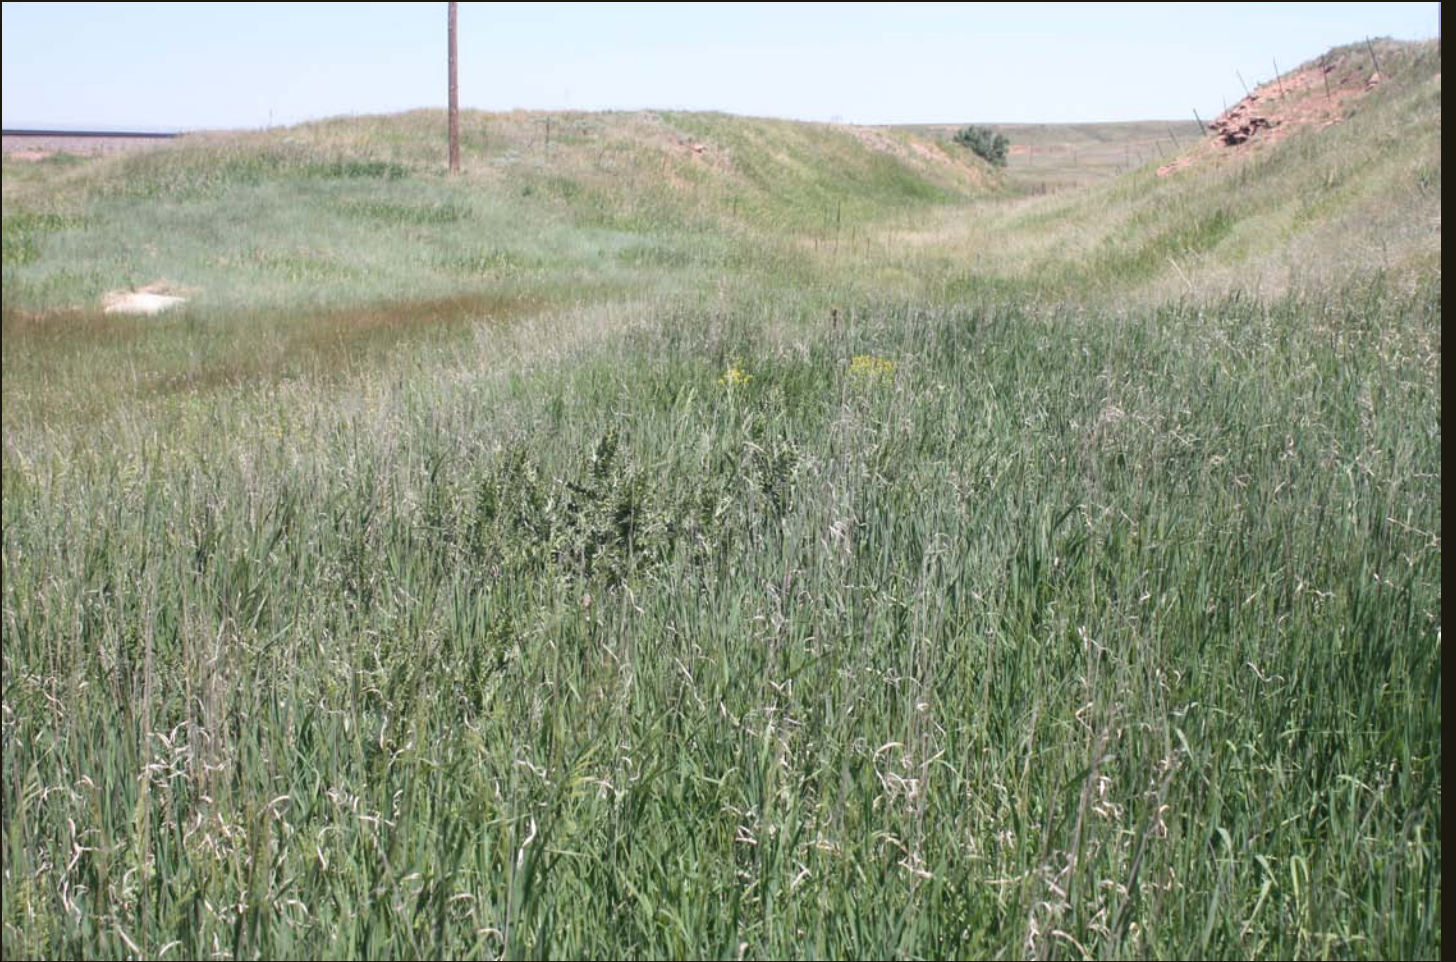
Abandoned cut for a siding.
