During the westward push of the Union Pacific Railroad to complete the transcontinental "Pacific Railroad," construction slowed in 1867 when the line reached Crow Creek at the eastern base of the north-south-trending Laramie Mountains, the UP route's most formidable obstacle. The "hell on wheels" town of Cheyenne grew as work progressed slowly over 8,247-foot Evans Pass (also called Sherman Pass) through the Laramie Mountains. Evans Pass is about 20 miles west of Cheyenne and was discovered by the UP-employed English surveyor and engineer, James Evans, in 1864. The new route surveyed across Wyoming was over 150 miles shorter and had a flatter profile than the emigrant wagon route over South Pass, and also went closer to Denver and to the coalfields in the Wasatch and Laramie Ranges. The line over Evans Pass and down to the next hell on wheels town, Laramie, was completed in 1868.

The Hermosa Tunnel was the key element of the 1901 re-alignment of the UP mainline over Evans Pass. The new alignment involved about 10 miles of new grade located south of Evan's Pass; the new grade leaves the 1868 grade about 5 miles east of Evan's Pass, crosses the crest of the Laramie Mountains at the

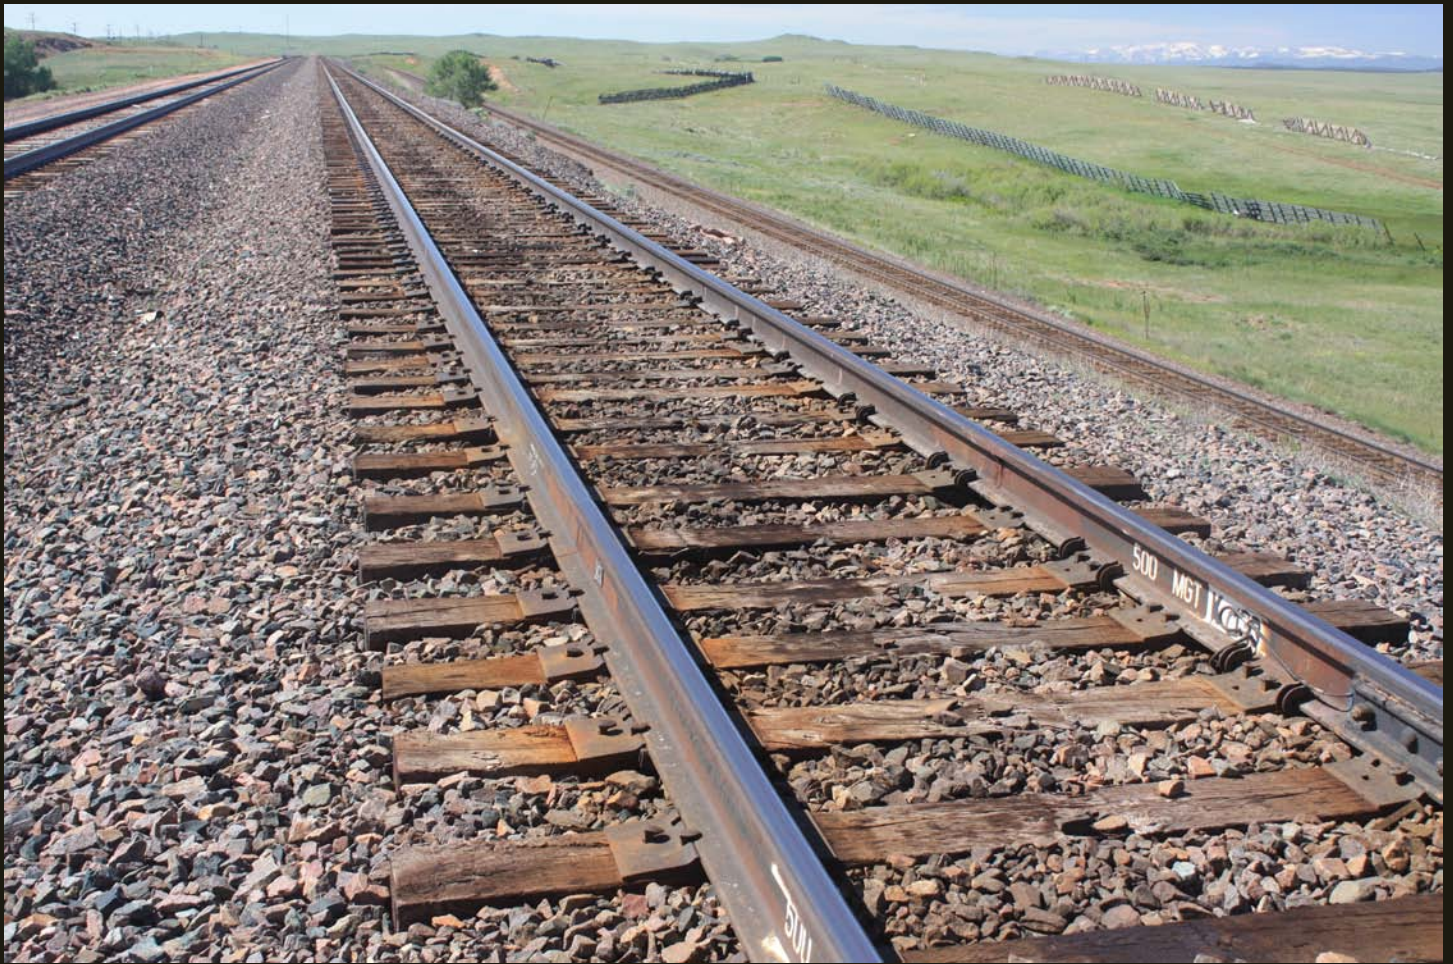
Eastward view of UP triple track. The right (south) track is the 1901 re-alignment and descends and follows the 1868 grade to Laramie. The two tracks on the left follow a new grade completed in 1917 from this point to Laramie.

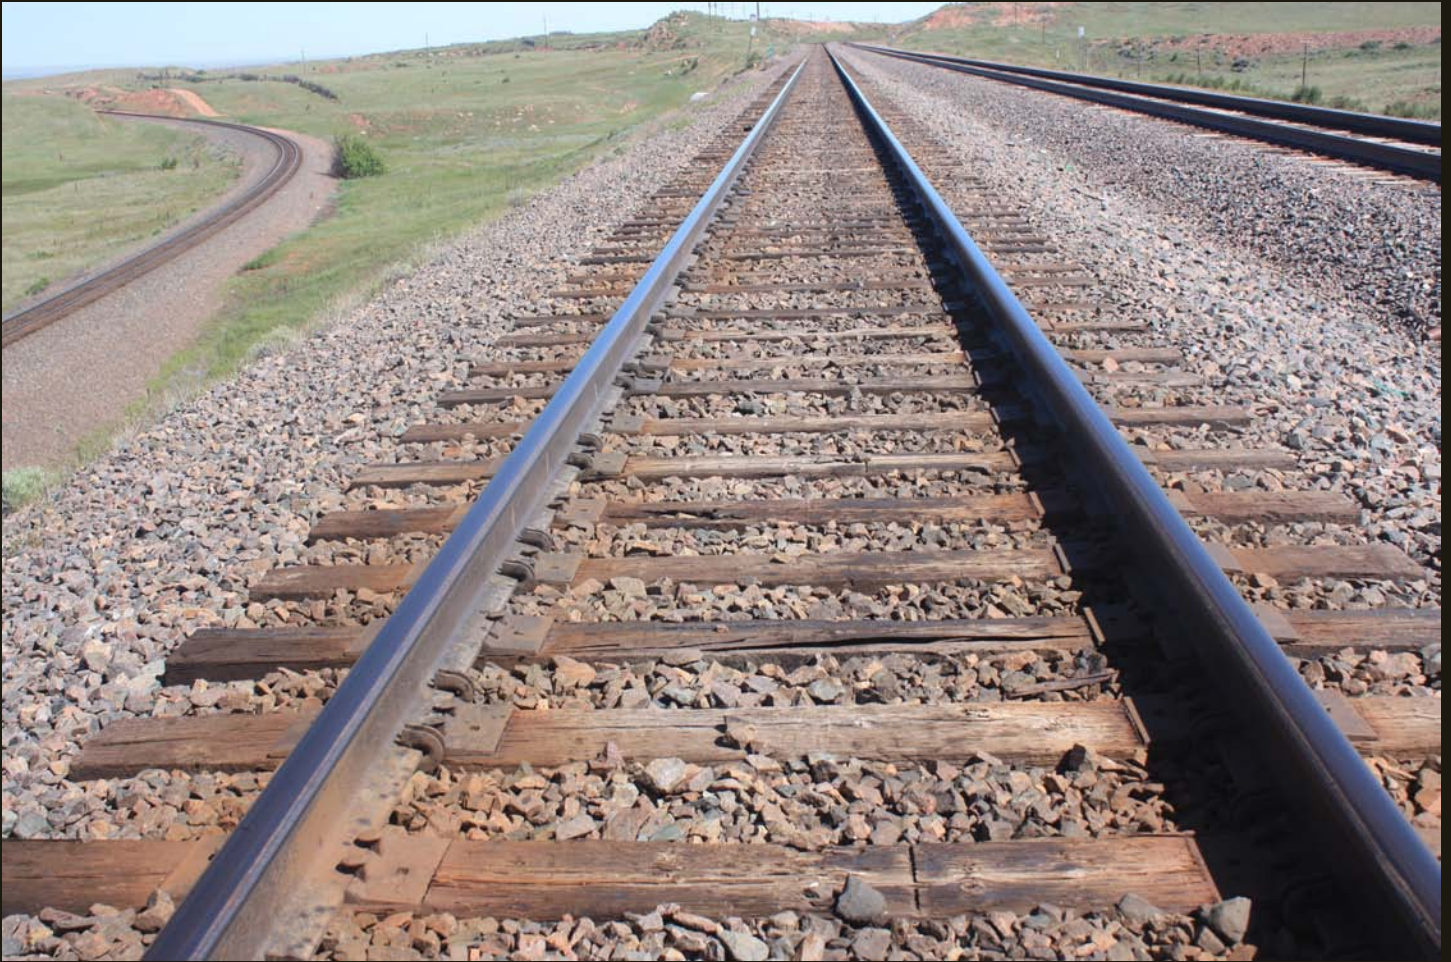
Westward view of UP triple track at same location as above. The left (south) track is the 1901 grade, which descends and joins the 1868 grade which it follows to Laramie. The two tracks on the right follow the 1917 grade to Laramie. The bare dirt area in the upper right corner of the photo is the abandoned 1868 grade, which crosses the double track and joins the single track in the upper left corner of the photo, just beyond where the single track disappears into a cut.
