We'll explore Donner Pass from west to east, starting with this westward view of the CP (later SP and now UP) at Norden, California, where the 1925 re-alignment to the then-new, longer, lower-elevation summit tunnel diverges from the original route over the pass. This is the east end of the Norden snowshed "complex" and the tracks diverge under the shed. The Norden snowshed was completely rebuilt in 1925. The west end of the 1,000-foot-long shed has a simple entrance with two tracks entering, the same two tracks seen here at the east end, which has three generations of snowshed entrances. The abandoned shed at the far right is on the original CP alignment, the abandoned center entrance (with the red door) is the 1925 second track to the lower summit tunnel, and the active shed on the left was built later to accommodate two tracks on the 1925 alignment to the lower tunnel (I could not find a date for this third entrance).

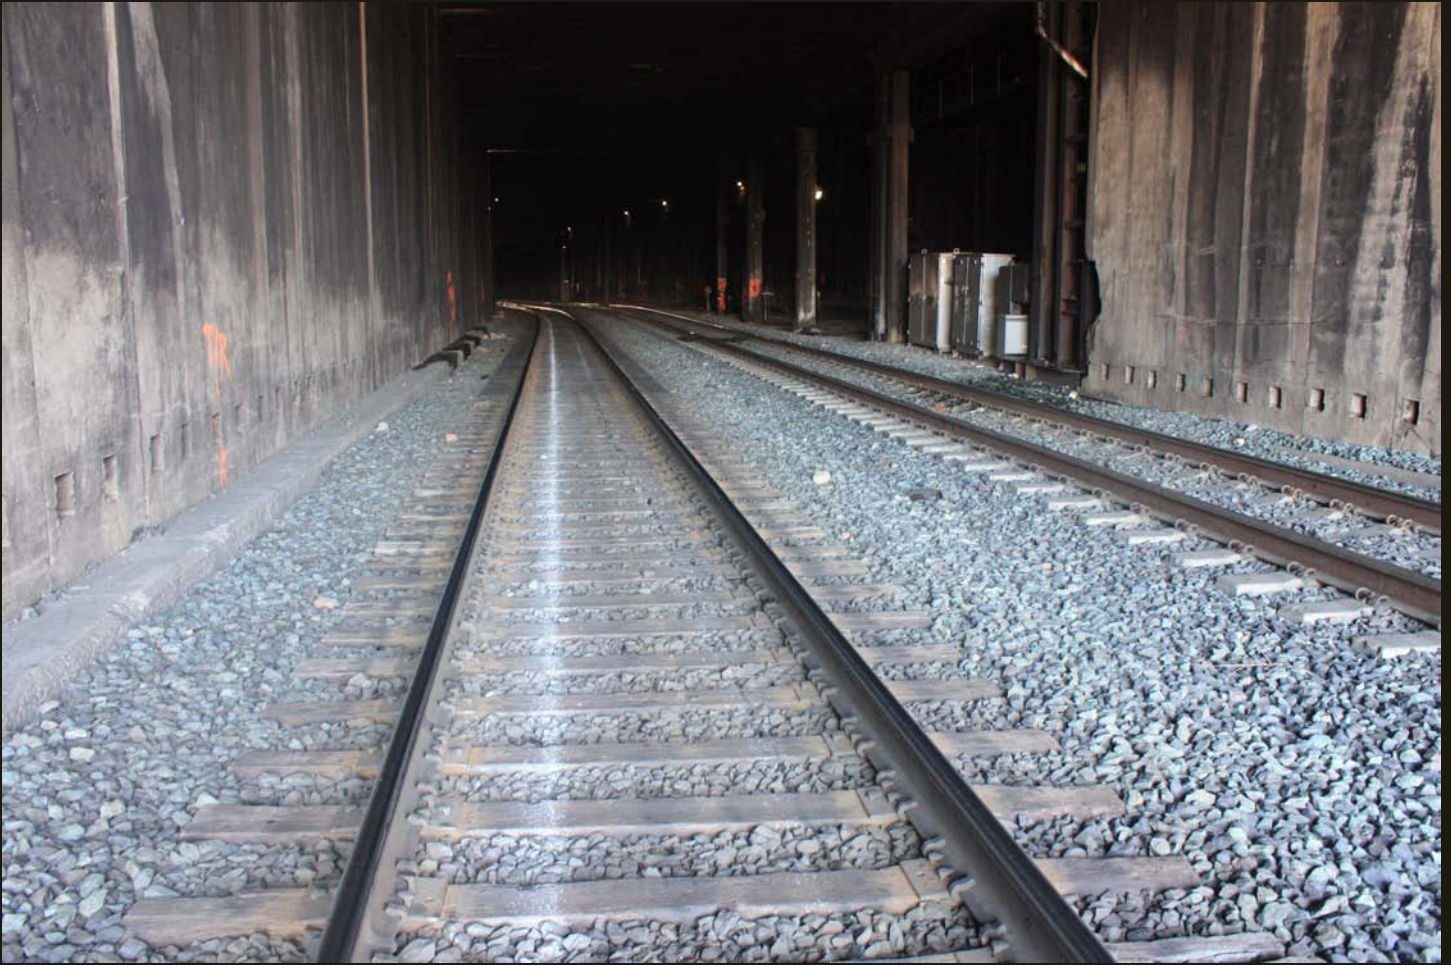
Westward view of the active shed entrance. The concrete wall on the right is the original (1925) south wall of the shed and the wall was removed to the left, where pillars replaced the wall when the wall was opened up to add the third (active entrance). The 1925 second track alignment is on the other side of the pillars and the original (1867) CP alignment is in the dark distance.

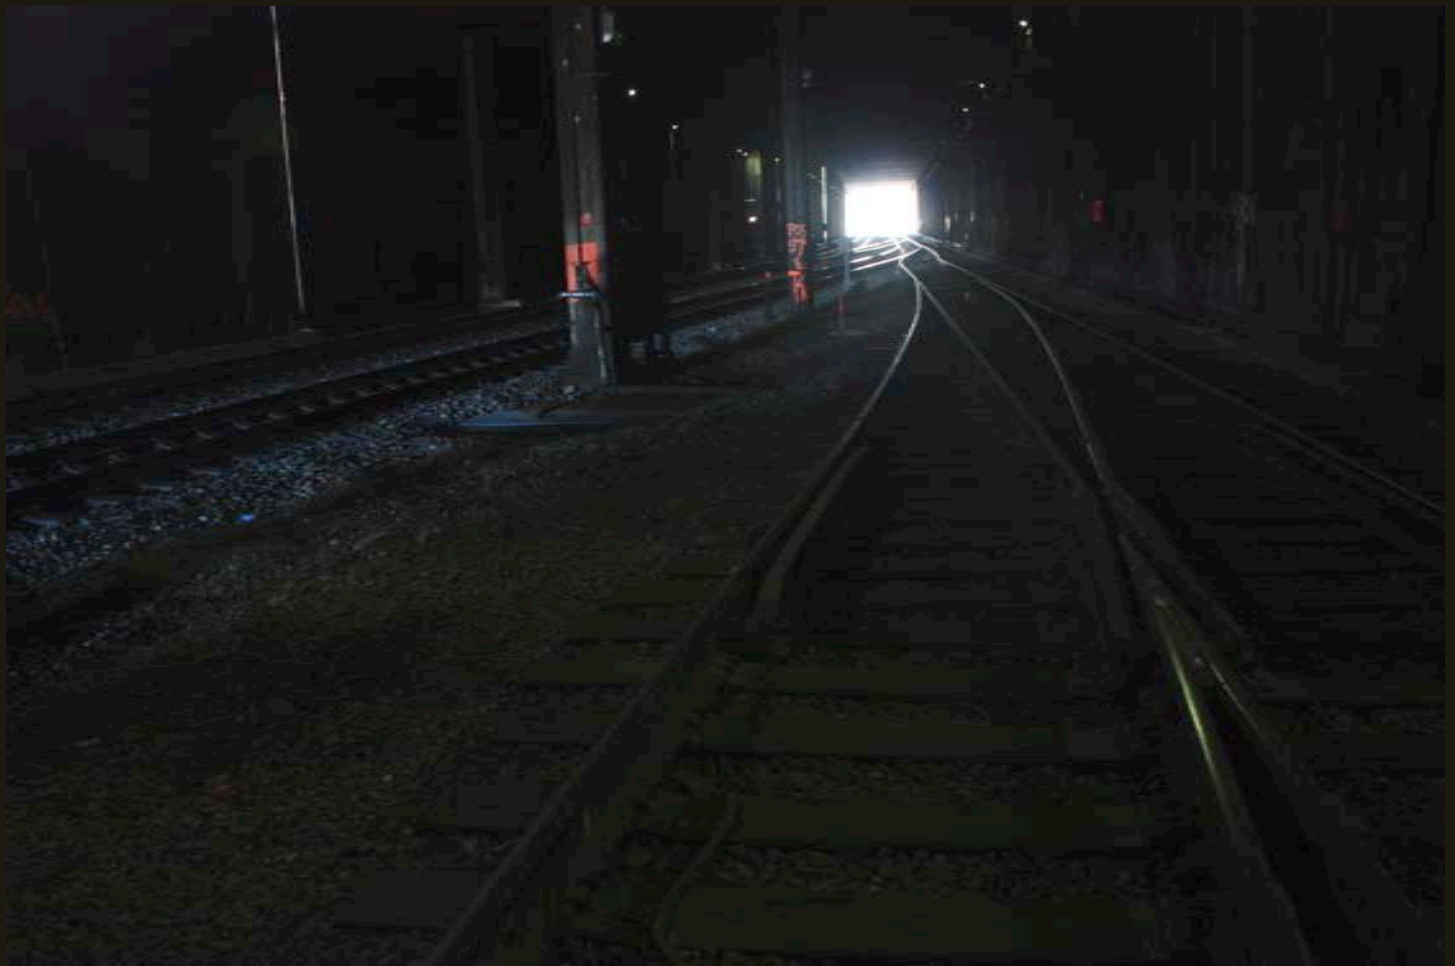
Westward view of the west shed entrance showing the inner workings of the Norden snowshed complex. There are four tracks here, from right to left: the original CP (1869) alignment; the 1925 second track alignment, which was re-aligned and once continued to the left side of the west entrance; and the two active tracks with concrete ties and fresh ballast.

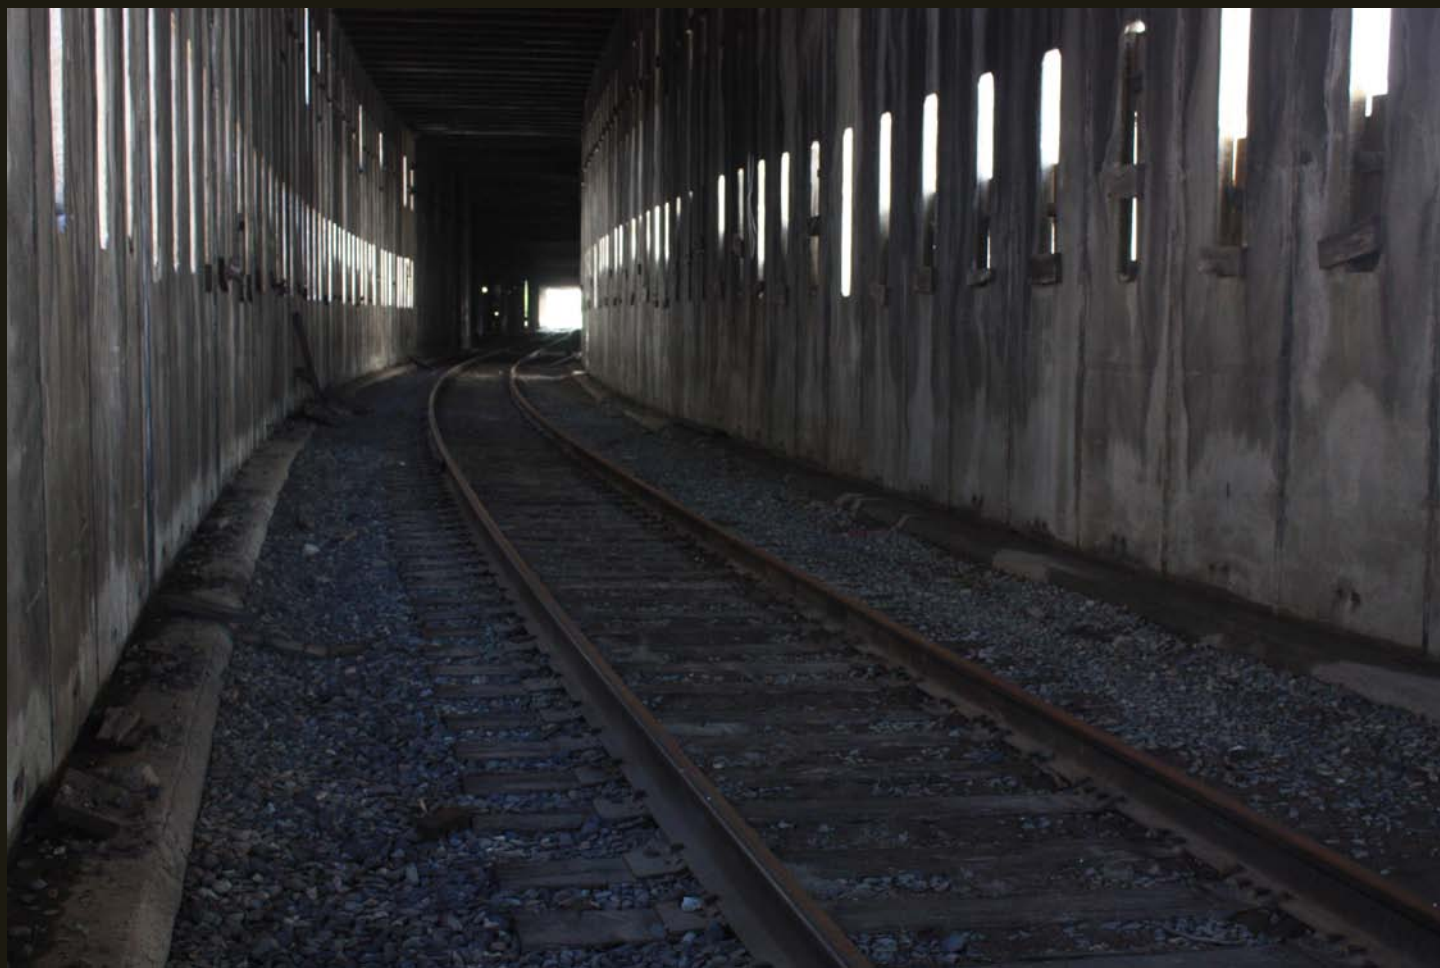
Westward view of the west shed entrance, the light at the end of the tunnel in this view. The original (1867) CP alignment, which is the northernmost of the three eastern entrances, is in the foreground.

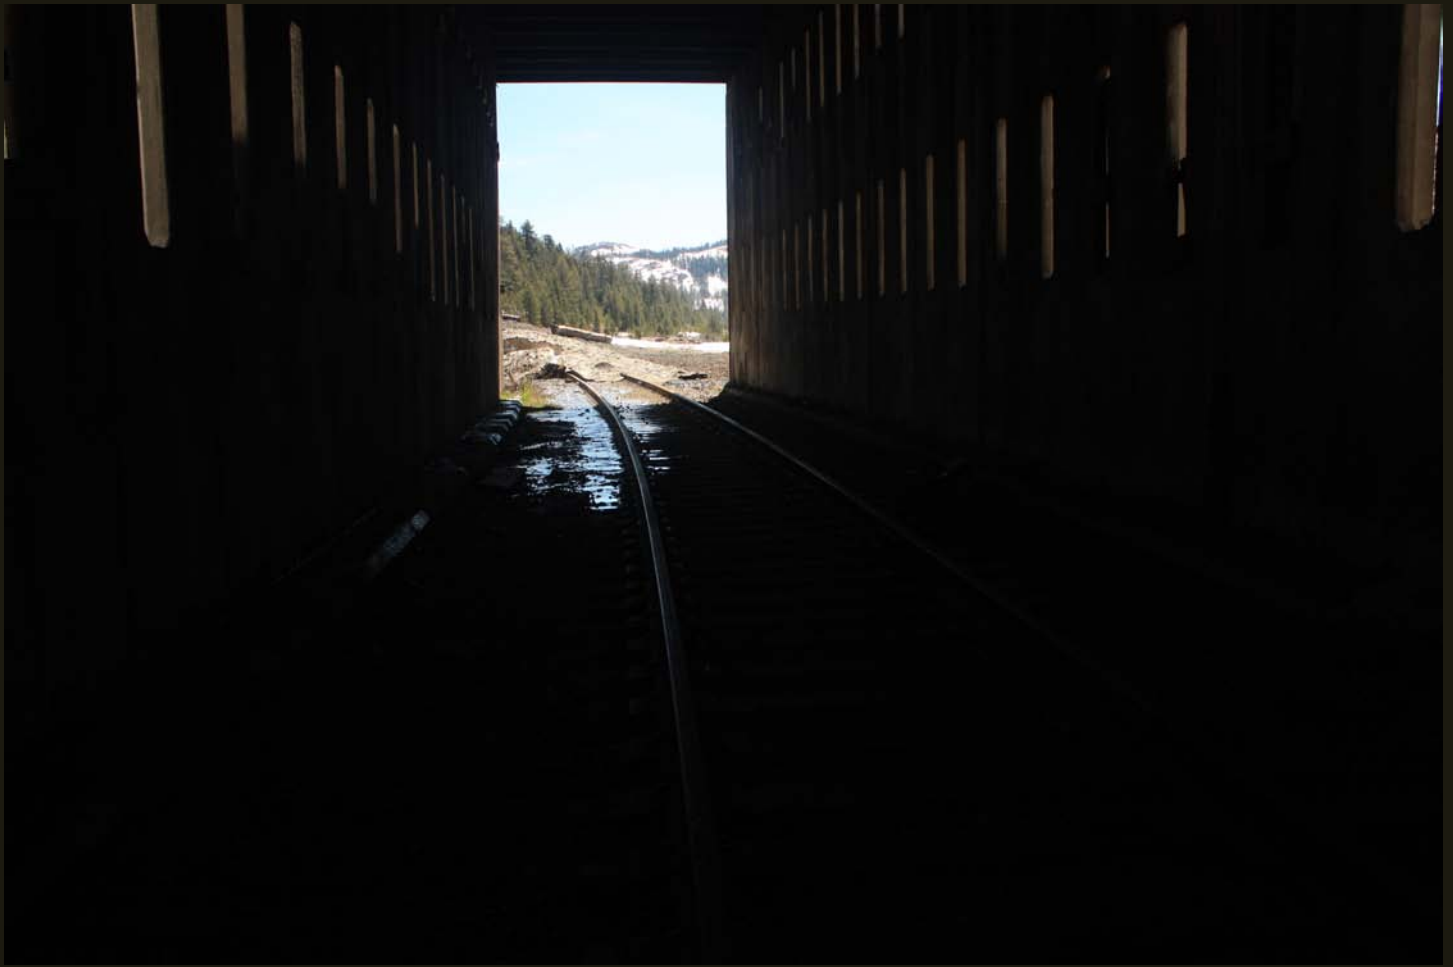
Eastward view of the original (1867) CP alignment, same location as previous photo. The track begins a curve to the left to climb to the original (1868) summit tunnel.

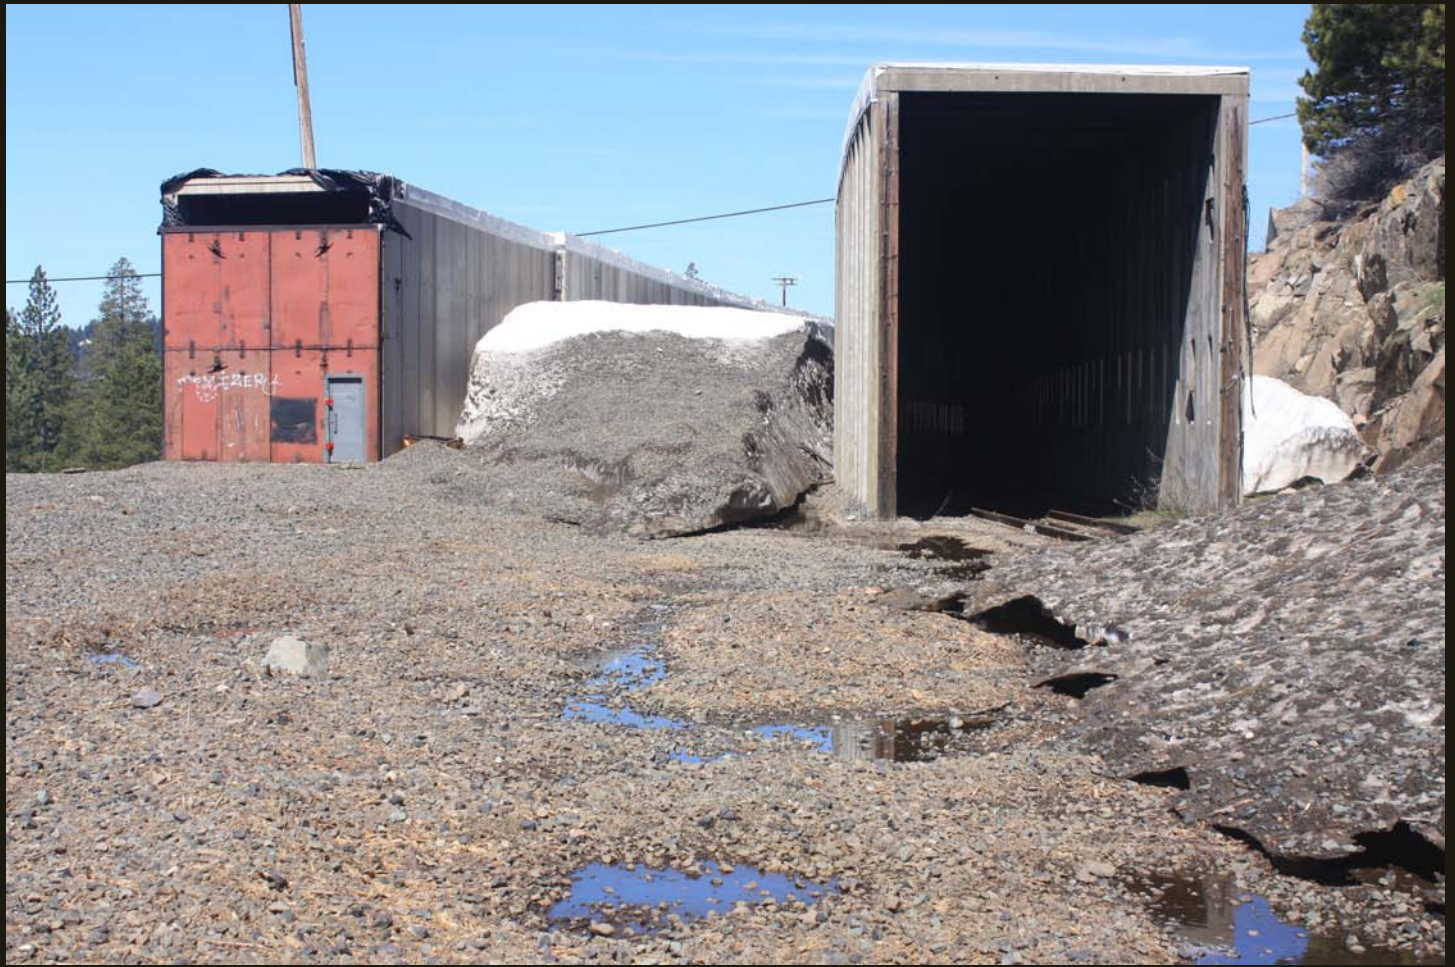
Westward view of the original (1925) east entrances for the Norden snowshed complex. The original CP alignment is on the right and still has tracks; this is the line to the original/higher summit tunnel. The shed entrance on the left (with the red door) is the 1925 second track to the lower summit tunnel. Both entrances had to have been built in 1925 to accommodate the two tracks, but it is unclear why their construction is so different.

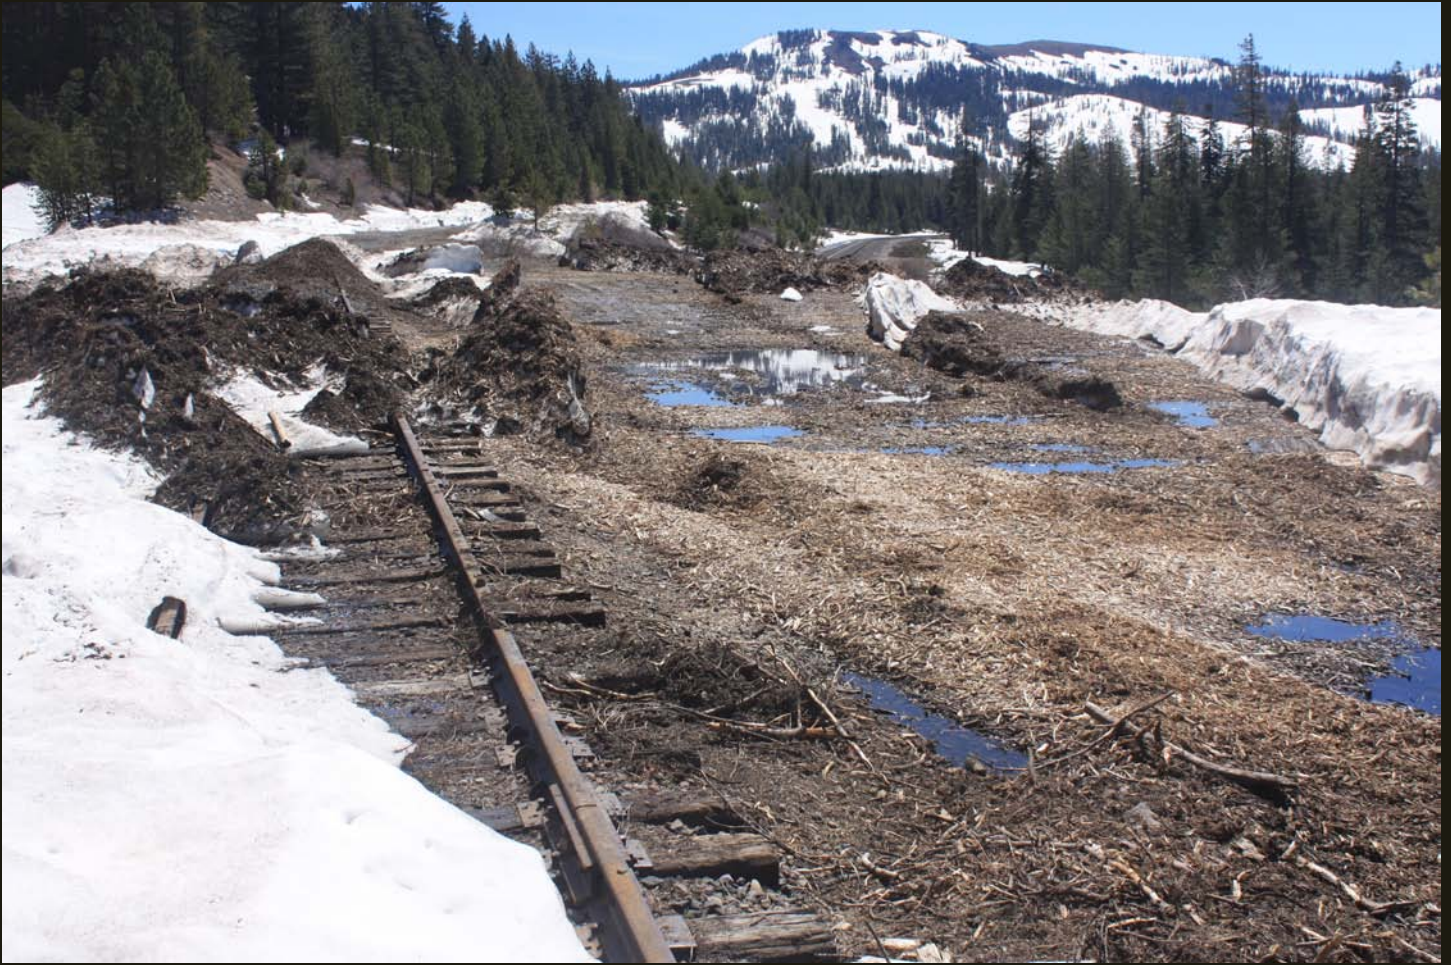
Eastward view of the original CP alignment, as it begins its climb to the upper tunnel and cuts a steeper grade than the active tracks (visible in the center distance) to the lower tunnel. The old track ends at a pile of dirt on the left.

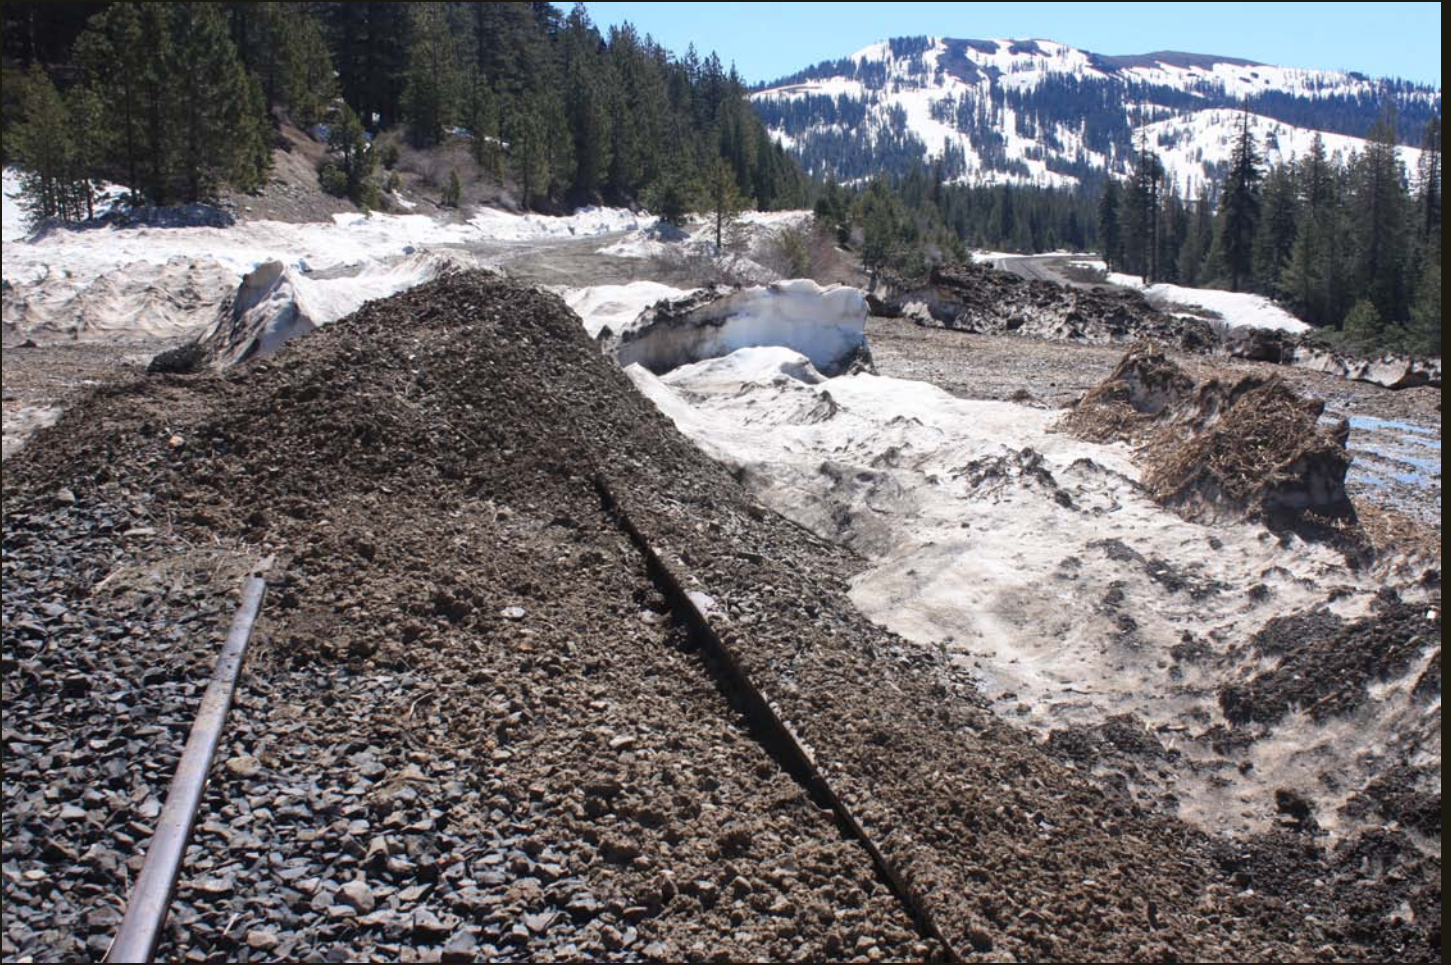
Closer eastward view of the end-of-track of the original CP alignment, which was abandoned in 1993. Somewhere in this view there was once a turntable to turn helper engines; the turntable was built in 1924 as part of the SP's double tracking project.

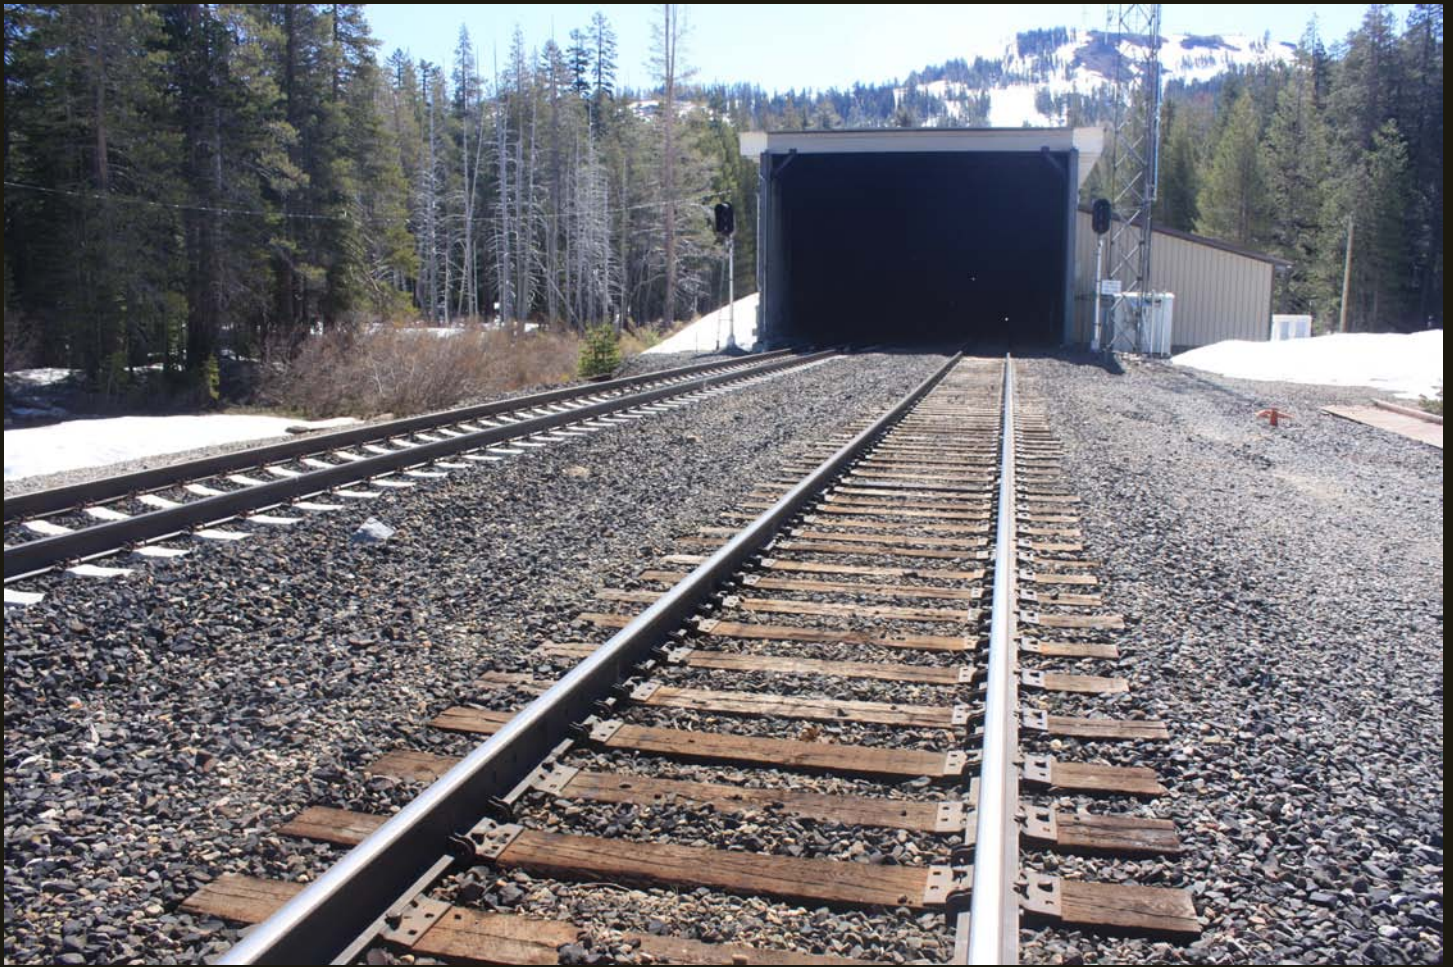
Eastward view of the west entrance of the SP's 1925 summit tunnel under Donner Pass, 1.1 miles east of Norden (previous location). The west entrance of the 2-mile-long tunnel has a 700-foot snow shed that covers a switch that brings the double track down to one track before entering actual tunnel. On-line discussions indicate this is a bottleneck on the UP's primary transcontinental route and diverts traffic to the UP's Western Pacific (1909) Feather River Route.

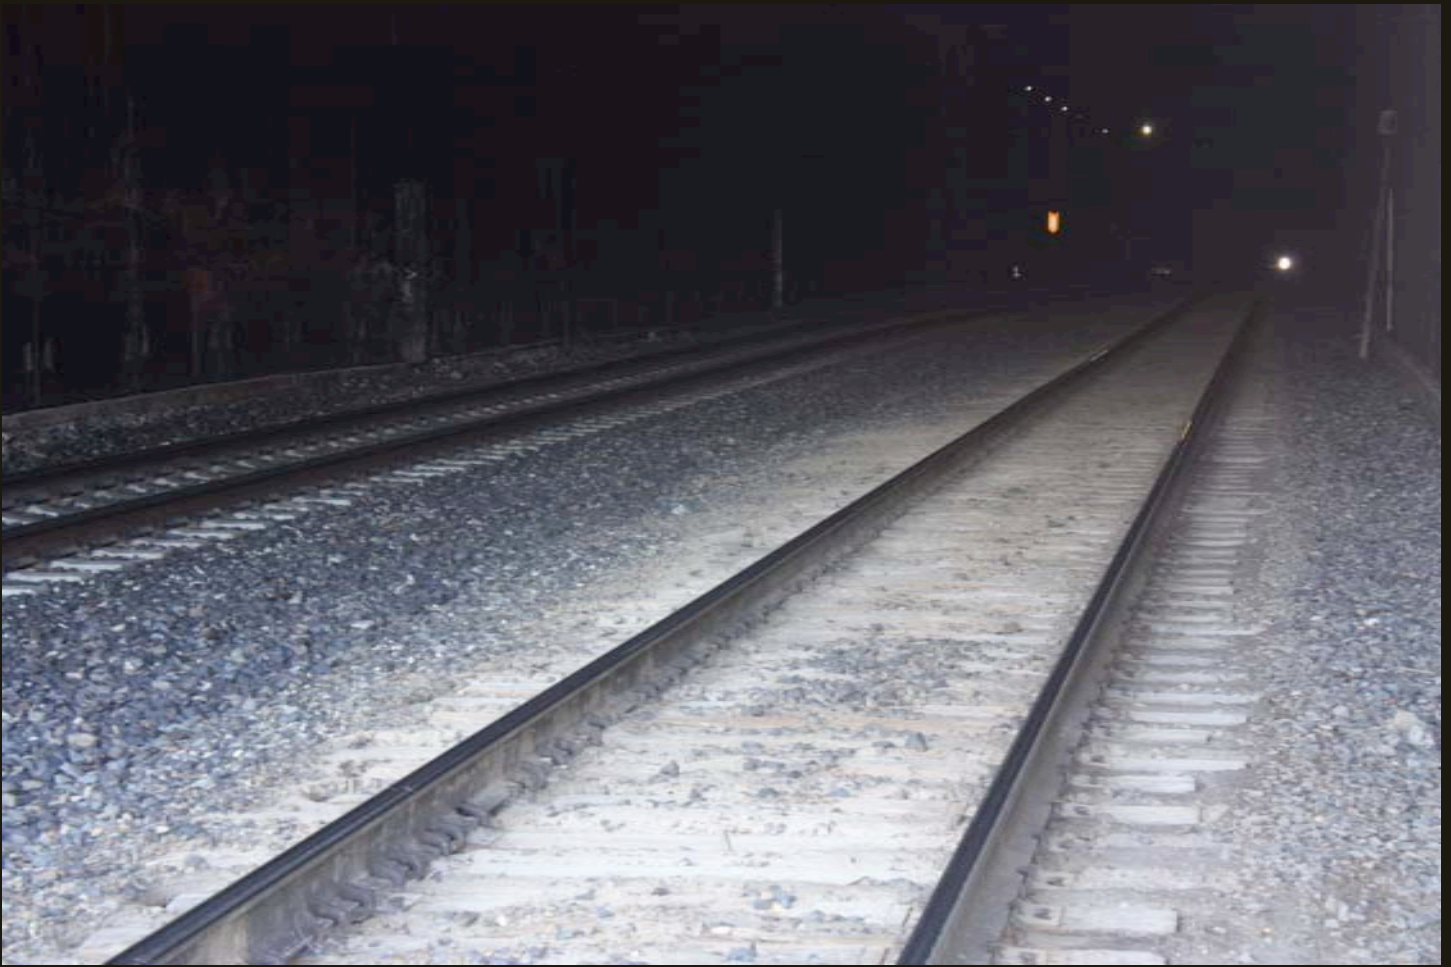
Eastward view of the trackage within the snowshed at the west entrance of the SP's 1925 summit tunnel. The switch that brings the double track down to one track is marked by converging track and the bright orange chevron on the switch. The light at the end of the tunnel is 2 miles away and is in the Great Basin.

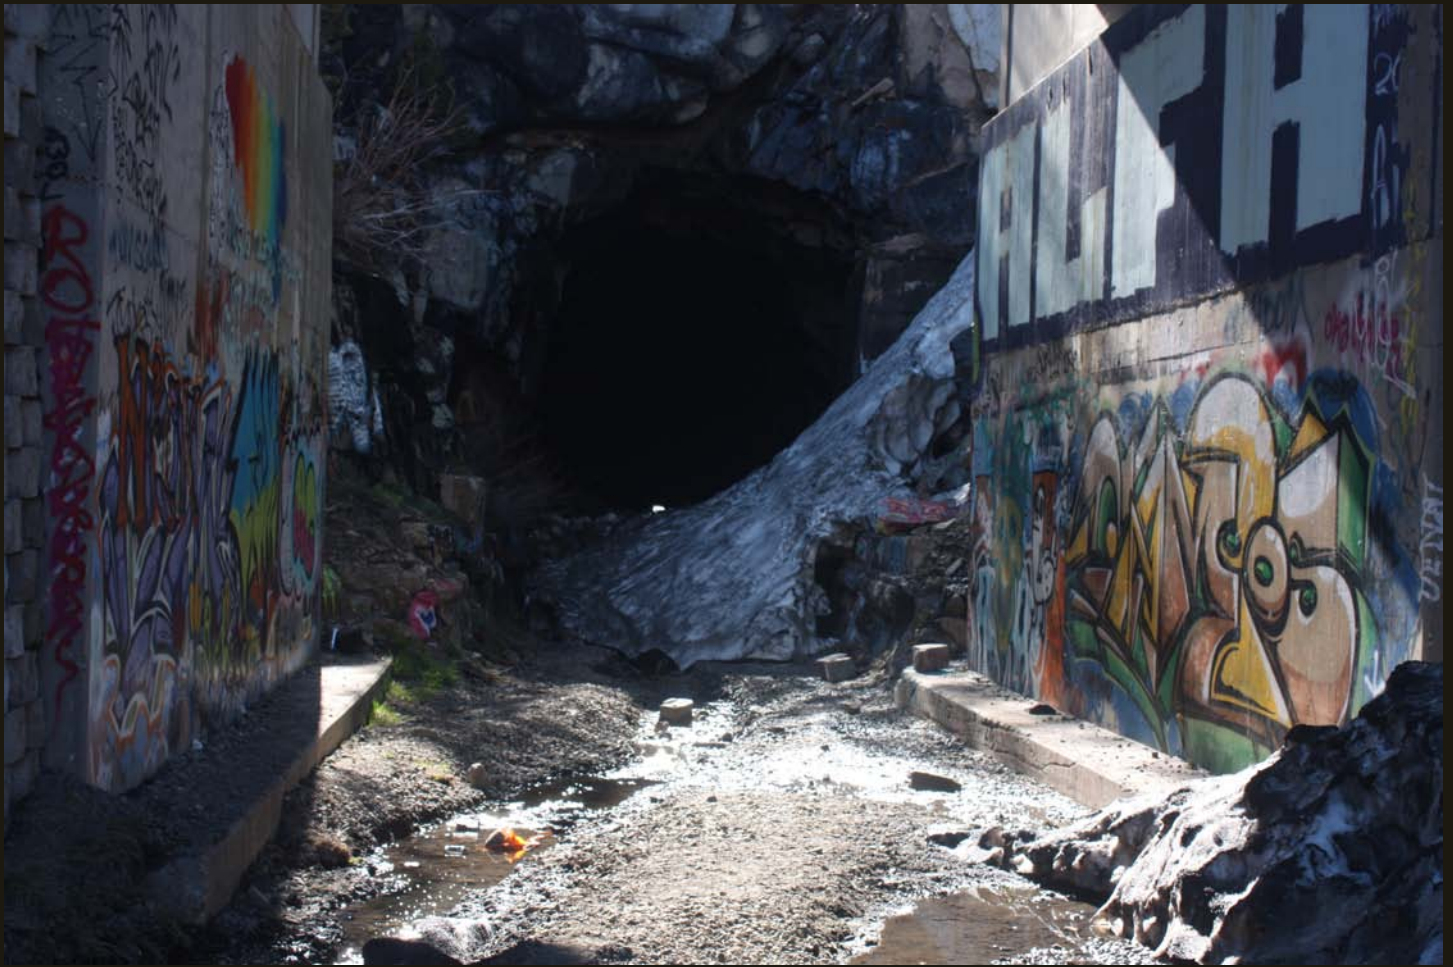
Eastward view of the west entrance of the original CP summit tunnel, built by thousands of Chinese craftsmen and laborers during 1867 and 1868. The graffiti covered retaining walls support Sugar Bowl Road. Note that the 1,659-foot tunnel has no concrete work, which was not needed because the glaciated granite is so hard.

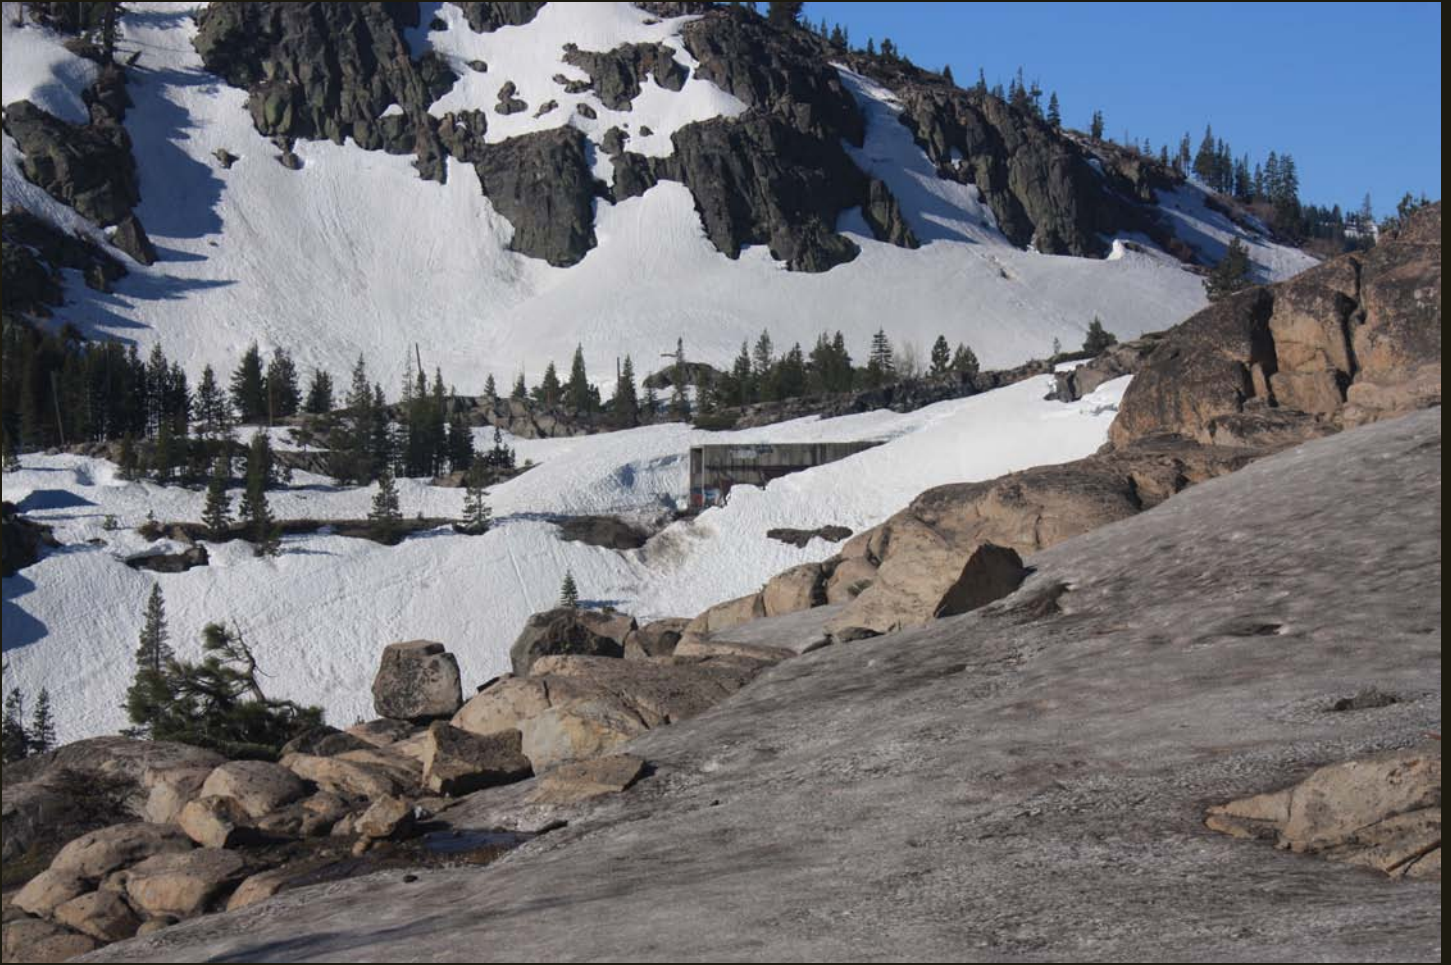
Whereas the western approach to Donner Pass follows the South Yuba River, which provided only moderate construction challenges, the east entrances of the two summit tunnels daylight on a steep mountain slope. The snowshed in this southward view is the east entrance to the original CP tunnel. Note the bare, glaciated granite and the steep slope to the left (east) at the western boundary of the Great Basin.

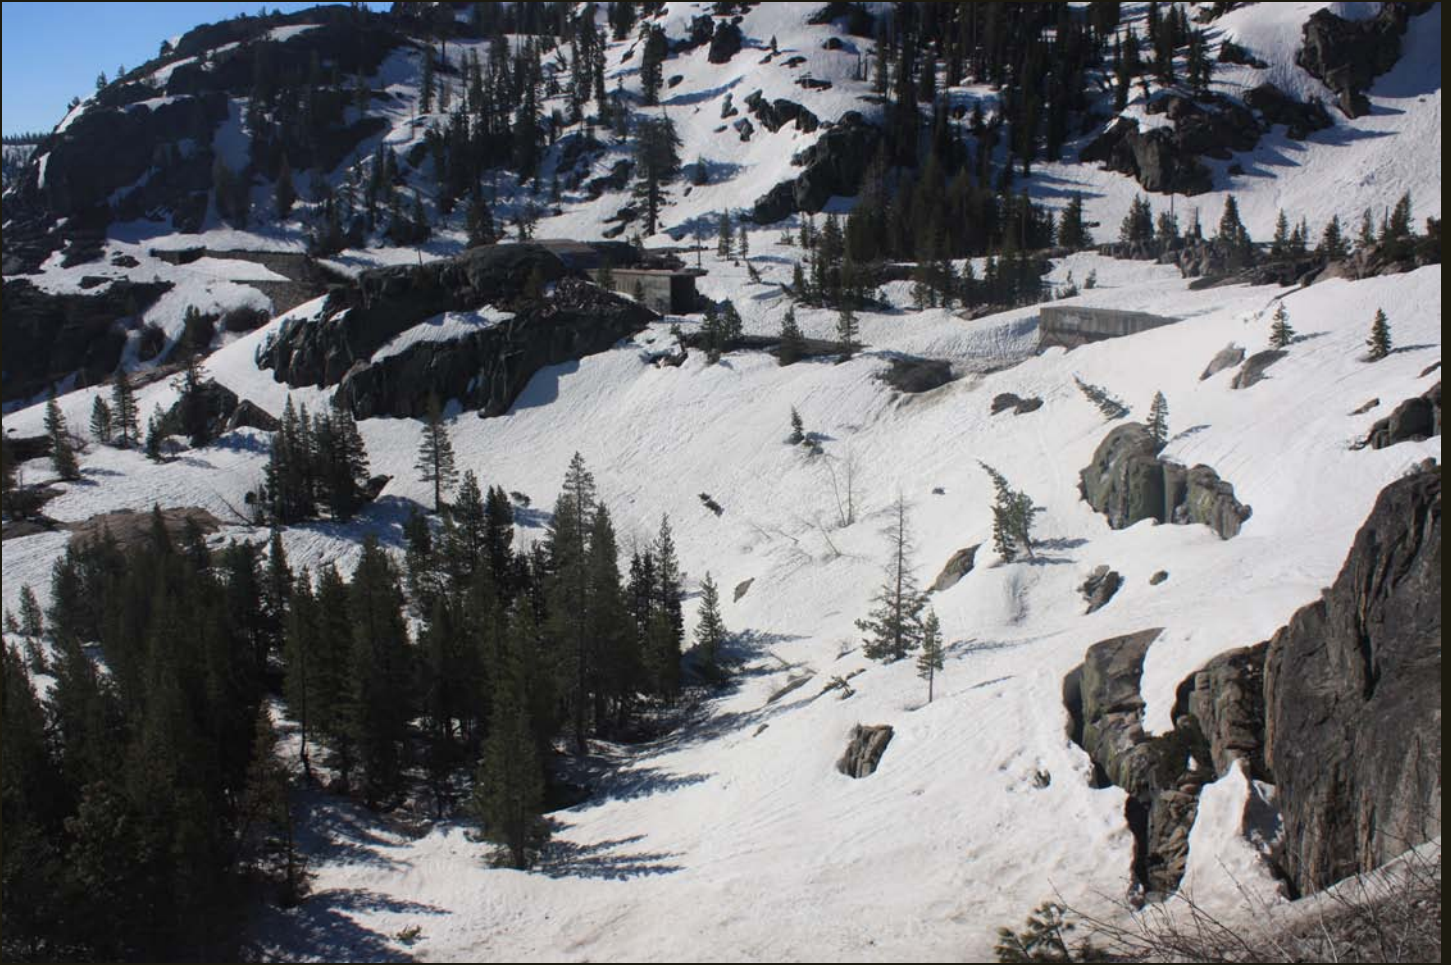
Southeastward view near the same location as previous. The snowshed on the right is the same one as in the previous photo, i.e. the east entrance of the original CP tunnel. Going left (east) from that shed is an open cut grade, then a shed built into a cut grade through a granite hump, then an open ledge grade with retaining walls – the “China Wall.”

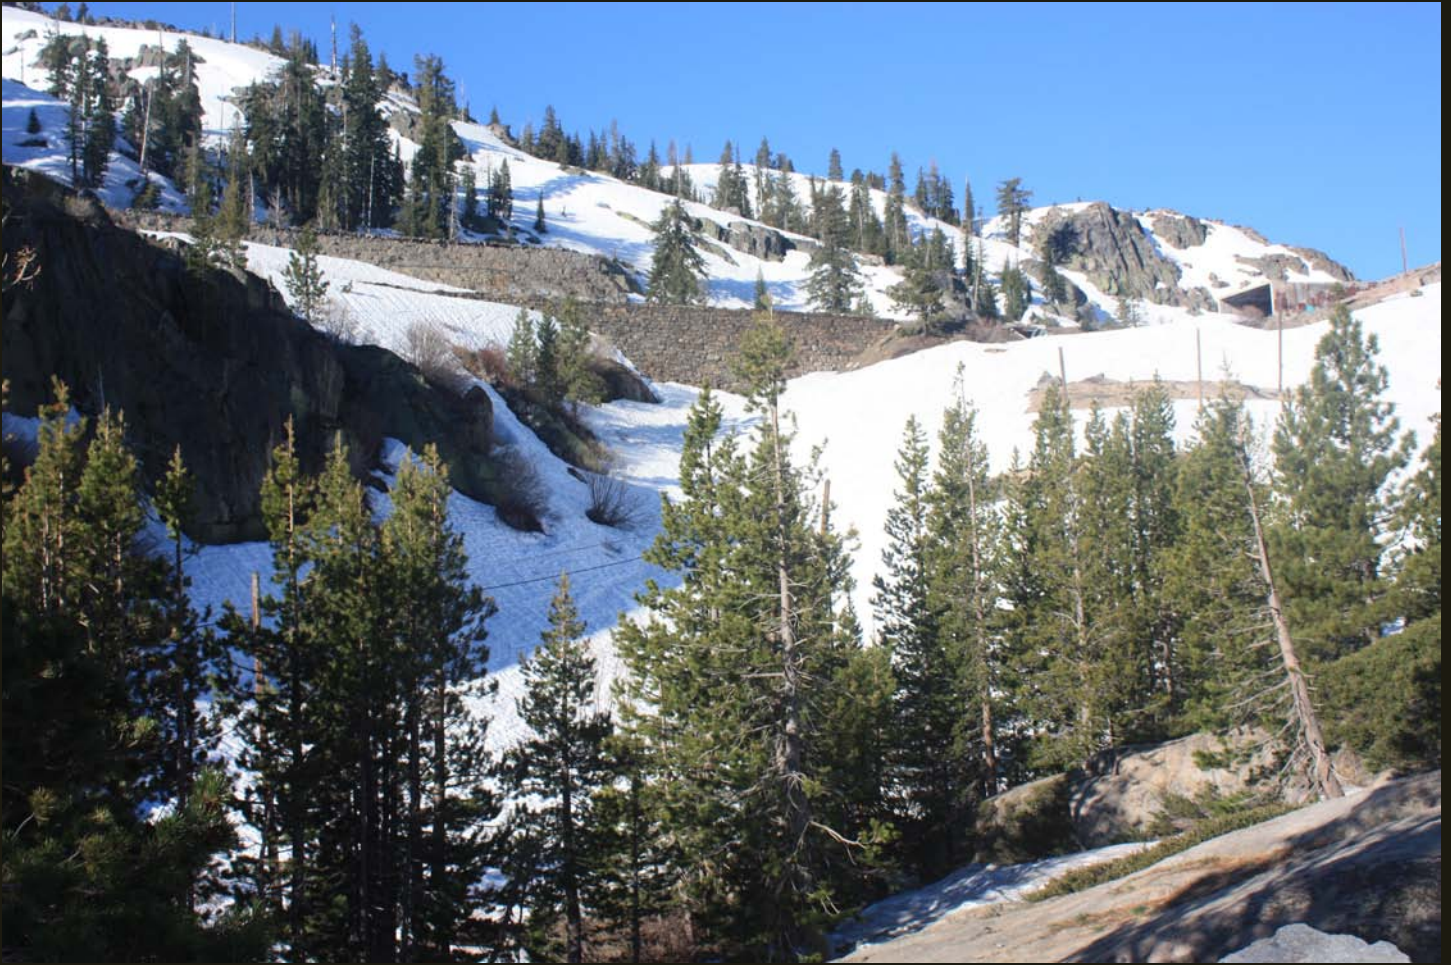
Southward view of the China Wall. Rock excavated from the summit tunnel was used to fill in the ravine and was faced with perfectly fitted quarried granite; there is no mortar in the cracks. The upper wall protects the track from avalanches and slides. The walls are in perfect condition, looking good for 150 years old and more than a century of heavy rail traffic.

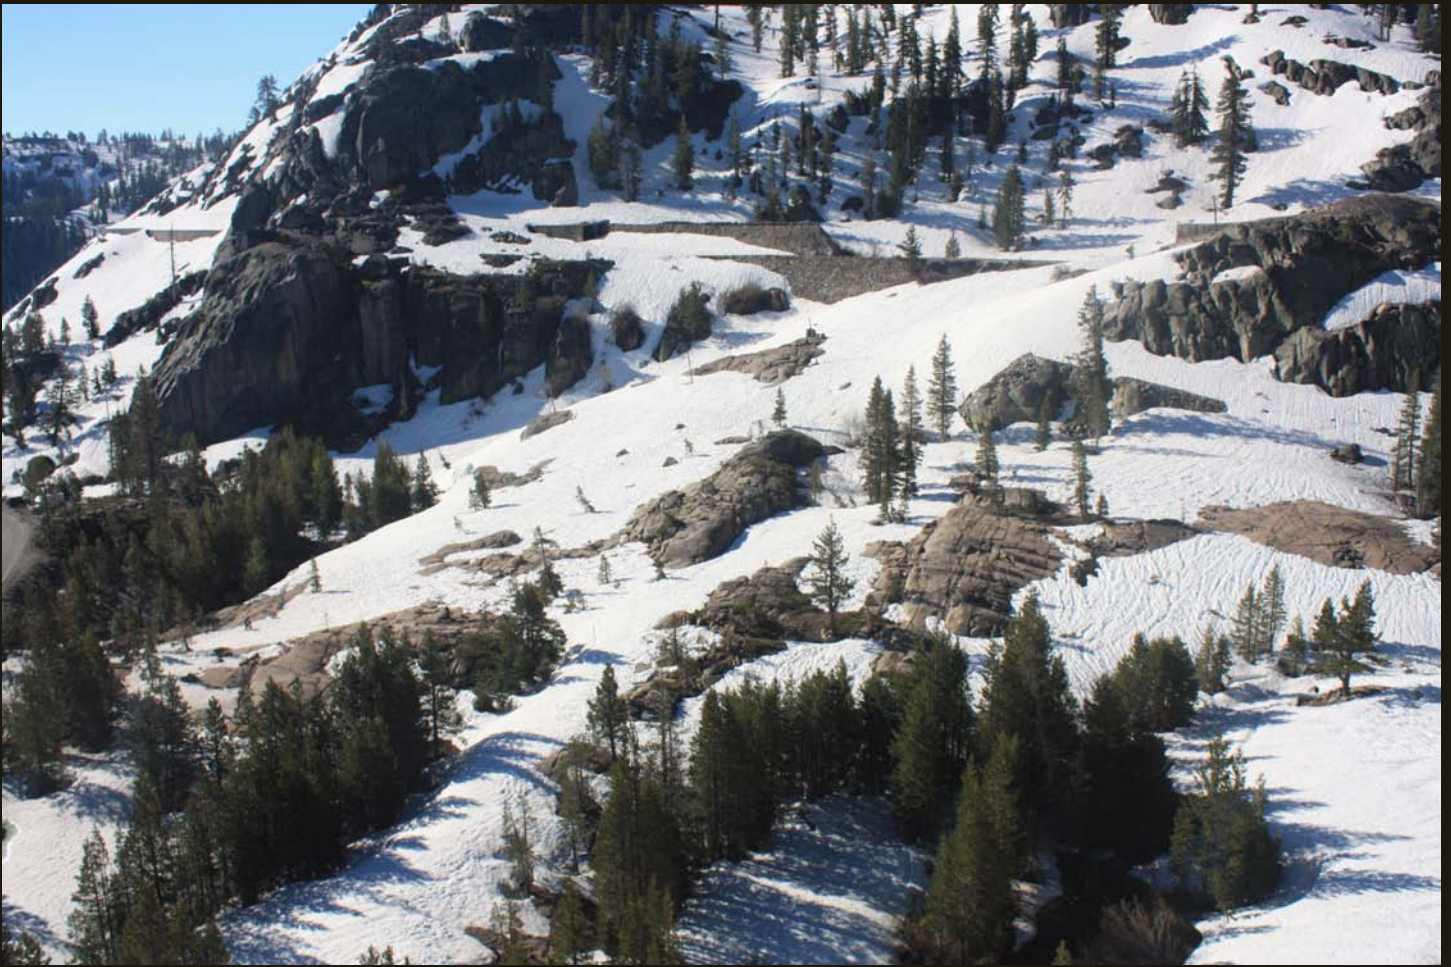
Southeastward view of the China Wall. To the left of the wall is a tunnel through a granite ledge, which emerges on the other side into a partially buried snowshed.

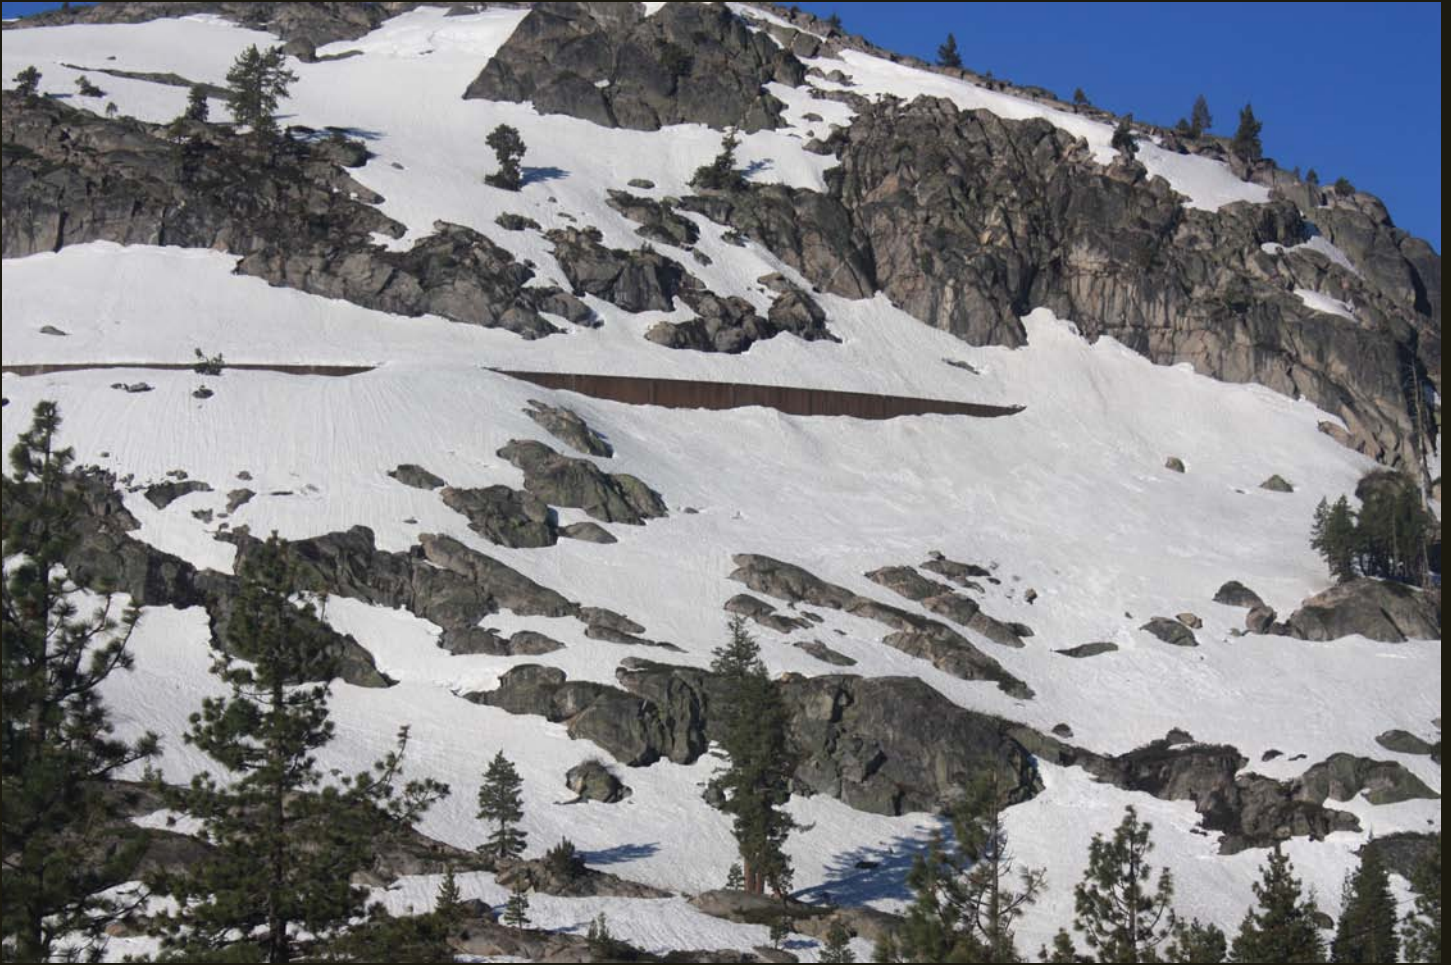
Southwestward view of the snowshed east of the China Wall. This shed continues 1.4 rail miles down the slope, interrupted only by four short tunnels. A lot of snow for late May.
