We'll explore Donner Pass from west to east, starting with this westward view of the CP (later SP and now UP) at Norden, California, where the 1925 re-alignment to the then-new, longer, lower-elevation summit tunnel diverges from the original route over the pass. This is the east end of the Norden snowshed "complex" and the tracks diverge under the shed. The Norden snowshed was completely rebuilt in 1925. The west end of the 1,000-foot-long shed has a simple entrance with two tracks entering, the same two tracks seen here at the east end, which has three generations of snowshed entrances. The abandoned shed at the far right is on the original CP alignment, the abandoned center entrance (with the red door) is the 1925 second track to the lower summit tunnel, and the active shed on the left was built later to accommodate two tracks on the 1925 alignment to the lower tunnel (I could not find a date for this third entrance).

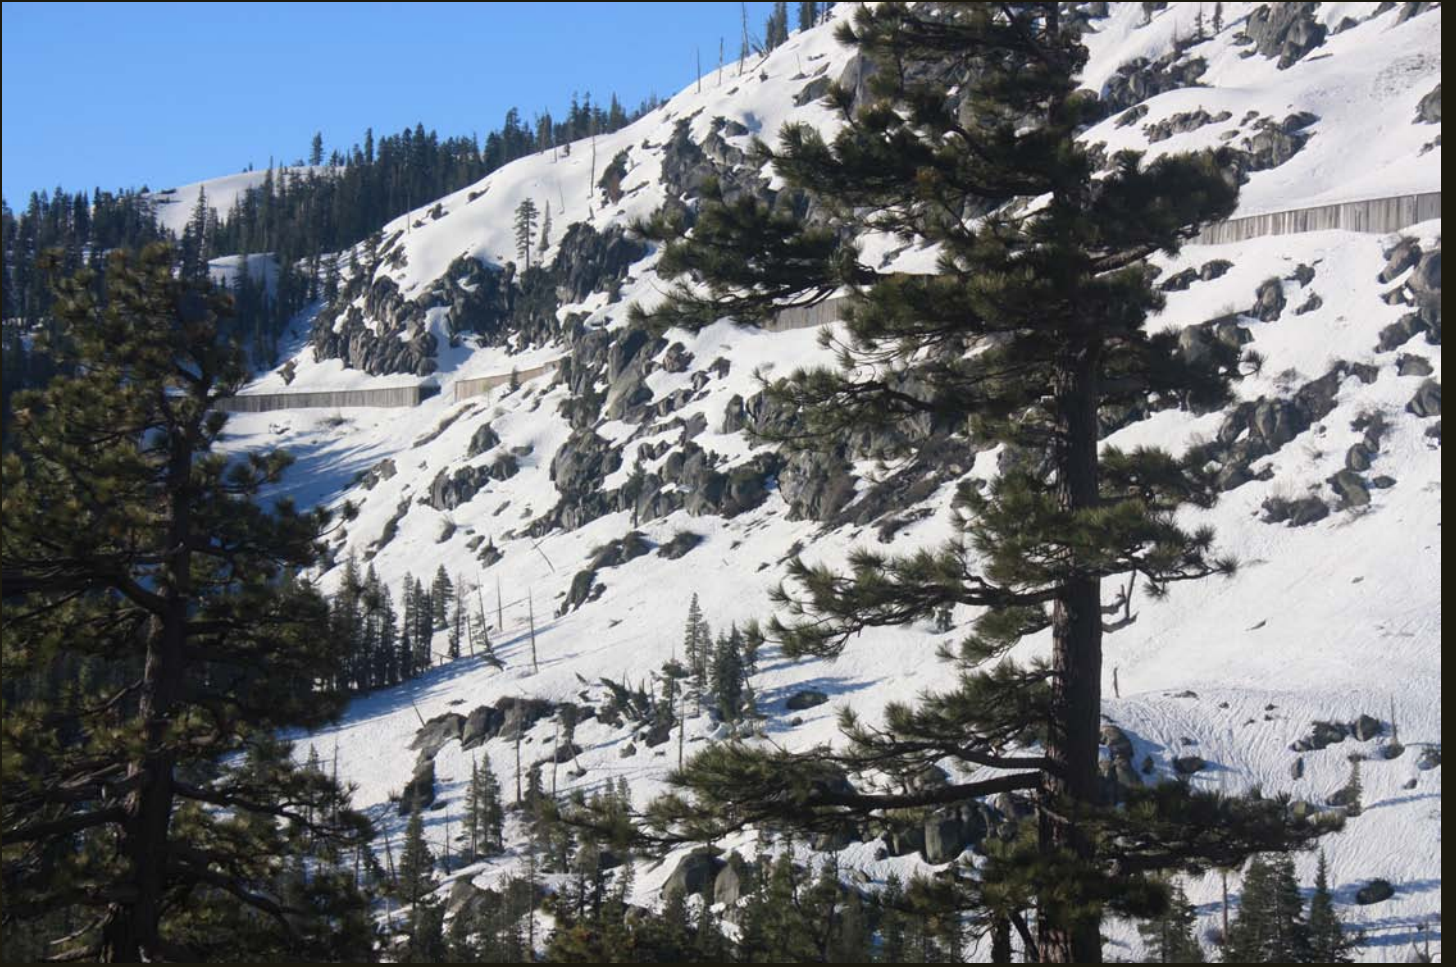
Southward view of the 1.4 mile snowshed east of the China Wall, just east of the previous location, where an avalanche has breached the shed.

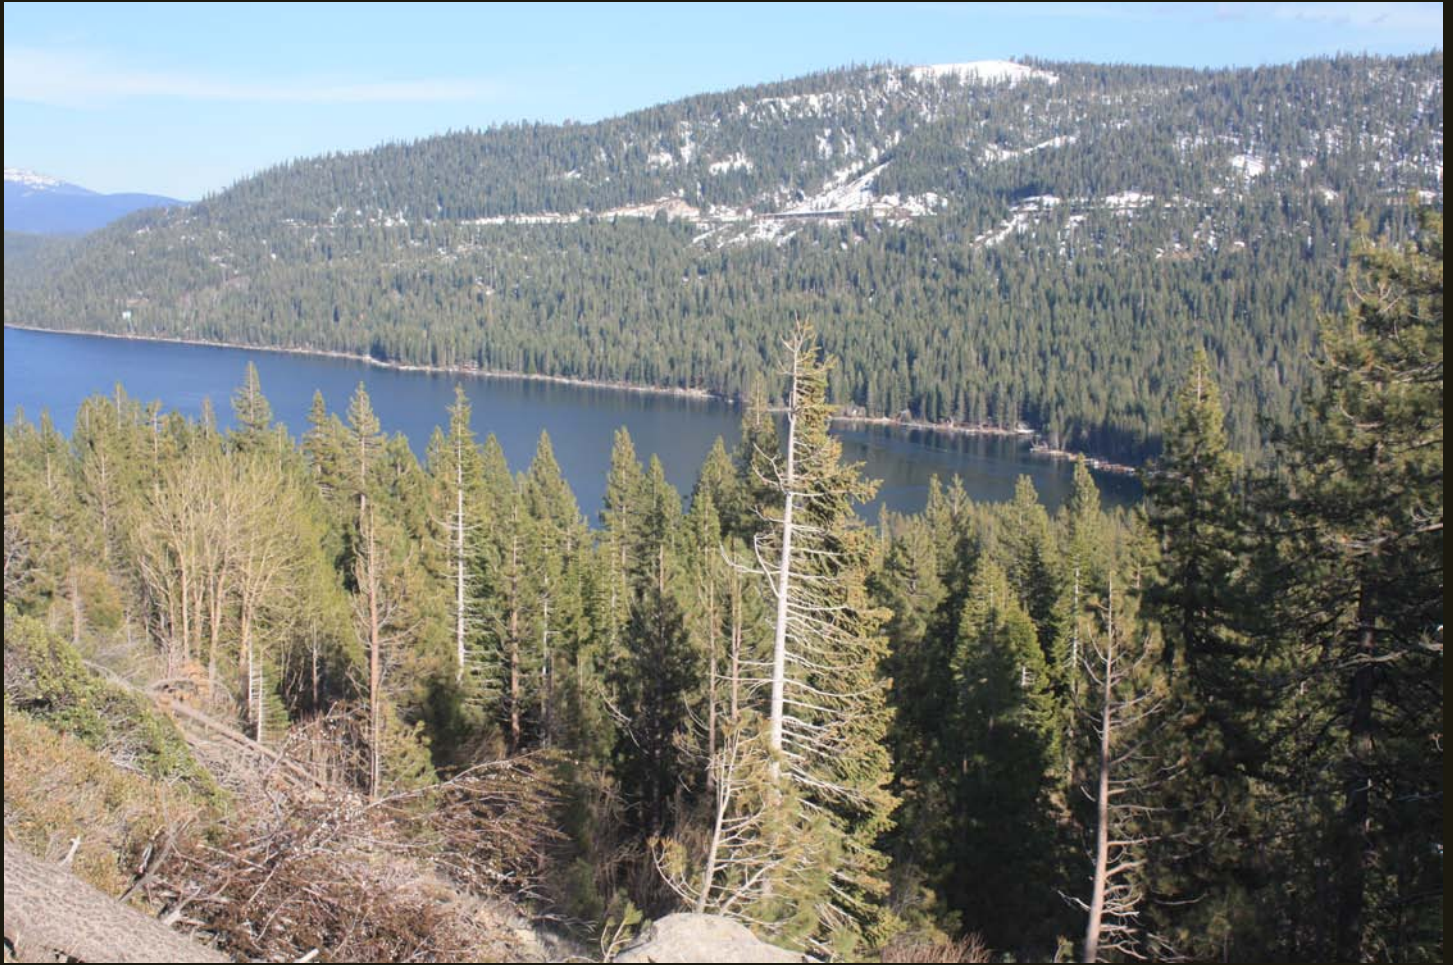
Southeastward view of Donner Lake, which empties into the Truckee River (left of photo) and the CP grade on the slope behind the lake. Eder, where the 1925 alignment diverges from the original CP alignment, is on the hillside just about at the right edge of the photo. Therefore, the grade in this view is the active track on the original CP (1869) alignment. Just to the right of center there is a snowshed, the only one on the active track east of Donner Pass; this shed covers the switch between single track to the right (east) of the shed and double track to the left.
