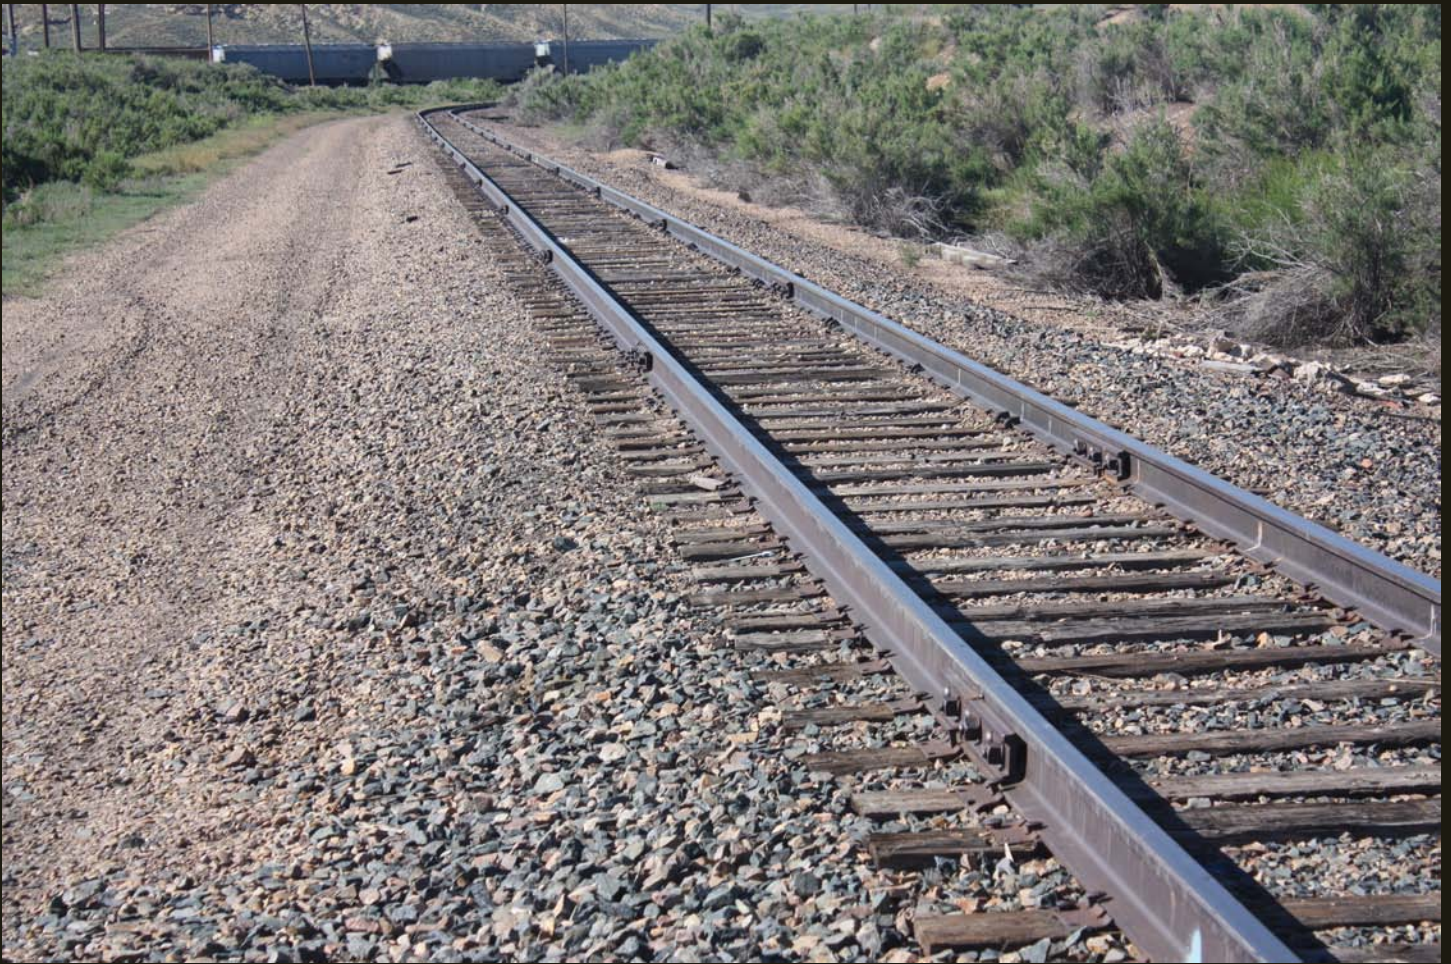
There are a couple of things going on at Thayer Junction, Wyoming. The bolted track is the 1868 UP mainline. In this southwestward view, the curve in the track takes the grade around a bend in Bitter Creek, which the UP follows for 60 miles. The train in the background is on the active UP double track mainline, which leaves the original grade for 2 miles to straighten the grade around the bend in Bitter Creek by crossing the creek at two locations; the original grade stays on the north bank of the creek. The re-alignment of the grade likely occurred in the years before 1918, when the UP completed double tracking of its entire transcontinental mainline.

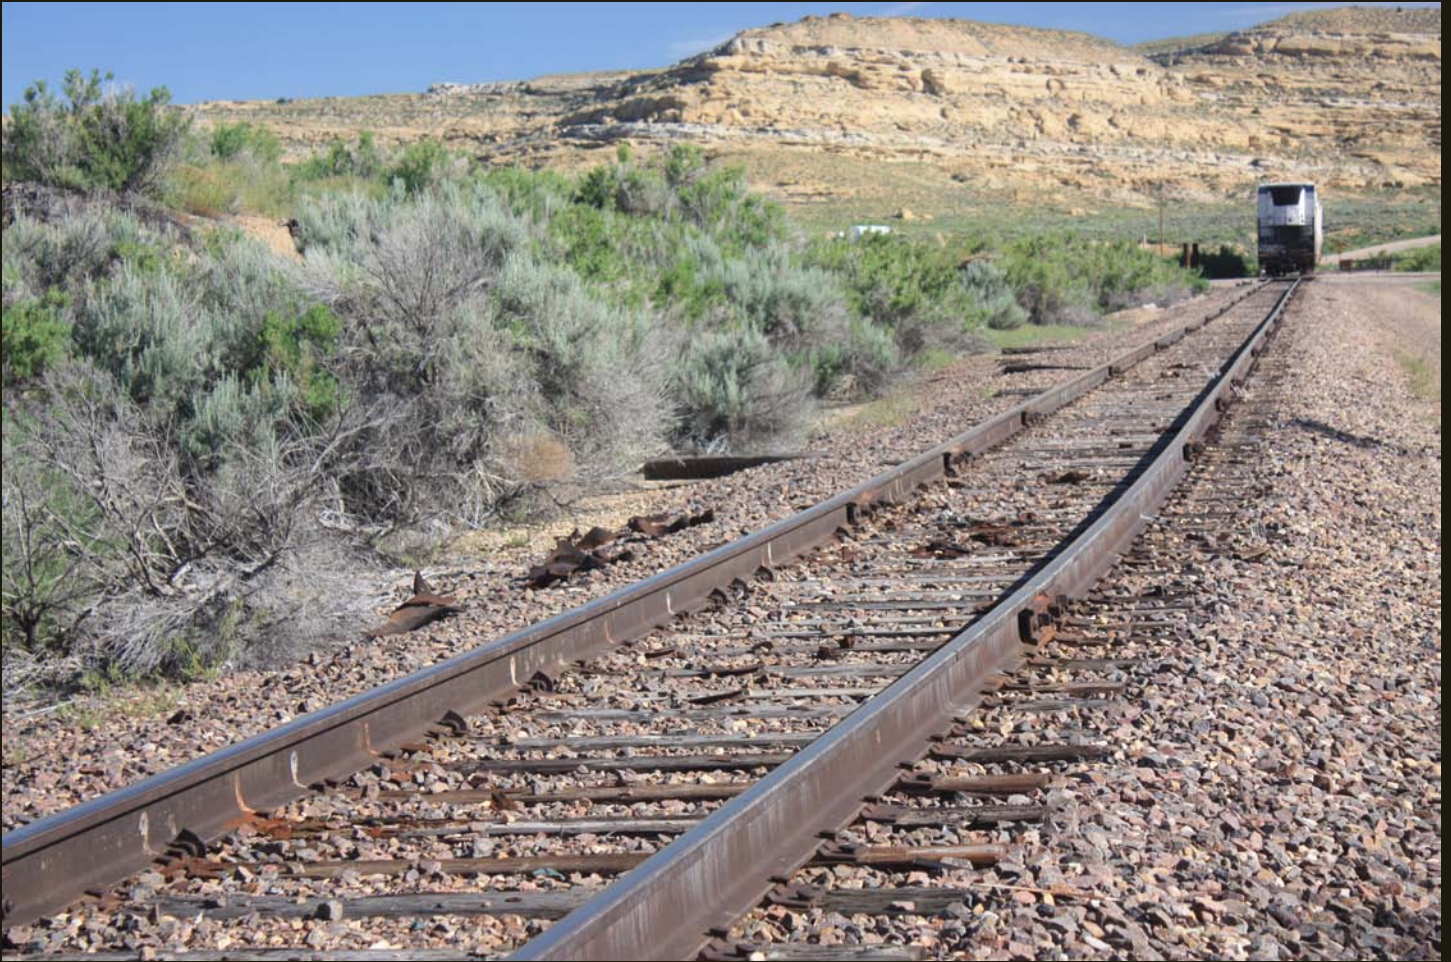
Northeastward view of the 1868 grade around the Bitter Creek bend at Thayer Junction. A few cars are stored on this inactive track.

Also in this view is the other thing that is going on at Thayer Junction, but it is hard to see. Between the foreground curve and the cars there was once a junction with an 8-mile-long UP coal spur to mines around the town of Superior. The UP Superior Branch veered to the left (west and north) and the longer ties that extend to the left were for the switch.

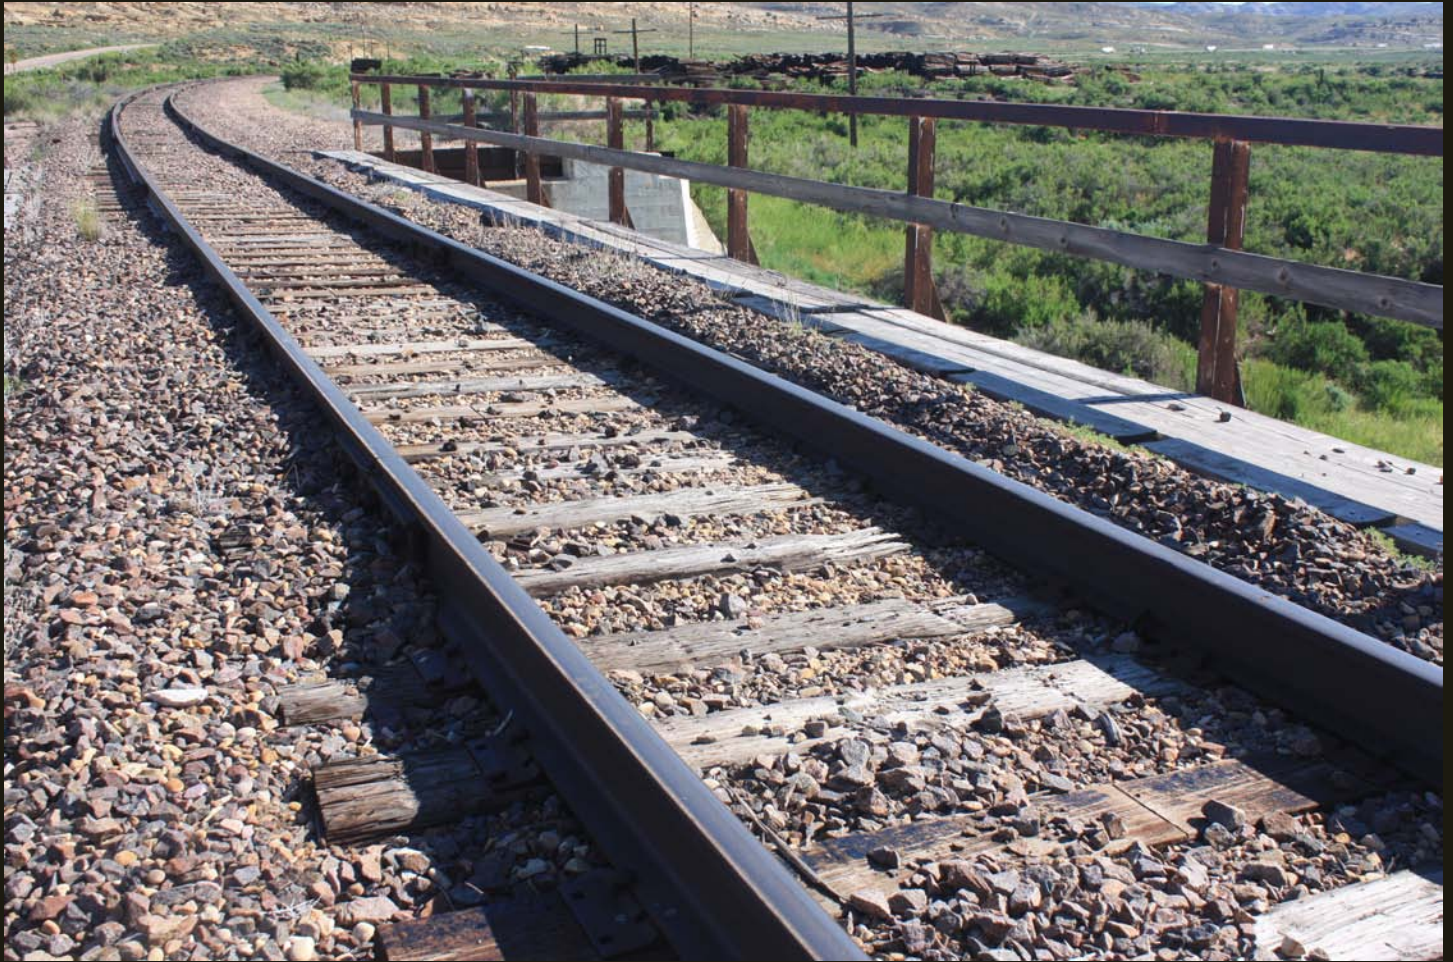
Northeastward view of the 1868 UP mainline around the Bitter Creek bend at Thayer Junction, northeast of the stored cars. Here the tracks curve eastward and join the active mainline 2 miles up (east). The bridge crosses the dry creek of Horsethief Canyon, which the UP Superior Branch followed up to the town of Superior.

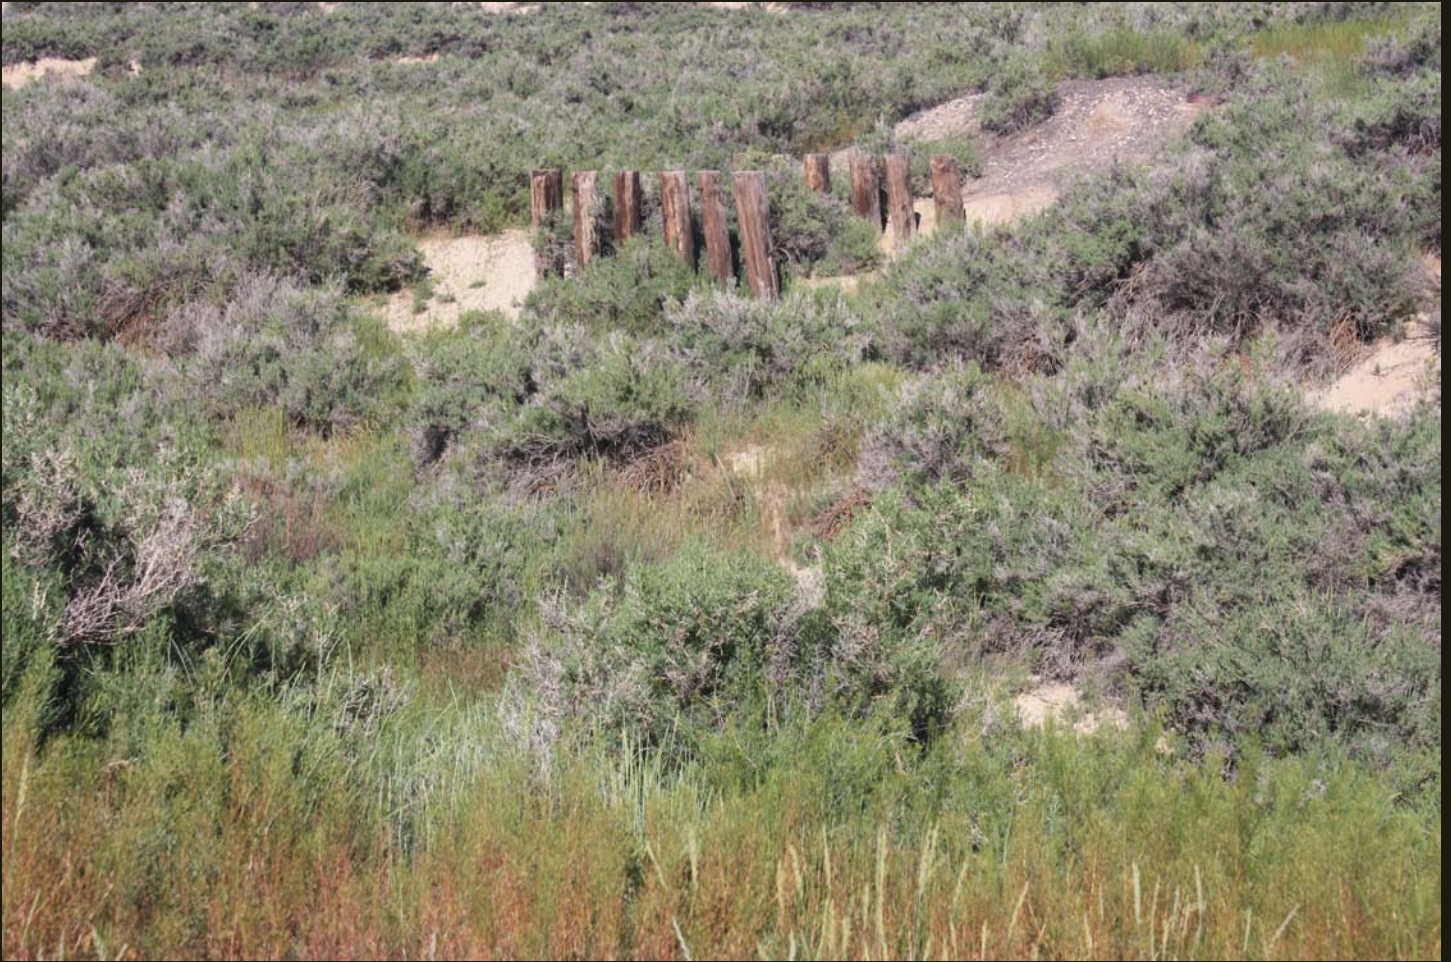
The dry creek of Horsethief Canyon at Thayer Junction. The piles carried the Superior Branch over the dry creek to the grade visible on the right. A web page for the town of Superior notes that "about 1903 plans were laid for the construction of a railroad from Thayer Junction on the main line to Superior," so I estimate the construction completion year as c1905.
