The narrow gauge Denver & Rio Grande mainline over the Rocky Mountains, known as the "Royal Gorge Route" or "Marshall Pass Route," was completed in 1883, when the D&RG building west from Denver, Colorado, and the Denver & Rio Grande Western Railway building east from Salt Lake City through this location in Colorado near Harley's Dome, Utah, met at Grand Junction, Colorado. In 1890, the D&RG and D&RGW completed a standard gauge route, the Tennessee Pass Route, which supplanted the narrow gauge Marshall Pass Route as the primary route from Denver to Salt Lake City. This new route involved a cooperative effort between the Colorado Midland Railway and D&RGW to build a standard gauge line, the Rio Grande Joint Railway, along the Colorado River west from Rifle to Grand Junction, Colorado, and involved standard-gauging of the D&RG Leadville Branch (1880n), Aspen Branch (1887n, which included the crossing of the continental divide at Tennessee Pass), and Rifle Extension (1889n), and the D&RGW (1883n) trackage in western Colorado and Utah. The standard-gauging of the D&RGW (1883n) was almost entirely just a matter of replacing the tracks, but there was a major realignment of the route along

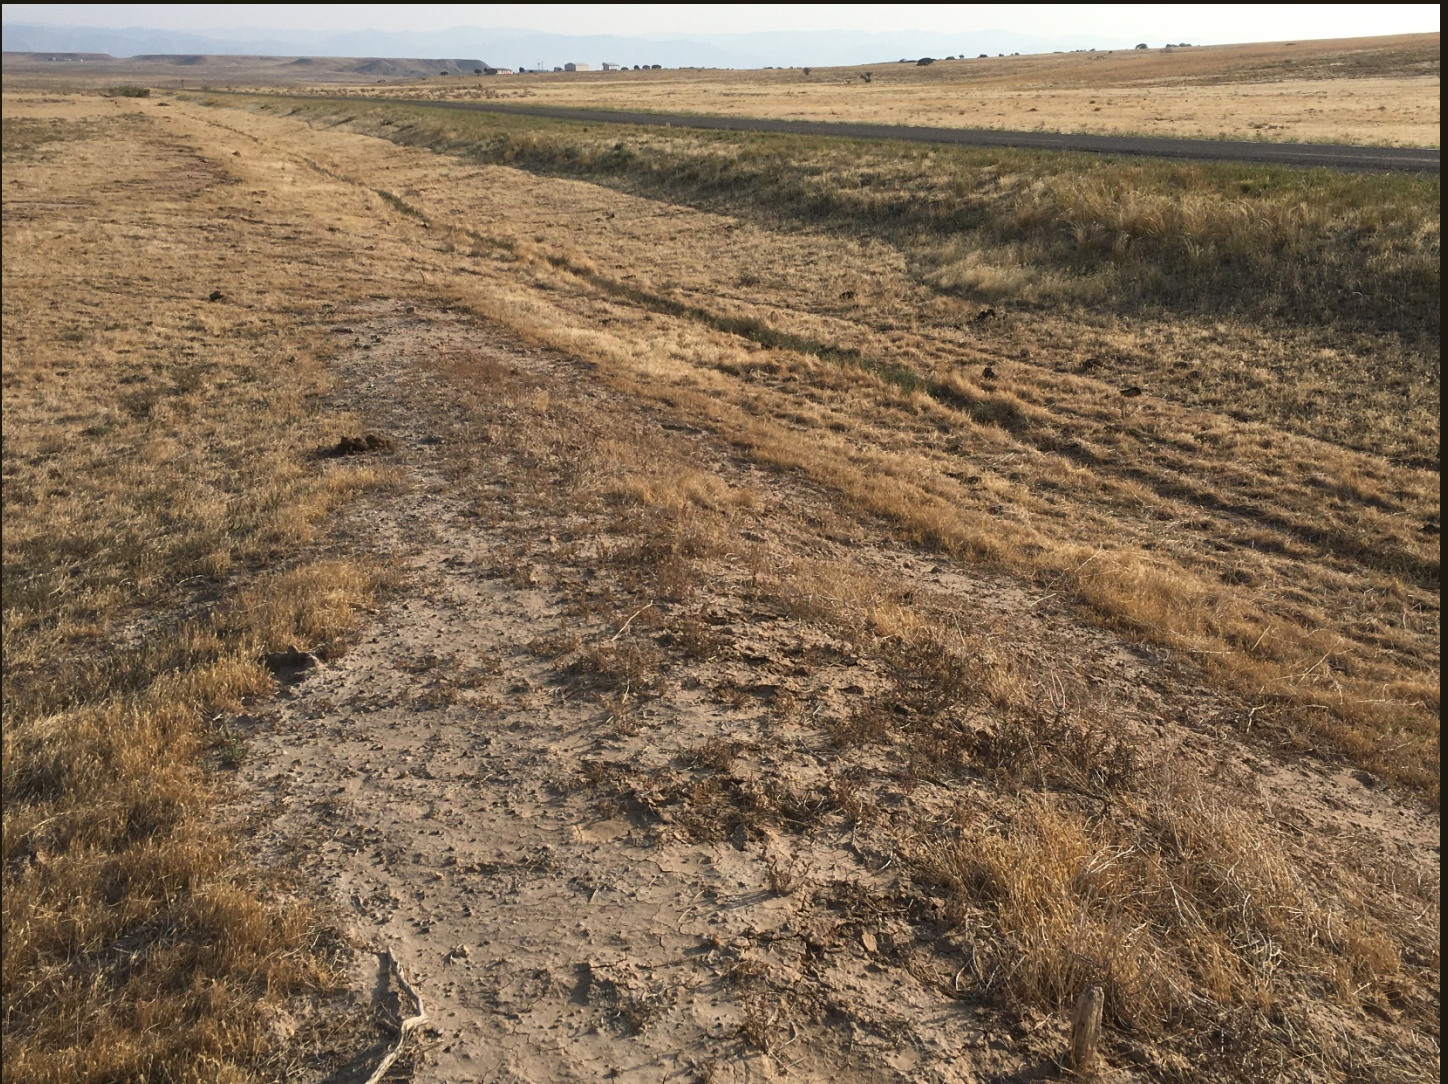
Northeastward view of the D&RGW (1883n) in Colorado, 1.6 miles east of the Utah border. Old U.S. Highway 6/50 is on top of the railroad grade at this location. Although the topography looks quite flat, this location is on the drainage divide between McDonald Creek on the east and Bitter Creek on the west (both of which flow south a few miles to the Colorado River). The bare ground in the foreground is the east branch of a turning wye to turn helper engines.

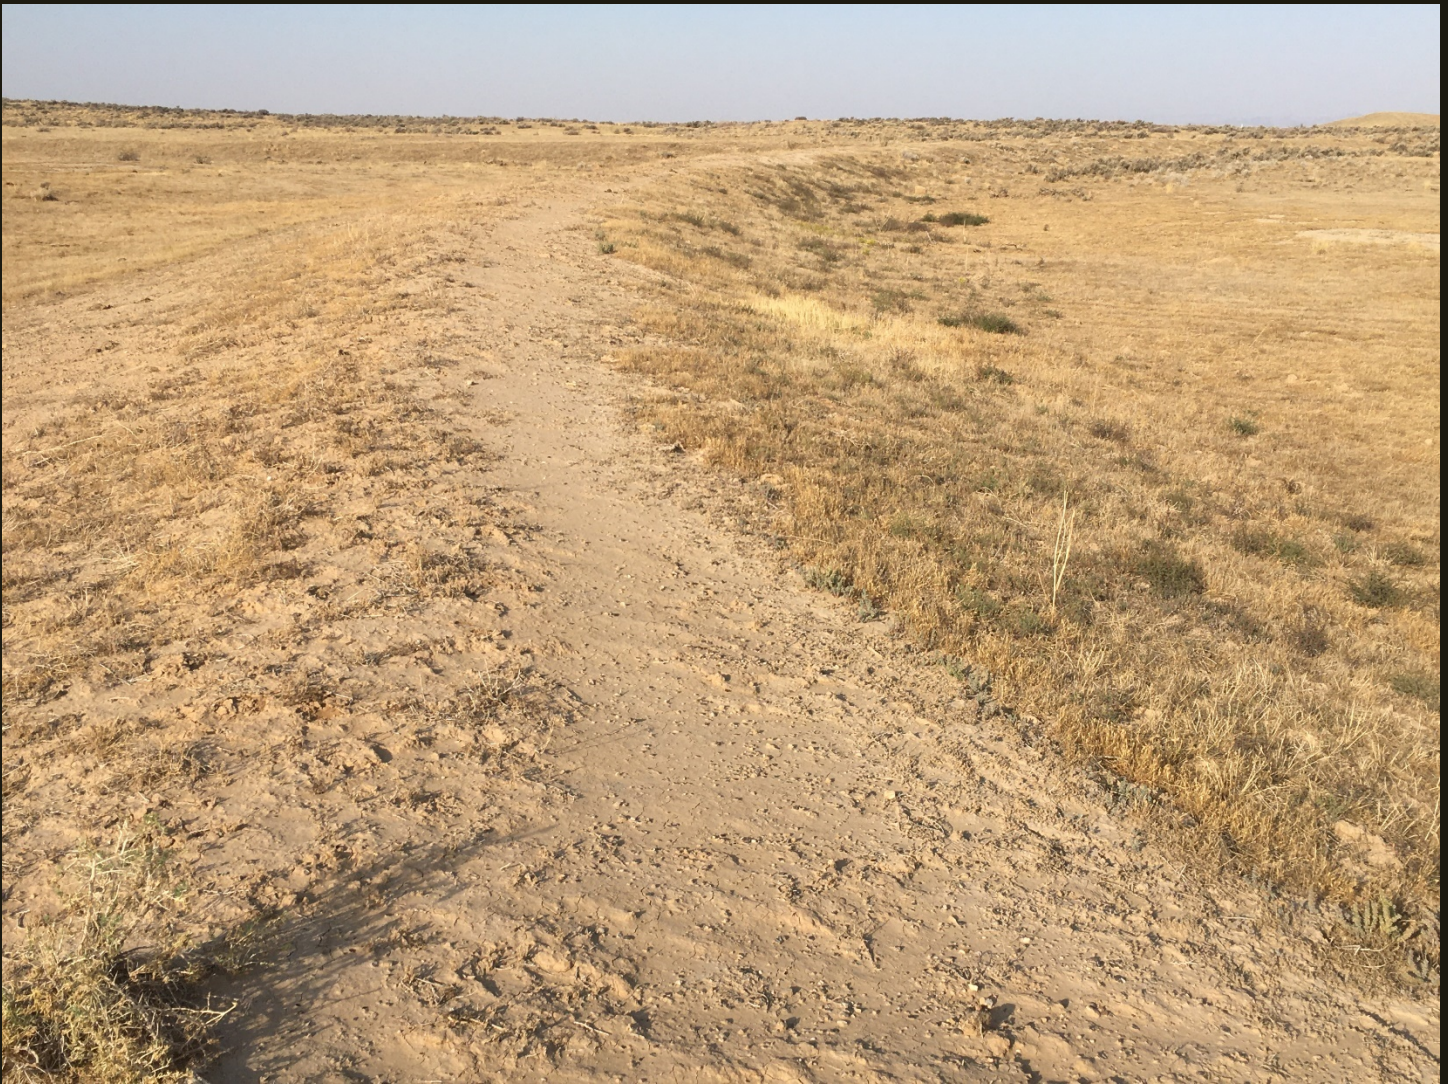
Westward view of the northeast branch of the turning wye at the same location as previous. Although it has been abandoned since 1890, the turning wye is quite apparent on the ground and in satellite imagery in this remote, undisturbed region.

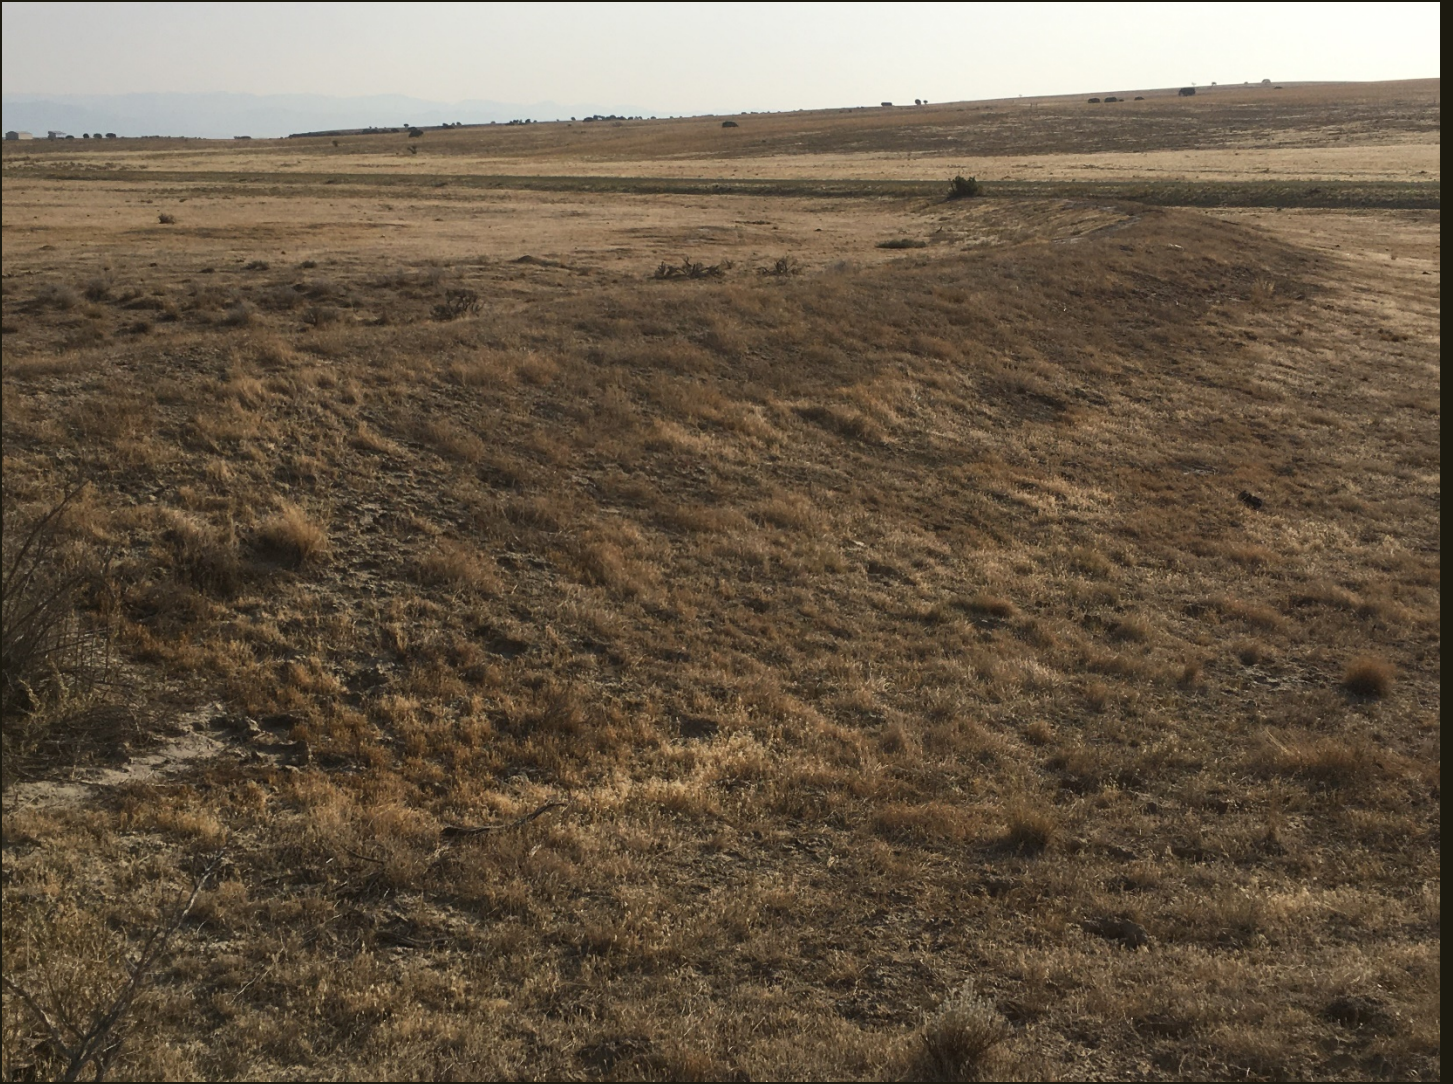
Eastward view of the northeast branch of the turning wye from the southwest branch near the tip of the wye, which is just out of view on the left.

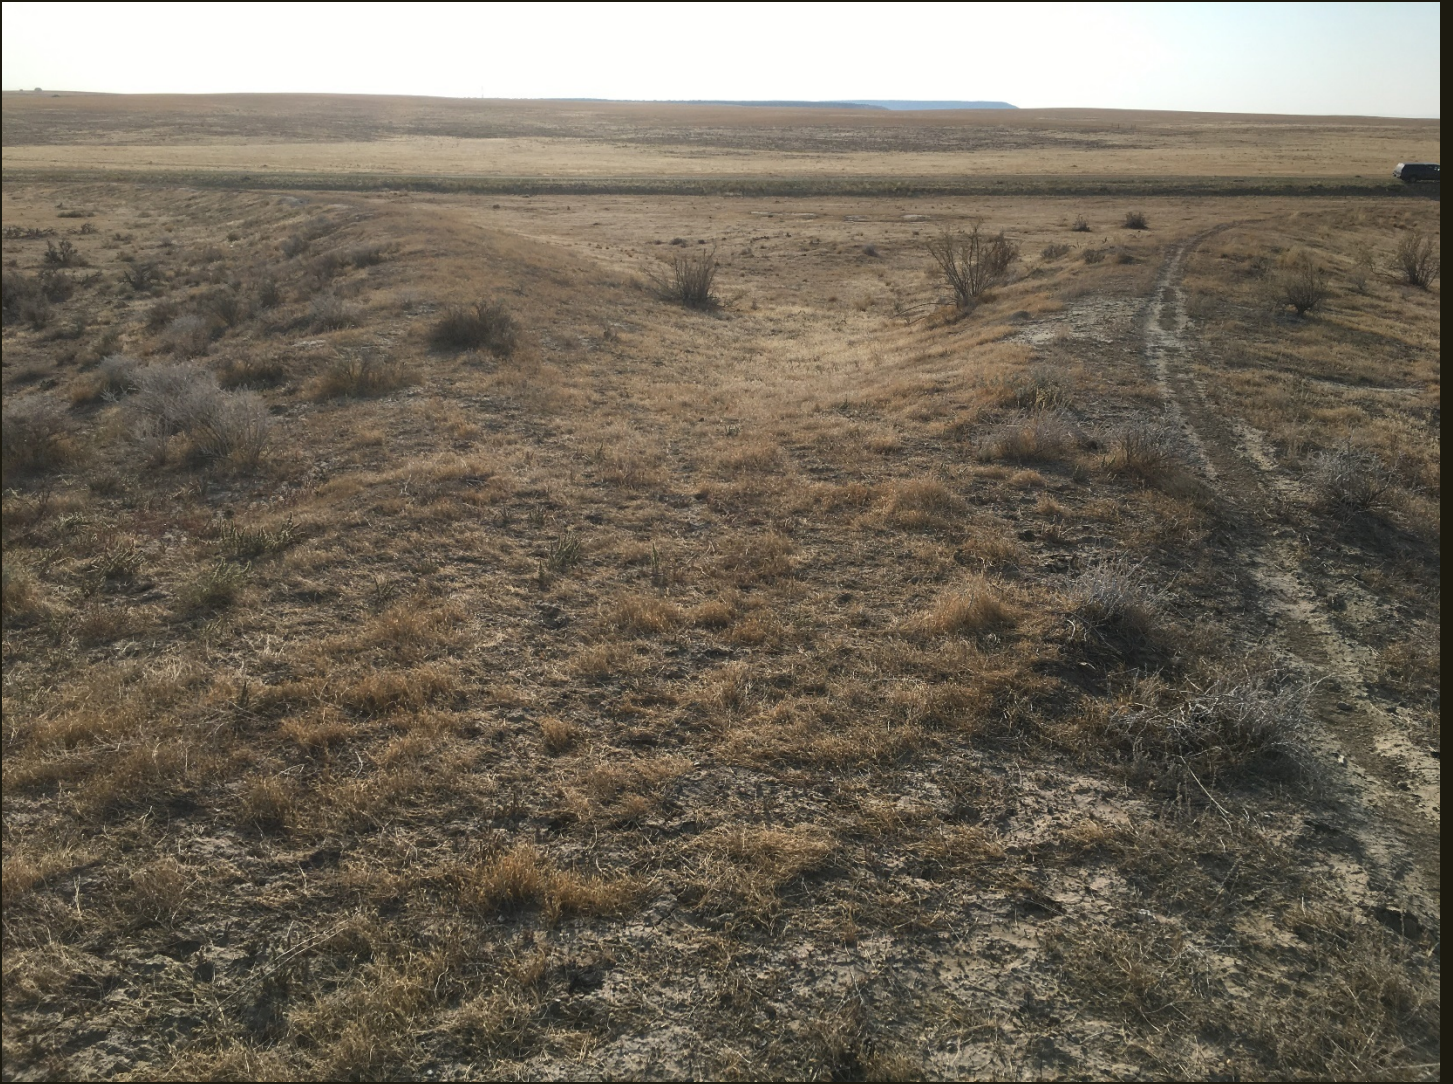
Southeastward view of the tip of the wye.

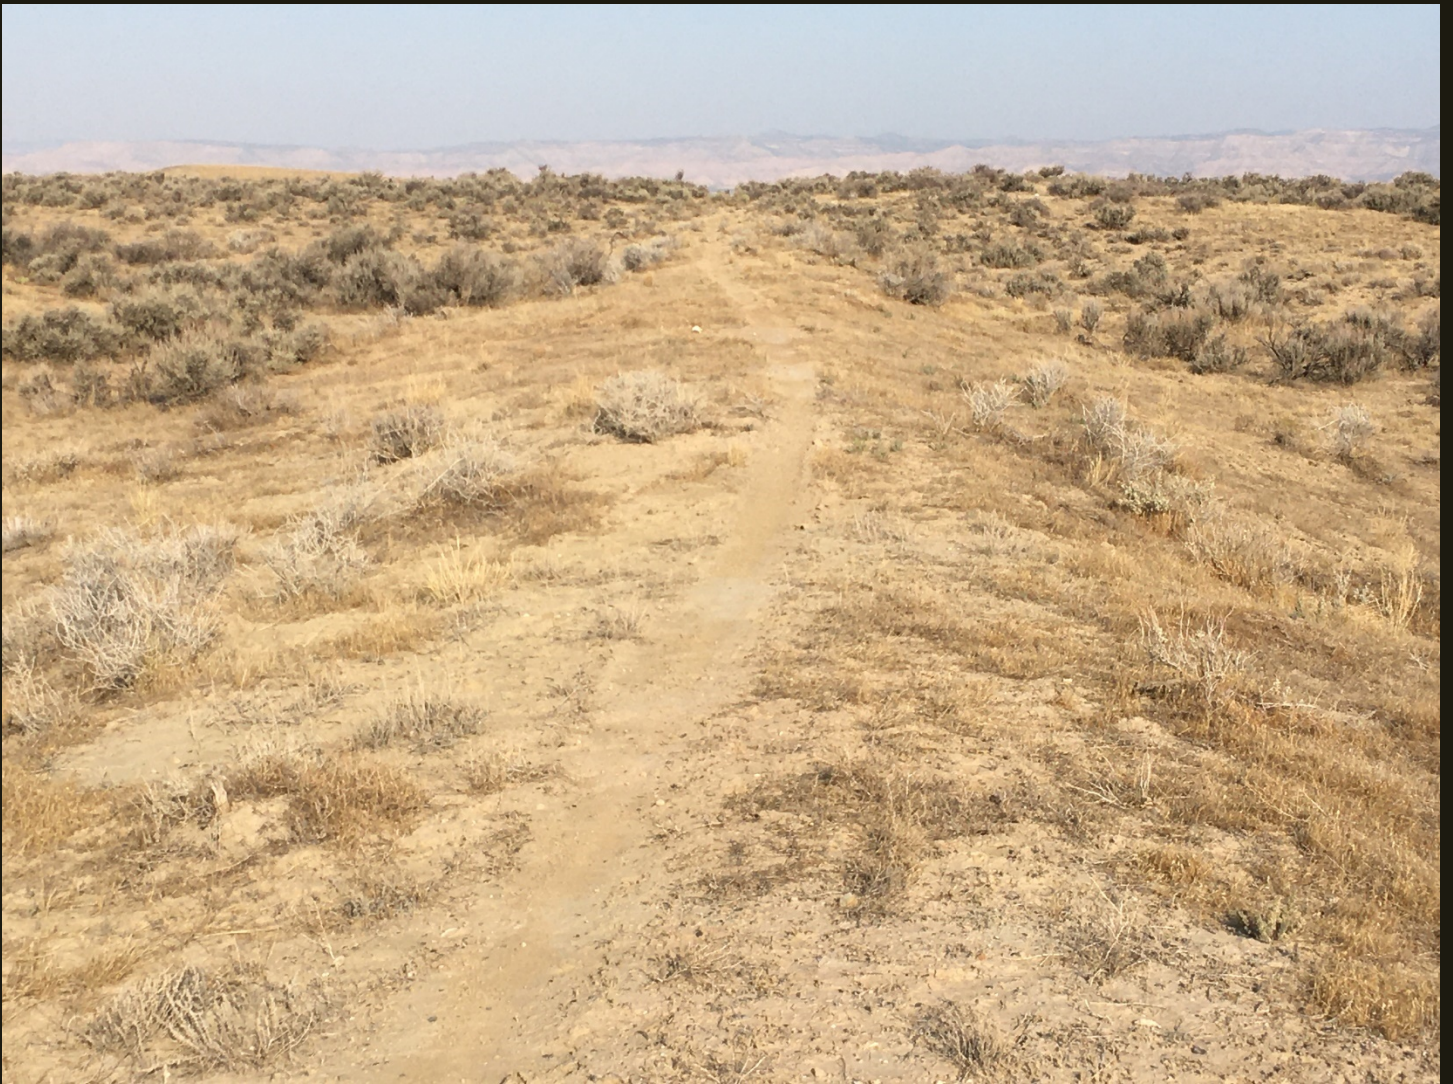
Northwestward view of the tip of the wye from the same location as previous.

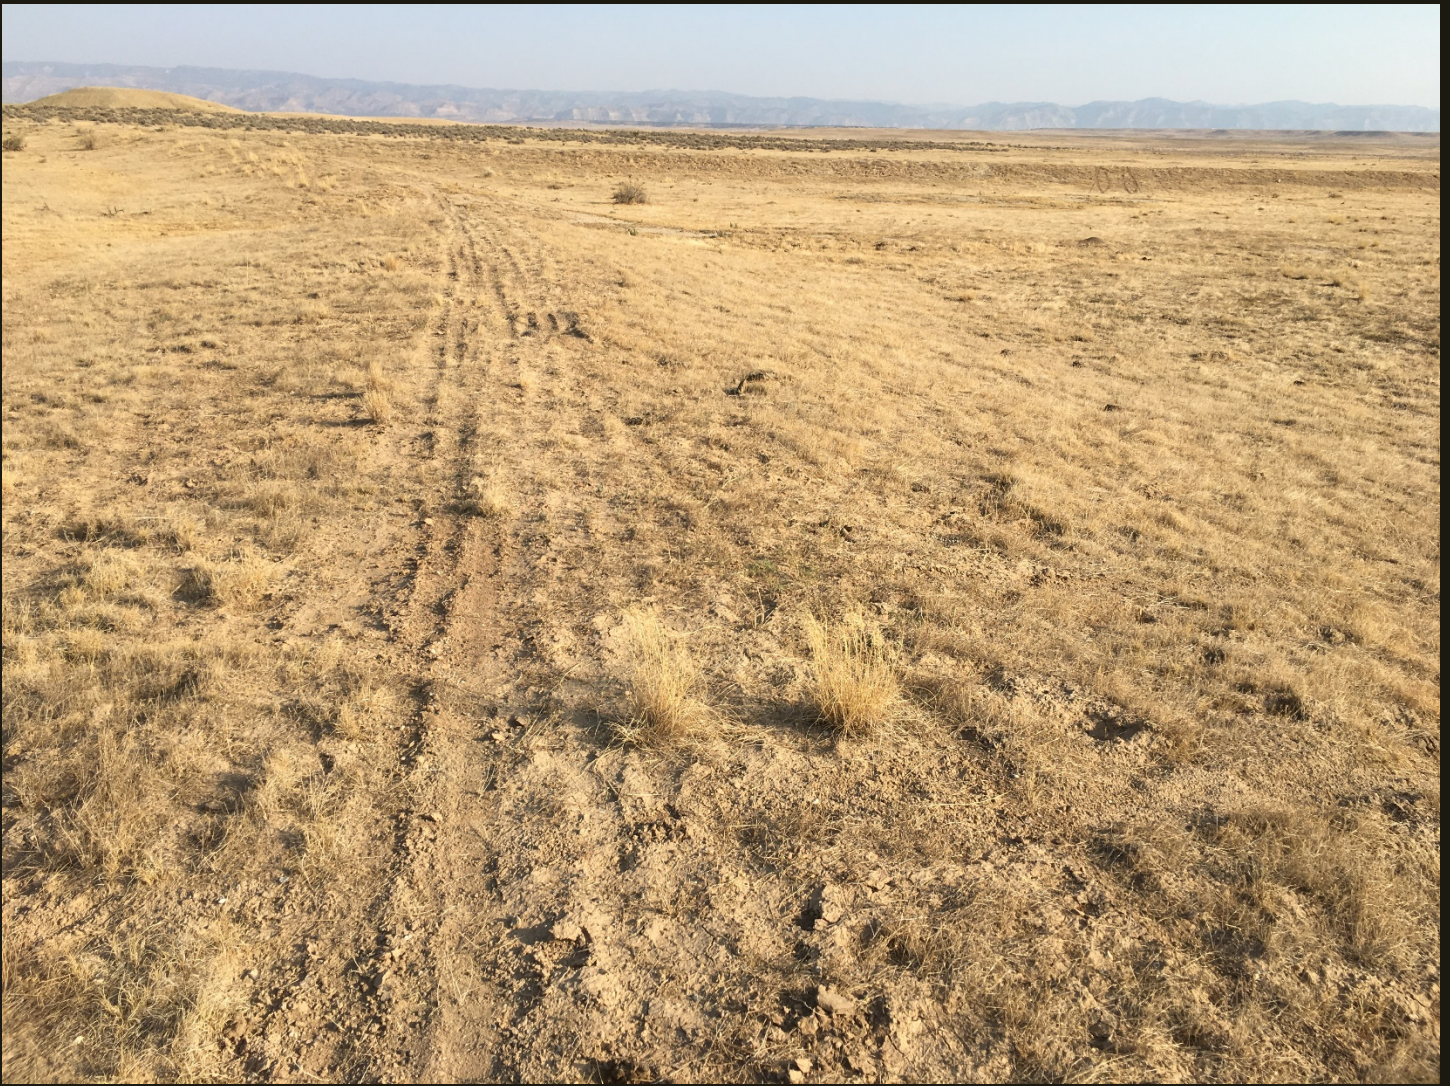
Northward view of the southwest branch of the wye, 200 feet south of the previous location. The tip of the wye is in the far left corner and the northeast branch of the wye runs across the width of the photo in the distance.

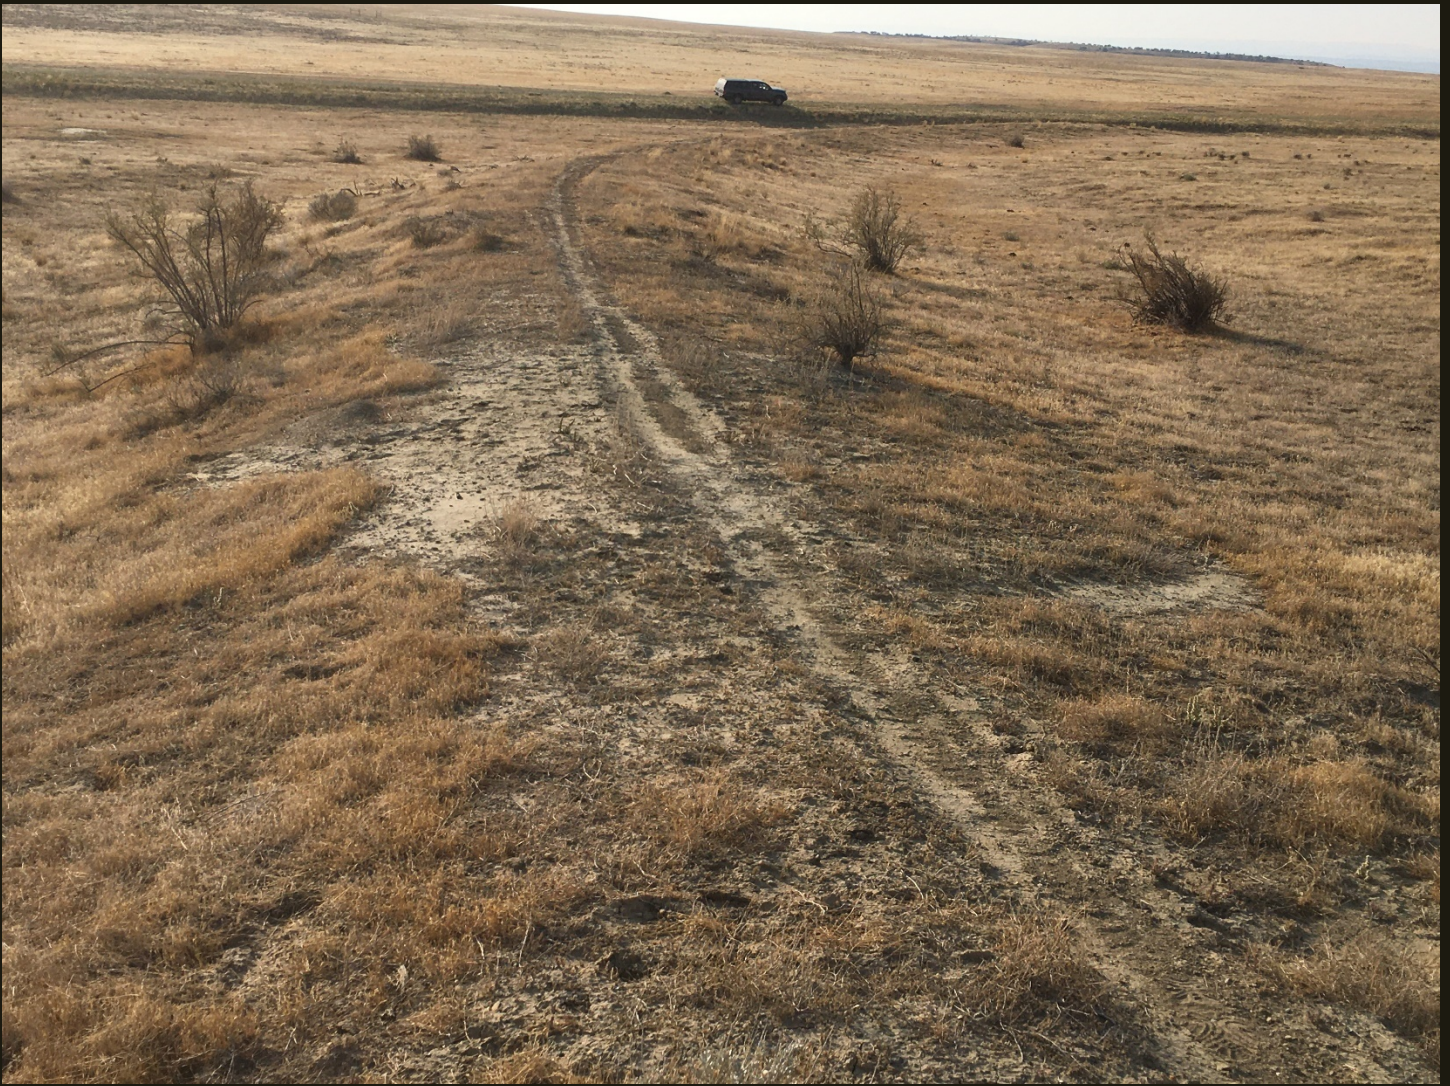
Southward view of the southwest branch of the wye at the same location as previous. The vehicle is on Old U.S. Highway 6/50, which was built in the late 1920's on top of the D&RGW (1883n), which had been abandoned since 1890.

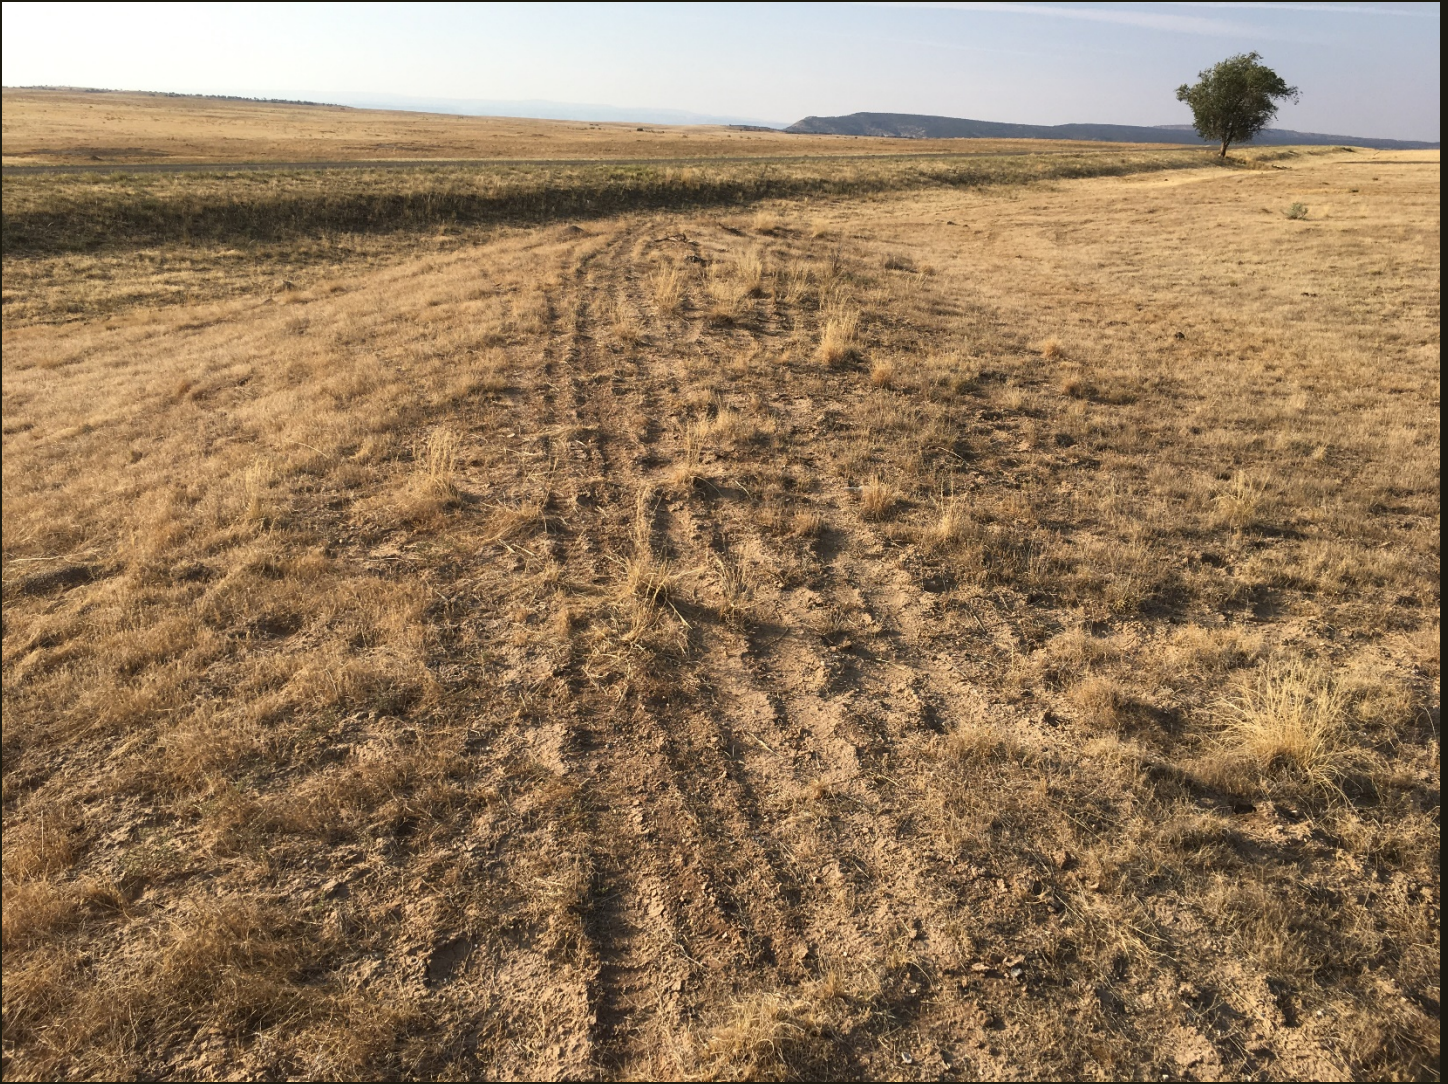
Southward view of the southwest branch of the wye and the D&RGW (1883n) mainline/Old U.S. Highway 6/50, 100 feet south of the previous location. In the distance, the topography drops off toward Bitter Creek. Note the lone tree next to the road.

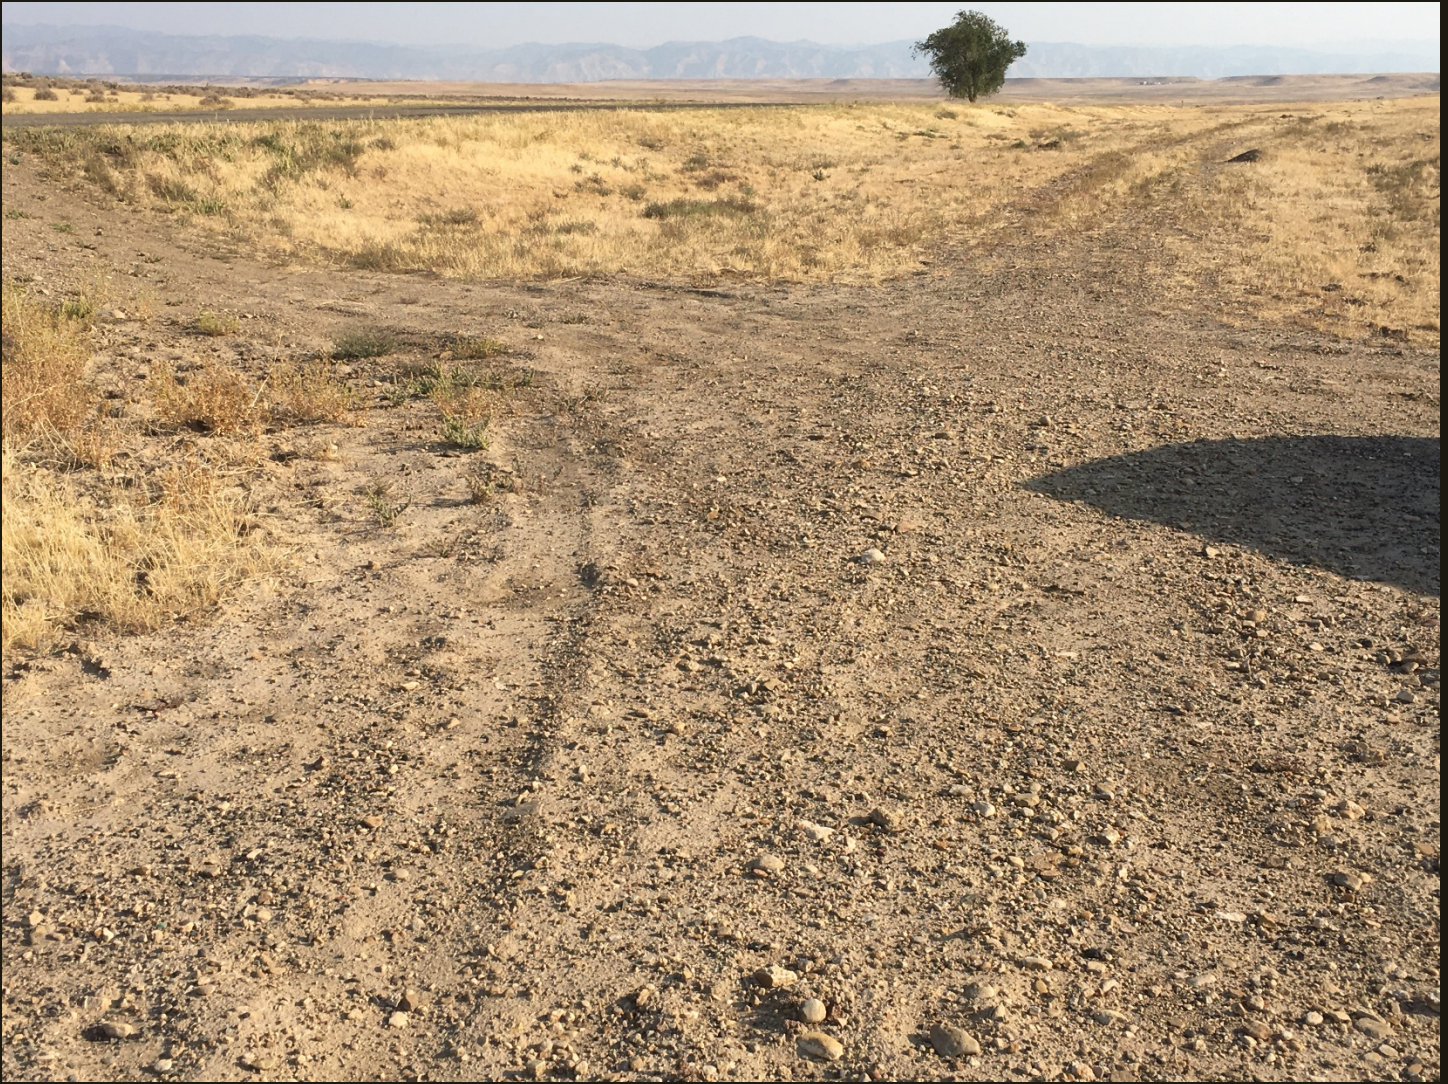
Northward view 1,000 feet southwest of the previous location; the same lone tree is visible next to the D&RGW (1883n) mainline/Old U.S. Highway 6/50. The bare ground in the foreground is on the D&RGW (1883n) grade, which once joined the highway alignment somewhere between here and the tree. The rough dirt road that runs to the right of the highway is just that, it is not the railroad grade.

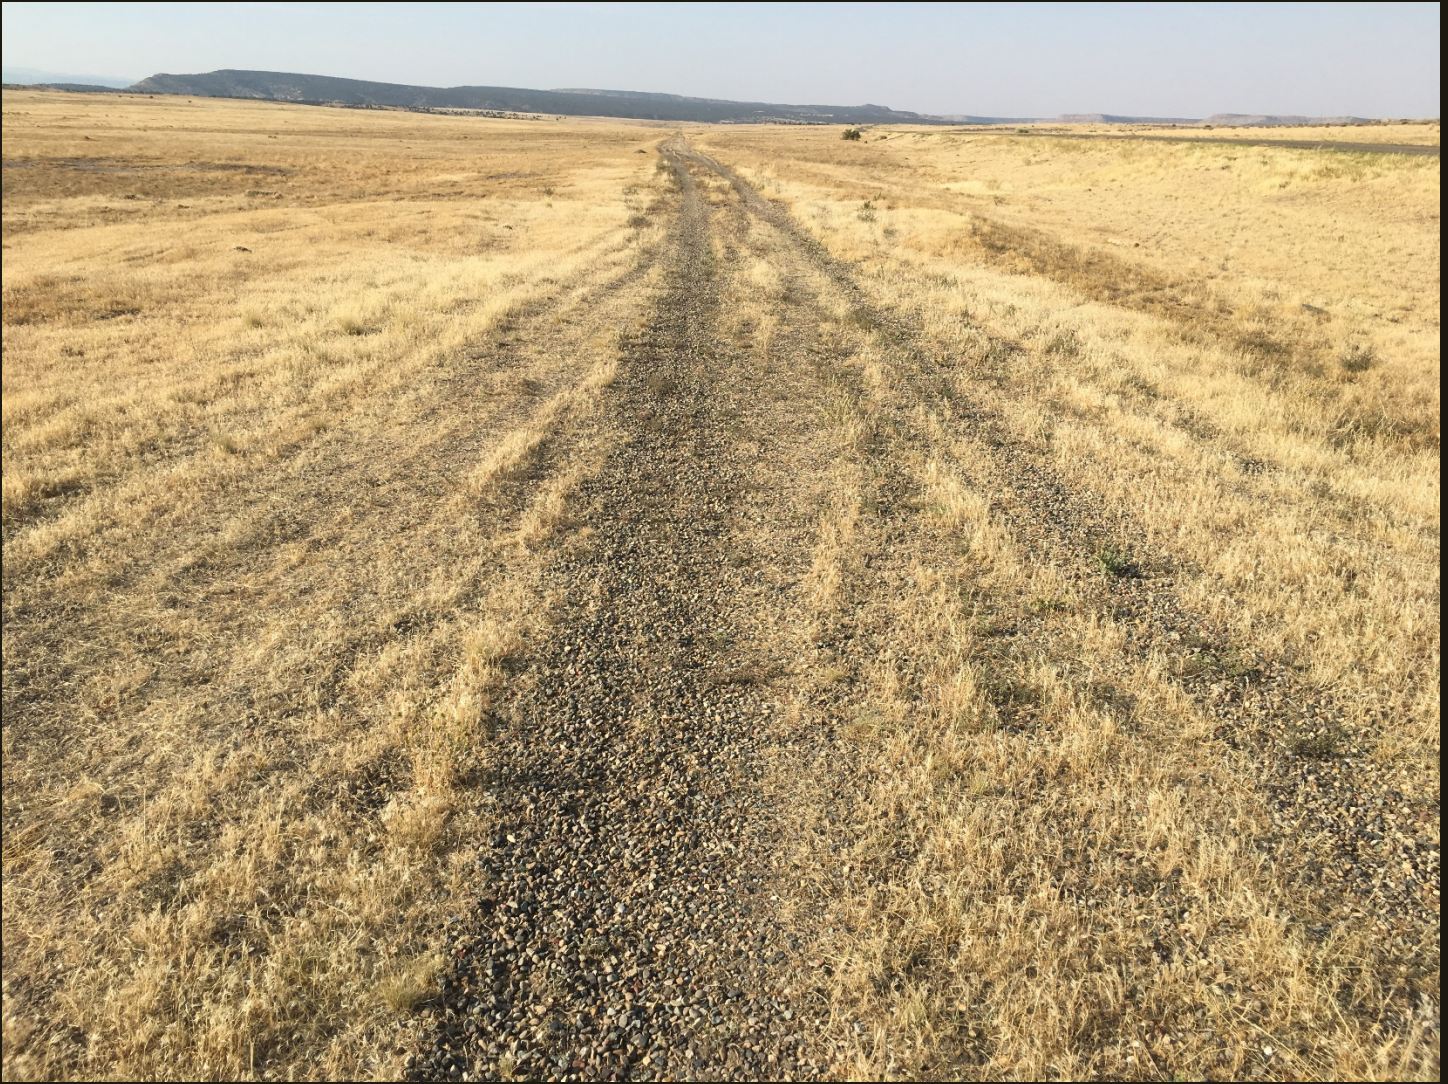
Southwestward view of the D&RGW (1883n) at the same location as previous. Old U.S. Highway 6/50, to the right of the railroad grade, is on a new (late 1920's) alignment.

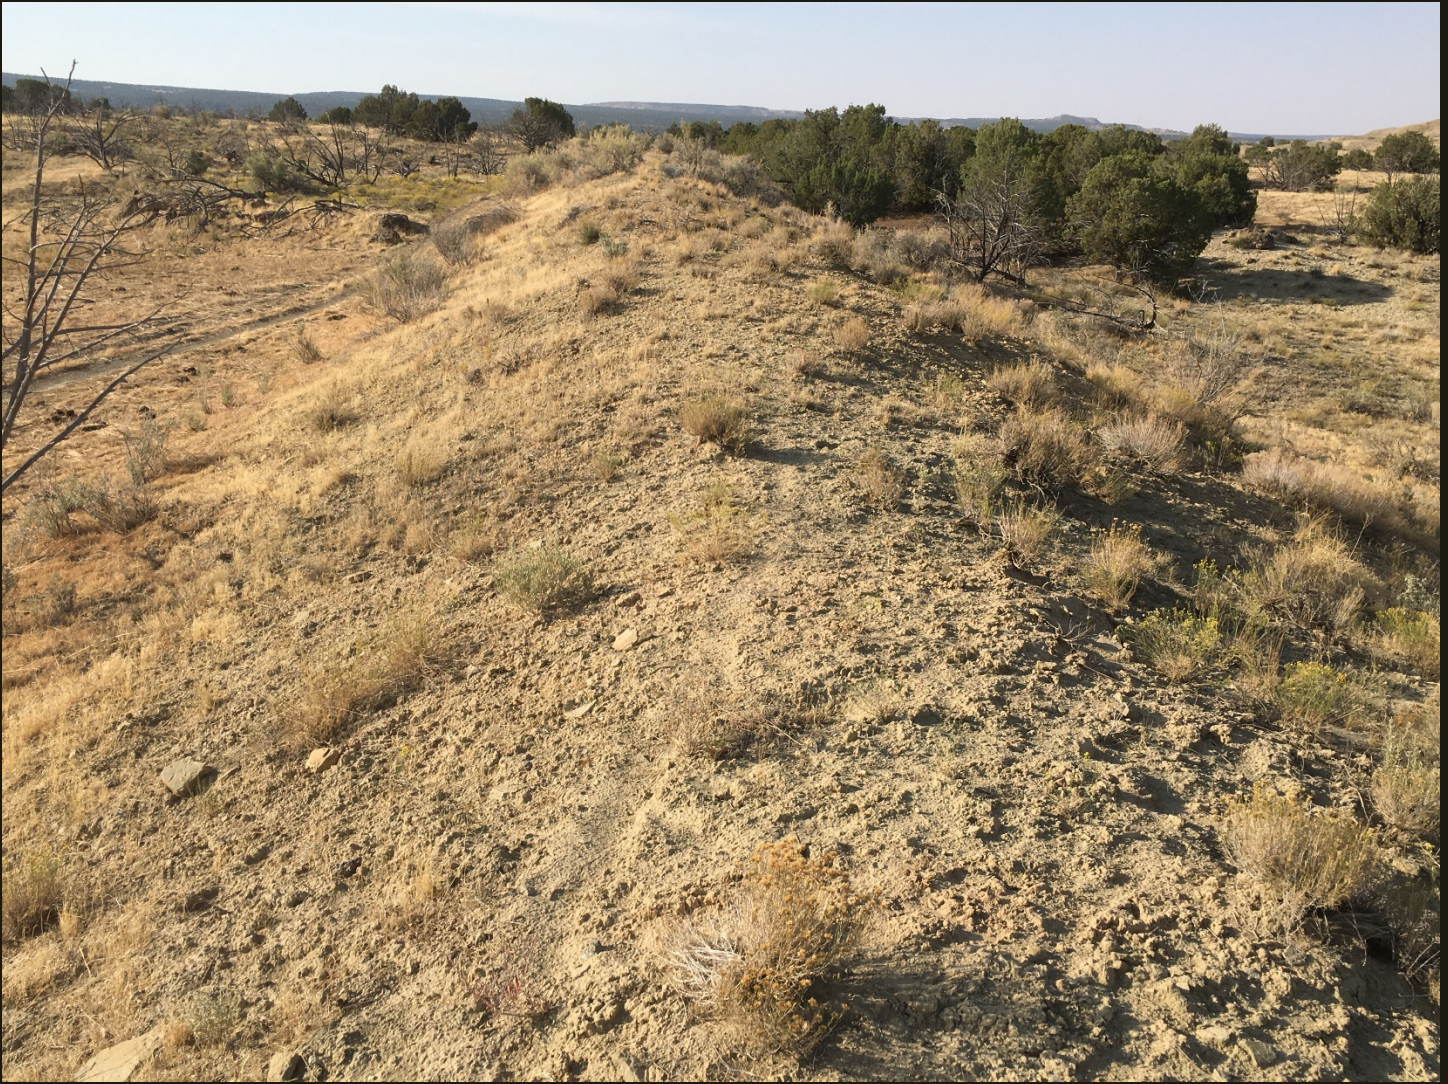
Southward view of the D&RGW (1883n) 2 miles southwest of the previous location. To negotiate the steep topography in this area, the alignment turns to the south and makes a 180 degree bend to the north, then crosses Old U.S. Highway 6/50 at this location. This significant fill grade deals with local topography, and beyond the visible part of the grade the alignment turns left (east) and continues the curve to its northeastward alignment at the previous locations. The dirt track to the left of the railroad alignment is a dirt-bike path.

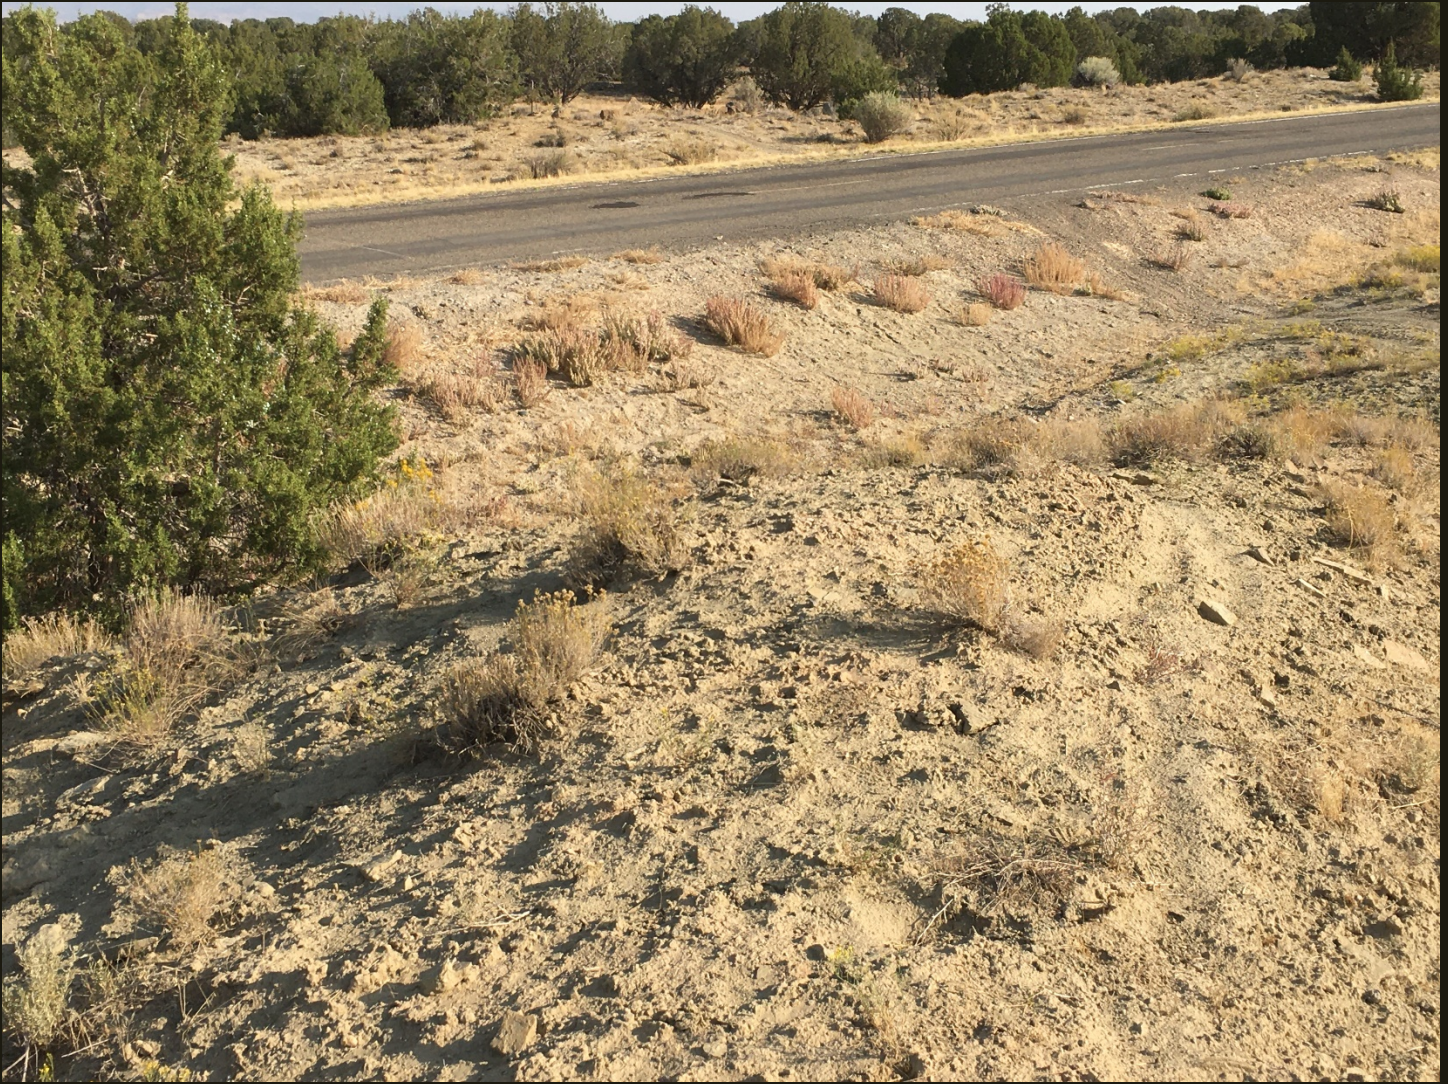
Northward view at the same location as previous. The bare ground in the foreground is the same fill grade on the D&RGW (1883n) as the previous photo. The grade alignment projects across Old U.S. Highway 6/50 to a dirt track, which is on the railroad grade, on the other side of the highway. The dirt track on the viewers side of the highway is not a railroad grade, but rather it is the same dirt-bike path as in the previous photo.

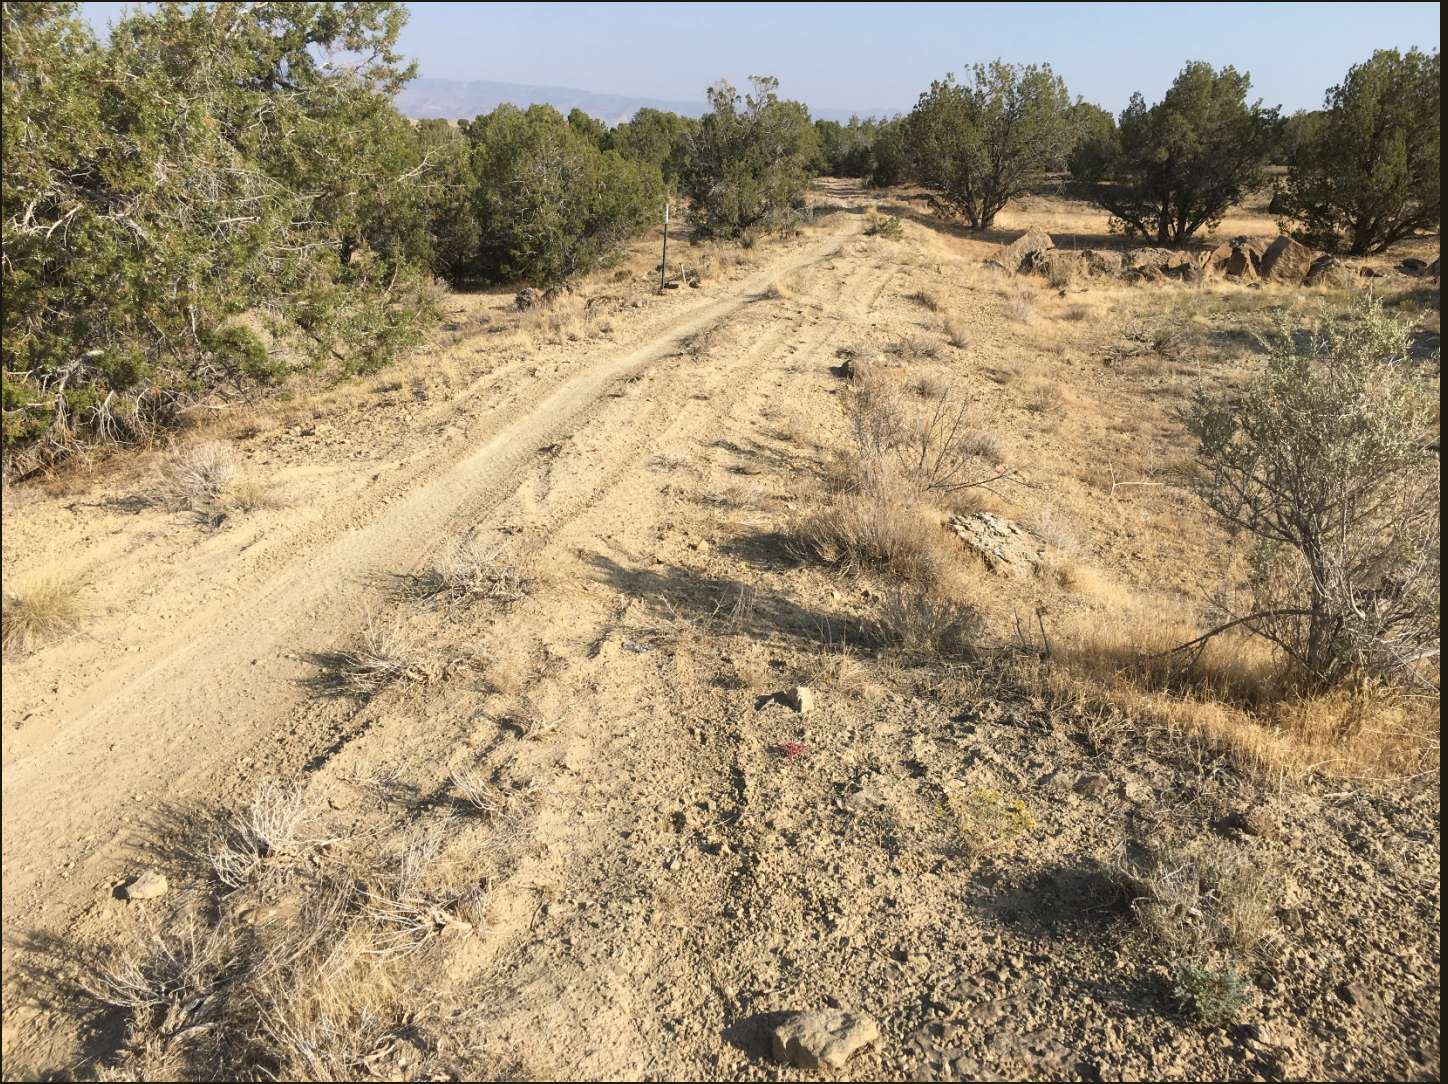
Northward view of the D&RGW (1883n) from a location just across Old U.S. Highway 6/50 from the previous location. Here, the railroad alignment is now used by dirt bikes.
