The narrow gauge Denver & Rio Grande mainline over the Rocky Mountains, known as the "Royal Gorge Route" or "Marshall Pass Route," was completed in 1883, when the D&RG building west from Denver, Colorado, and the Denver & Rio Grande Western Railway building east from Salt Lake City through this location in Colorado near Harley's Dome, Utah, met at Grand Junction, Colorado. In 1890, the D&RG and D&RGW completed a standard gauge route, the Tennessee Pass Route, which supplanted the narrow gauge Marshall Pass Route as the primary route from Denver to Salt Lake City. This new route involved a cooperative effort between the Colorado Midland Railway and D&RGW to build a standard gauge line, the Rio Grande Joint Railway, along the Colorado River west from Rifle to Grand Junction, Colorado, and involved standard-gauging of the D&RG Leadville Branch (1880n), Aspen Branch (1887n, which included the crossing of the continental divide at Tennessee Pass), and Rifle Extension (1889n), and the D&RGW (1883n) trackage in western Colorado and Utah. The standard-gauging of the D&RGW (1883n) was almost entirely just a matter of replacing the tracks, but there was a major realignment of the route along

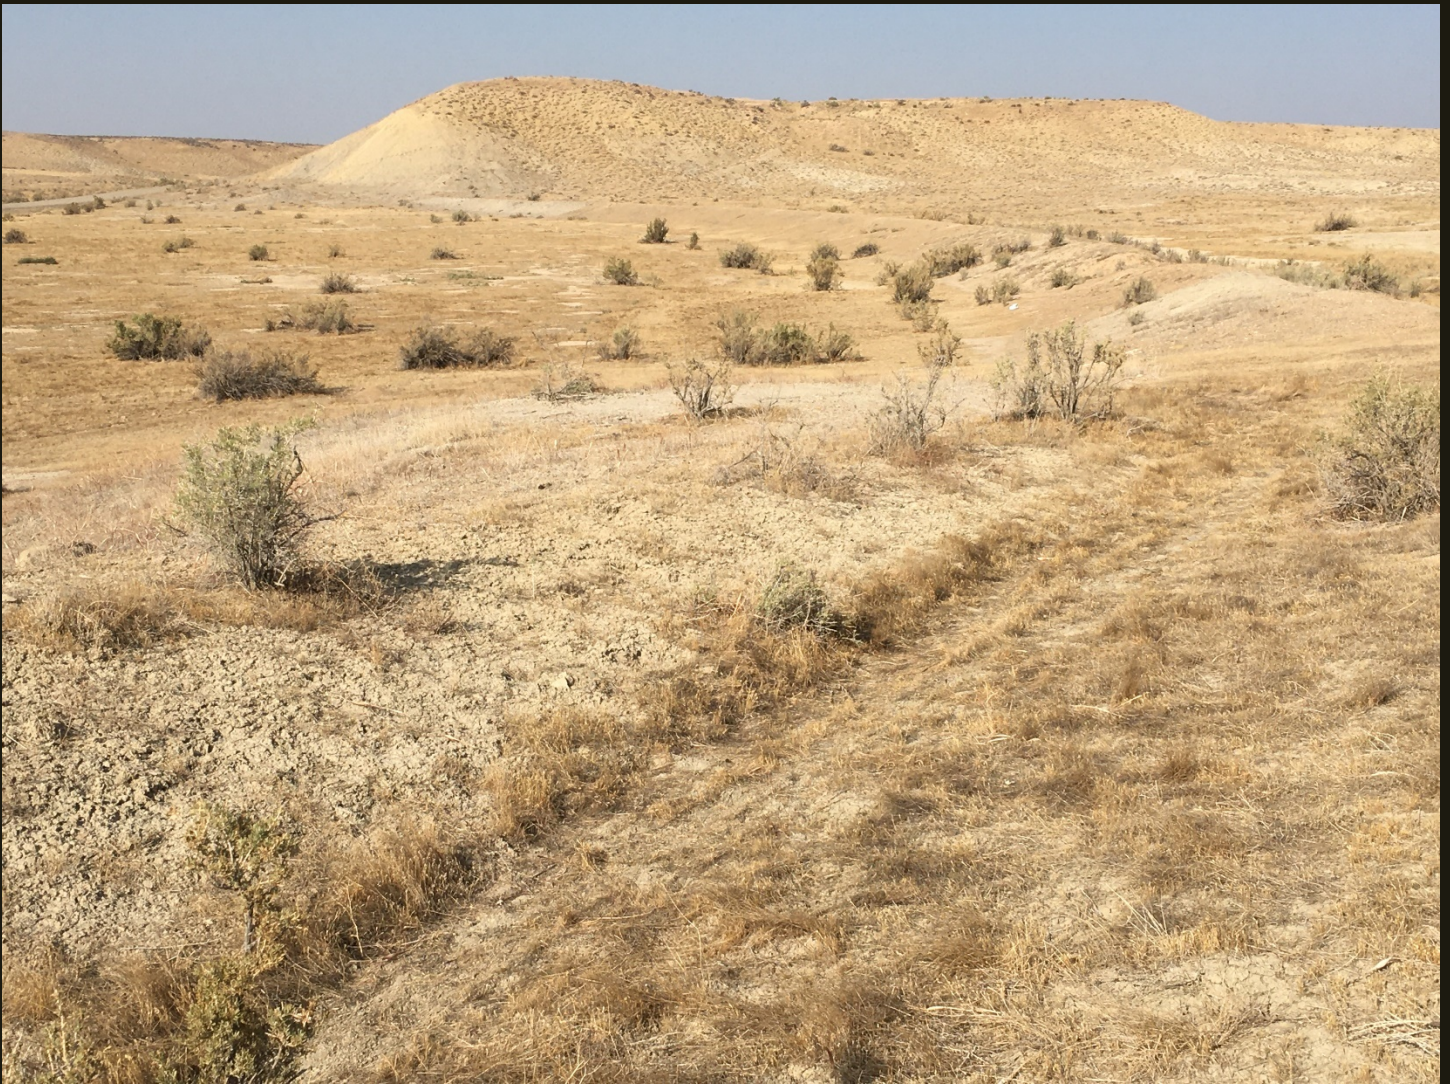
Westward view of the D&RGW (1883n) in Utah, 2.5 miles west of the previous location (which is in Colorado). The significant fill grade here is well preserved. Old U.S. Highway 6/50 is visible in the upper left where it crossed the railroad alignment.
