The Denver & Rio Grande Railroad built its San Juan Extension to serve the silver mining districts of the San Juan Mountains in southwestern Colorado. The narrow gauge line was built westward from the now-abandoned D&RG (1876n) mainline at Cuchara Junction (south of Denver) and reached the town of La Veta, Colorado (this location), in 1876. In 1877, the D&RG crossed the Sangre de Cristo Mountains at La Veta Pass to enter the Rio Grande drainage and in 1878 reached Alamosa on the Rio Grande in the San Luis Valley. In 1881, the narrow gauge San Juan Extension was completed to Durango via Cumbres Pass and in 1882 reached its terminus at the silver mining center of Silverton.

We will explore the D&RG lines in La Veta starting with this southwestward view of the depot. The depot, now the La Veta Town Hall, claims to date back to 1876, when the narrow gauge tracks of the D&RG San Juan Extension (1878n) arrived here.

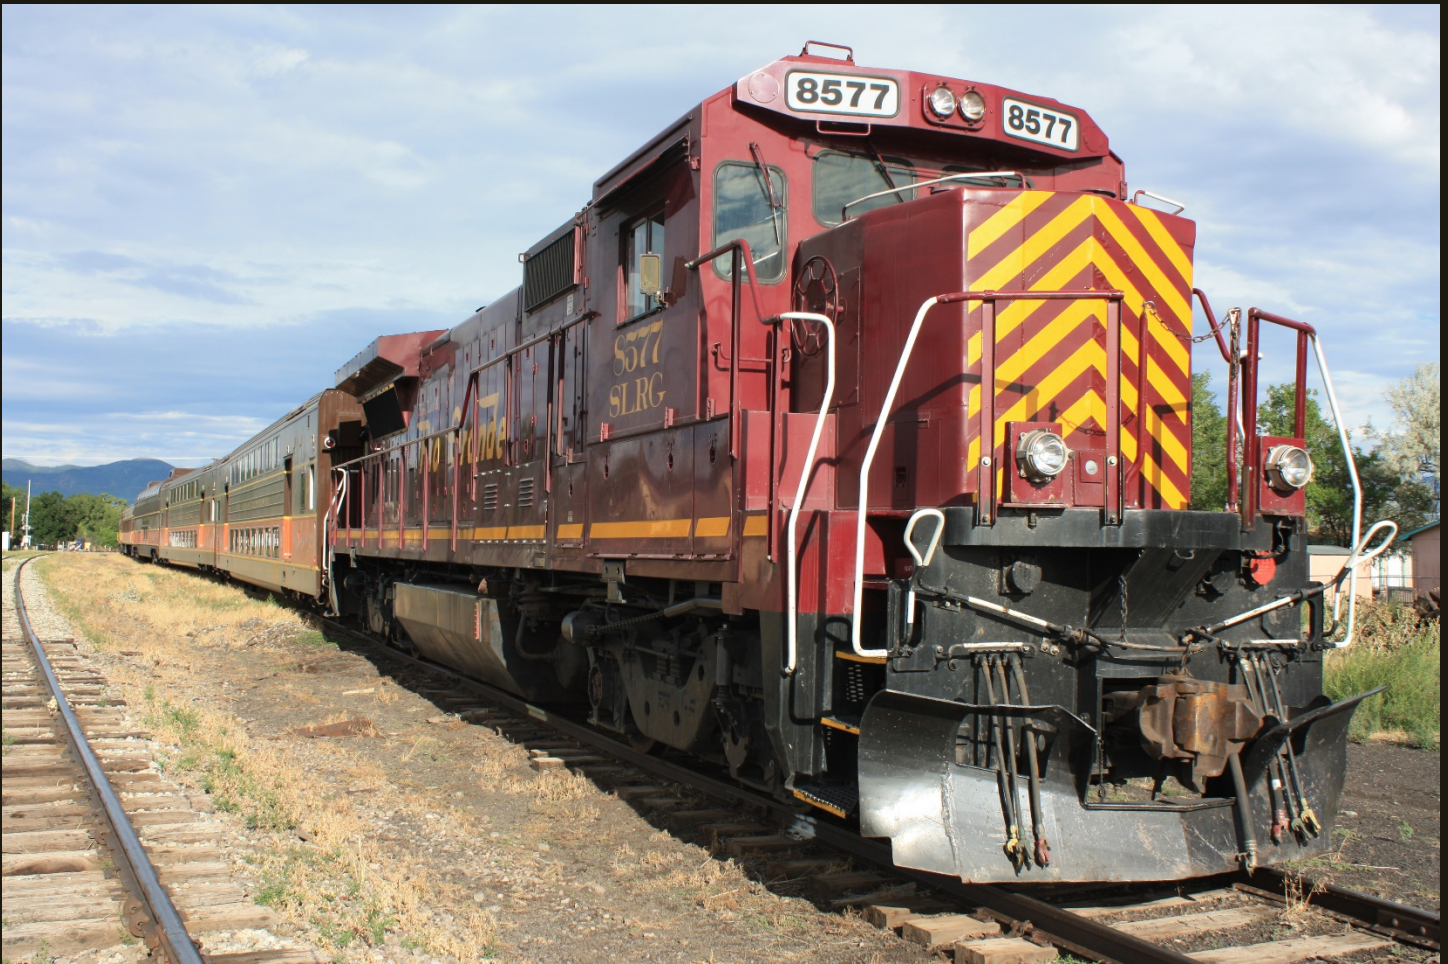
Westward view of the D&RG San Juan Extension (1878n), which at this location was converted to standard gauge in 1894. The SL&RG serves freight customers on the route as well as passenger excursions, such as the one shown here parked on a siding. The depot is just out of sight in the left distance, just beyond railroad crossing arm visible at the far left.

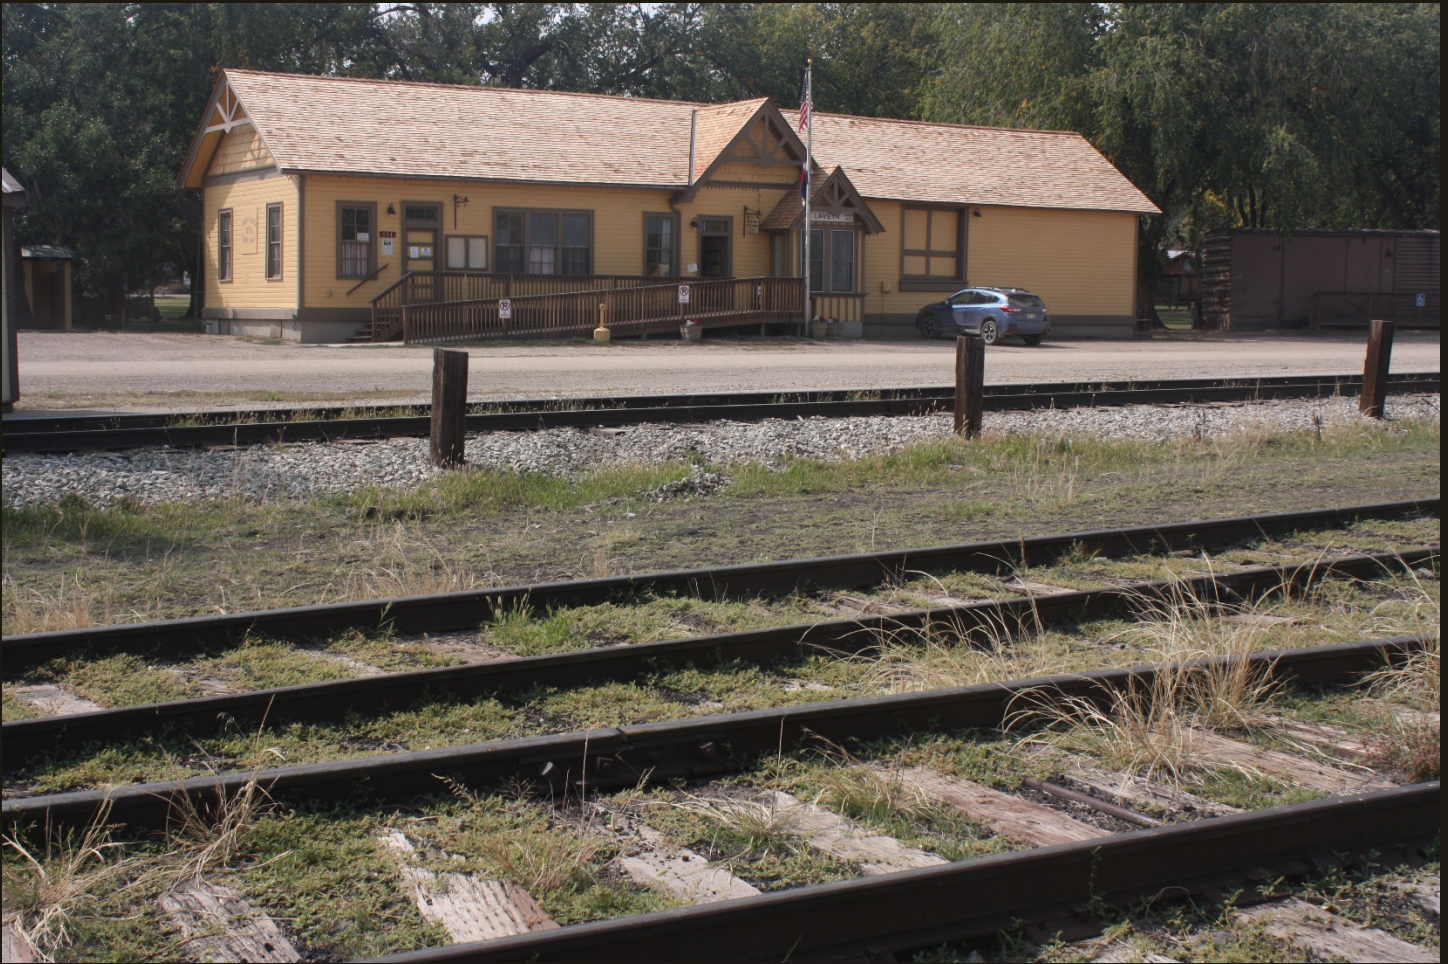
Now we are back at the depot looking south. The farthest track is the D&RG San Juan Extension (1878n) mainline, which at this location was converted to standard gauge in 1894. The next closer track is a siding, the same one with the SL&RG passenger train, which is parked 200 feet to the left (east) of this photo. The closest track is the east branch of a turning wye, which was used to turn helper engines for the climb up to La Veta Pass (for narrow gauge trains) and since 1899 has been used to turn helper engines for the climb up to Veta Pass (for standard gauge trains).

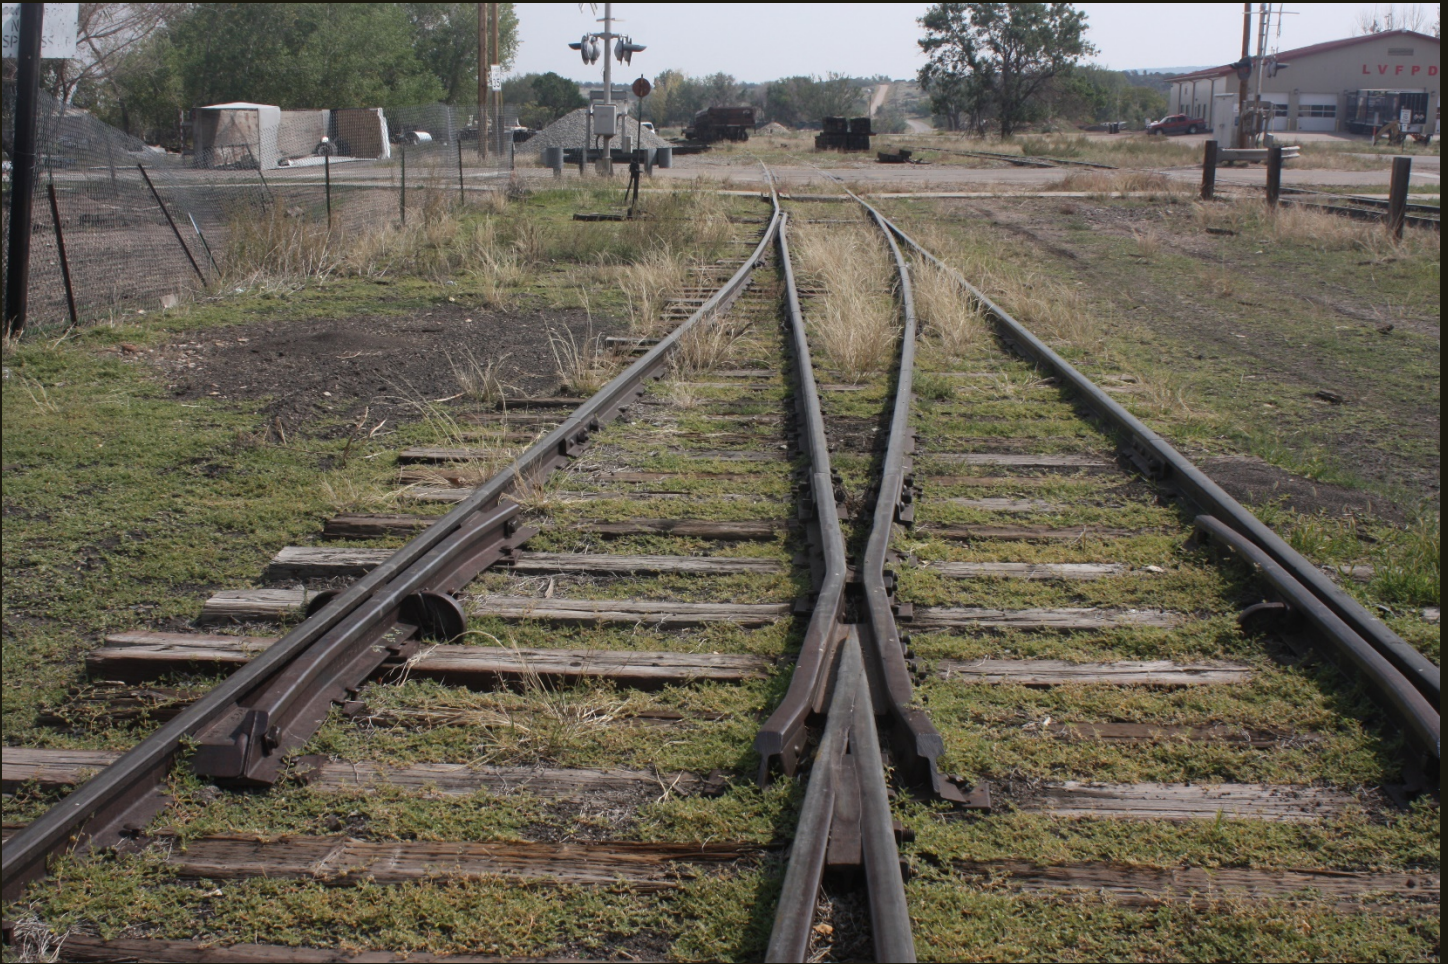
Eastward view at the same location as previous. The track in the upper right is the D&RG San Juan Extension (1878n) mainline and the depot is out of sight to the right of the photo. Of the two tracks in the foreground, the track on the right is the siding and the track on the left is the east branch of the turning wye. The two tracks converge and the siding beyond is where the SL&RG passenger train was parked, but this photo was taken on a different day and the train is gone.

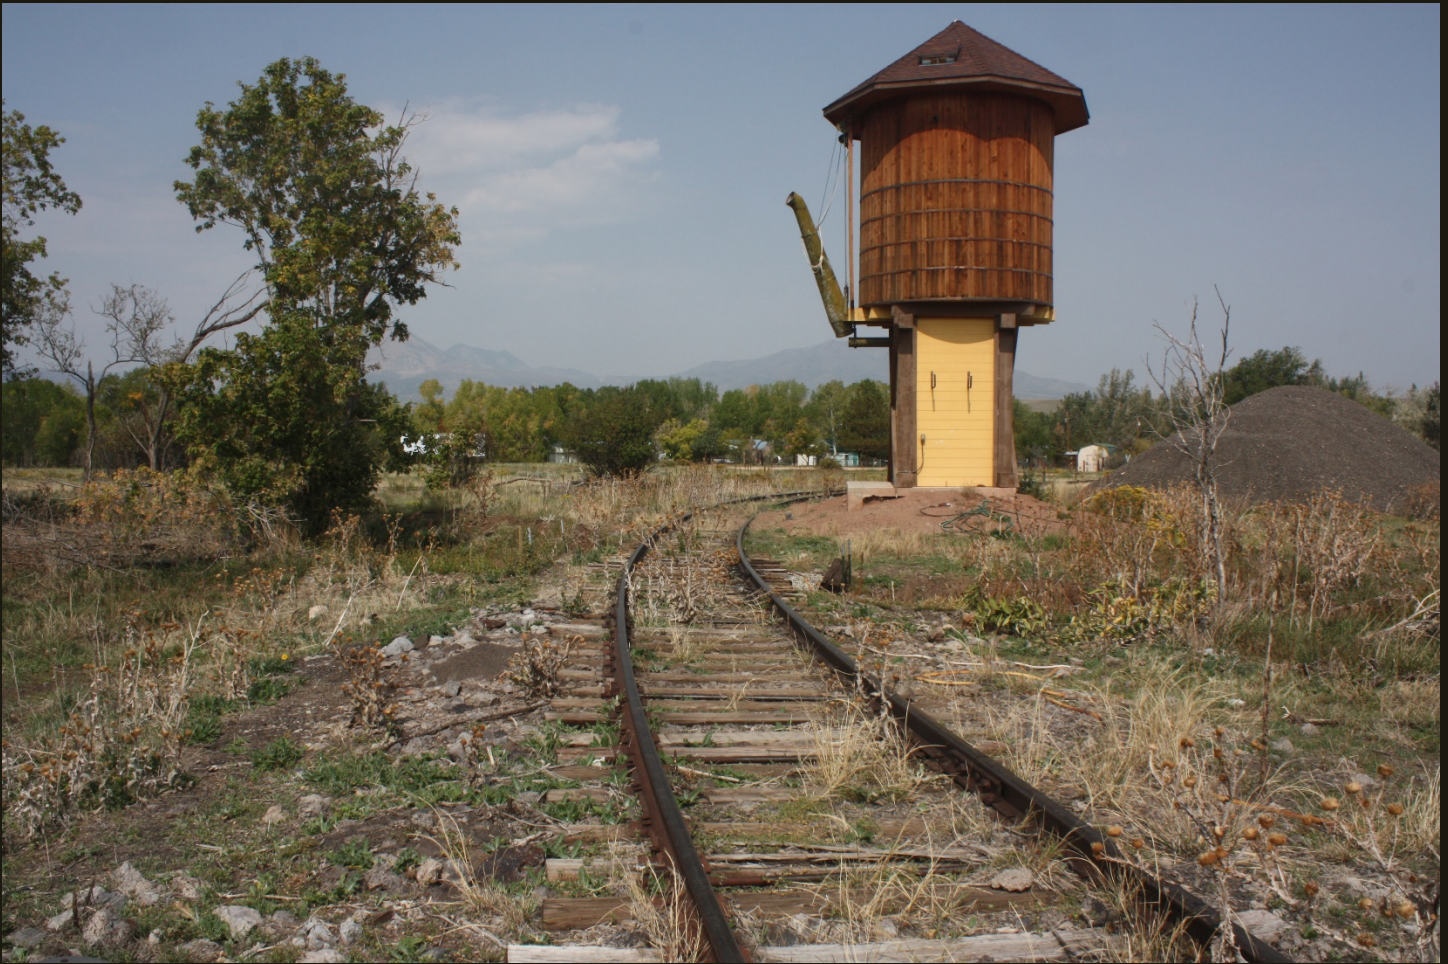
Northwestward view of the east branch of the turning wye, 200 feet northwest of the previous location. I'm not sure if this water tower is historical or was built for the current steam excursion operations.

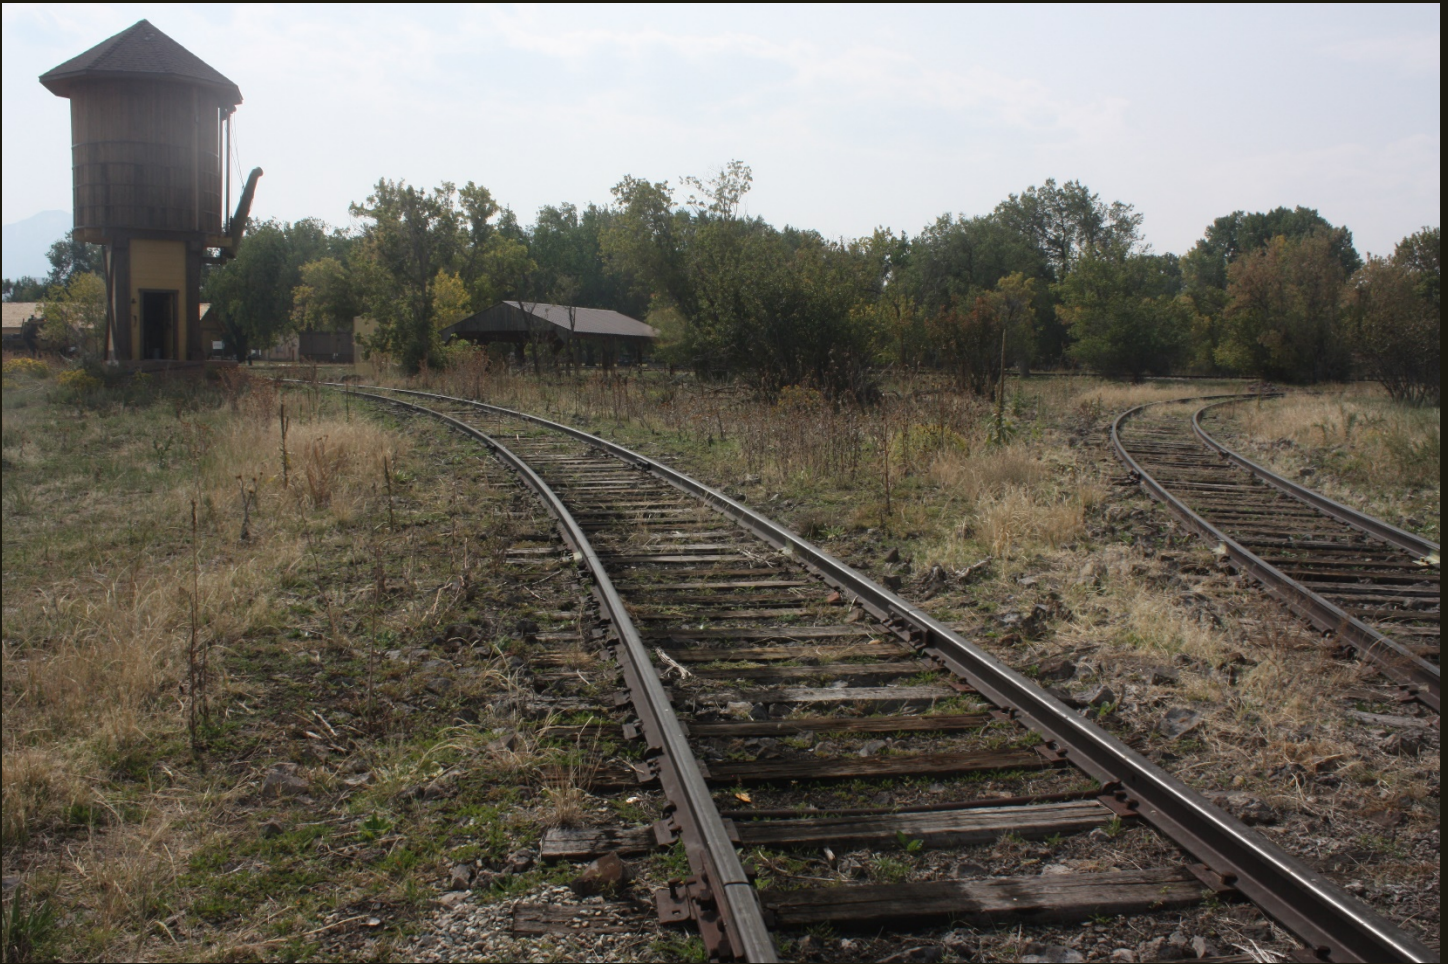
Southwestward view 150 feet northwest of the previous location. The east branch of the wye is in the foreground and runs next to the same water tower as in the previous photo and the west branch is on the right side of the photo. The siding is barely visible in the distance and the depot is visible behind the water tower.

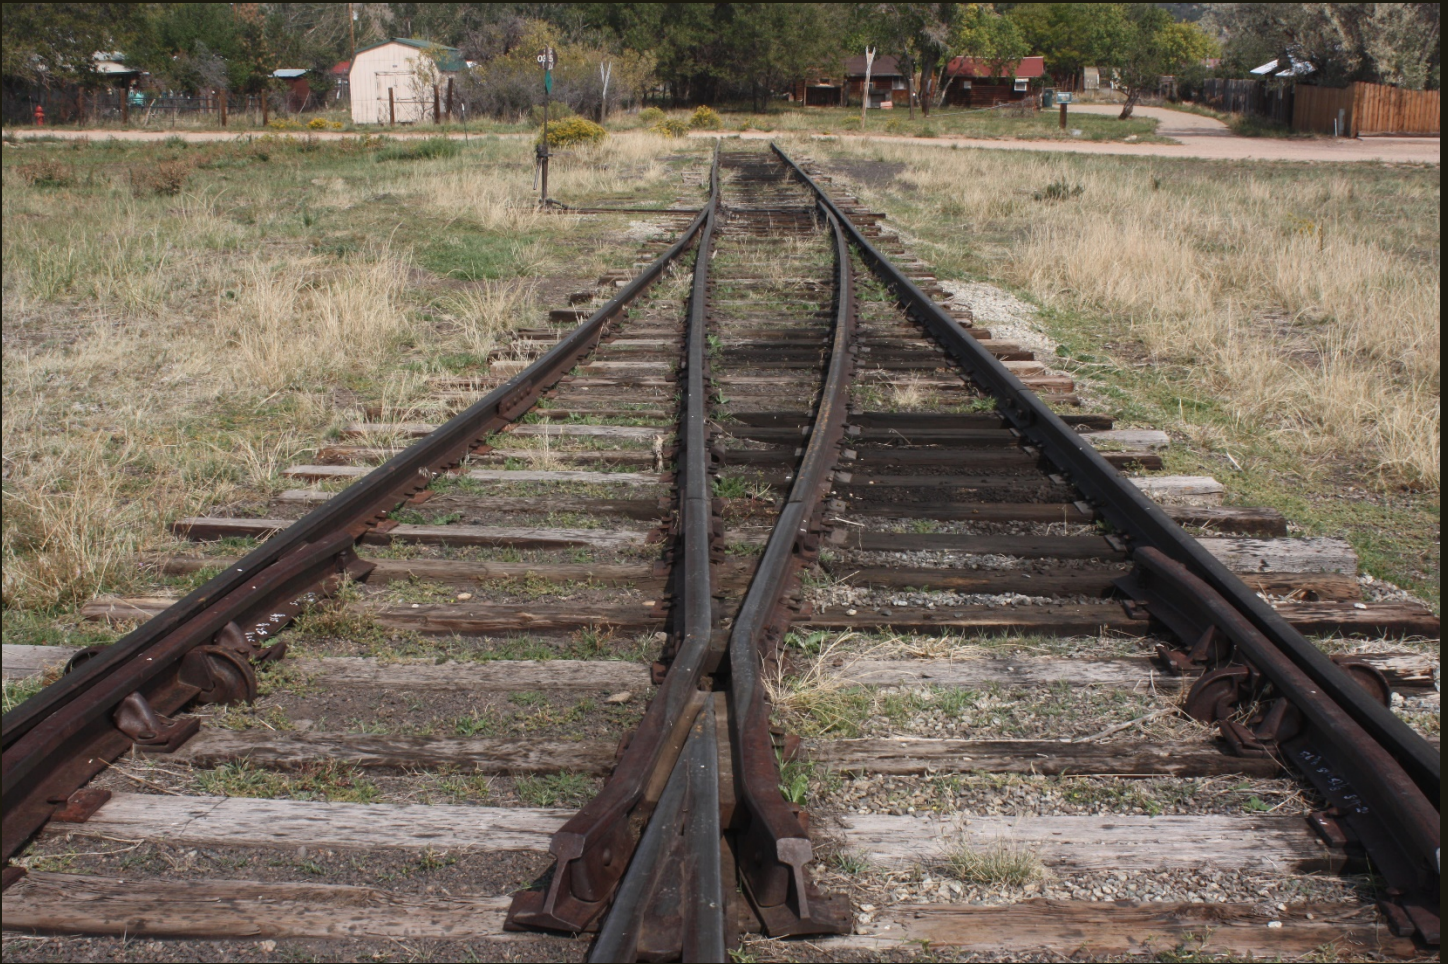
Northward view a few steps north of the previous location at the tip of the wye. There is just enough track beyond the switch to turn a steam engine with and its tender or a diesel engine.

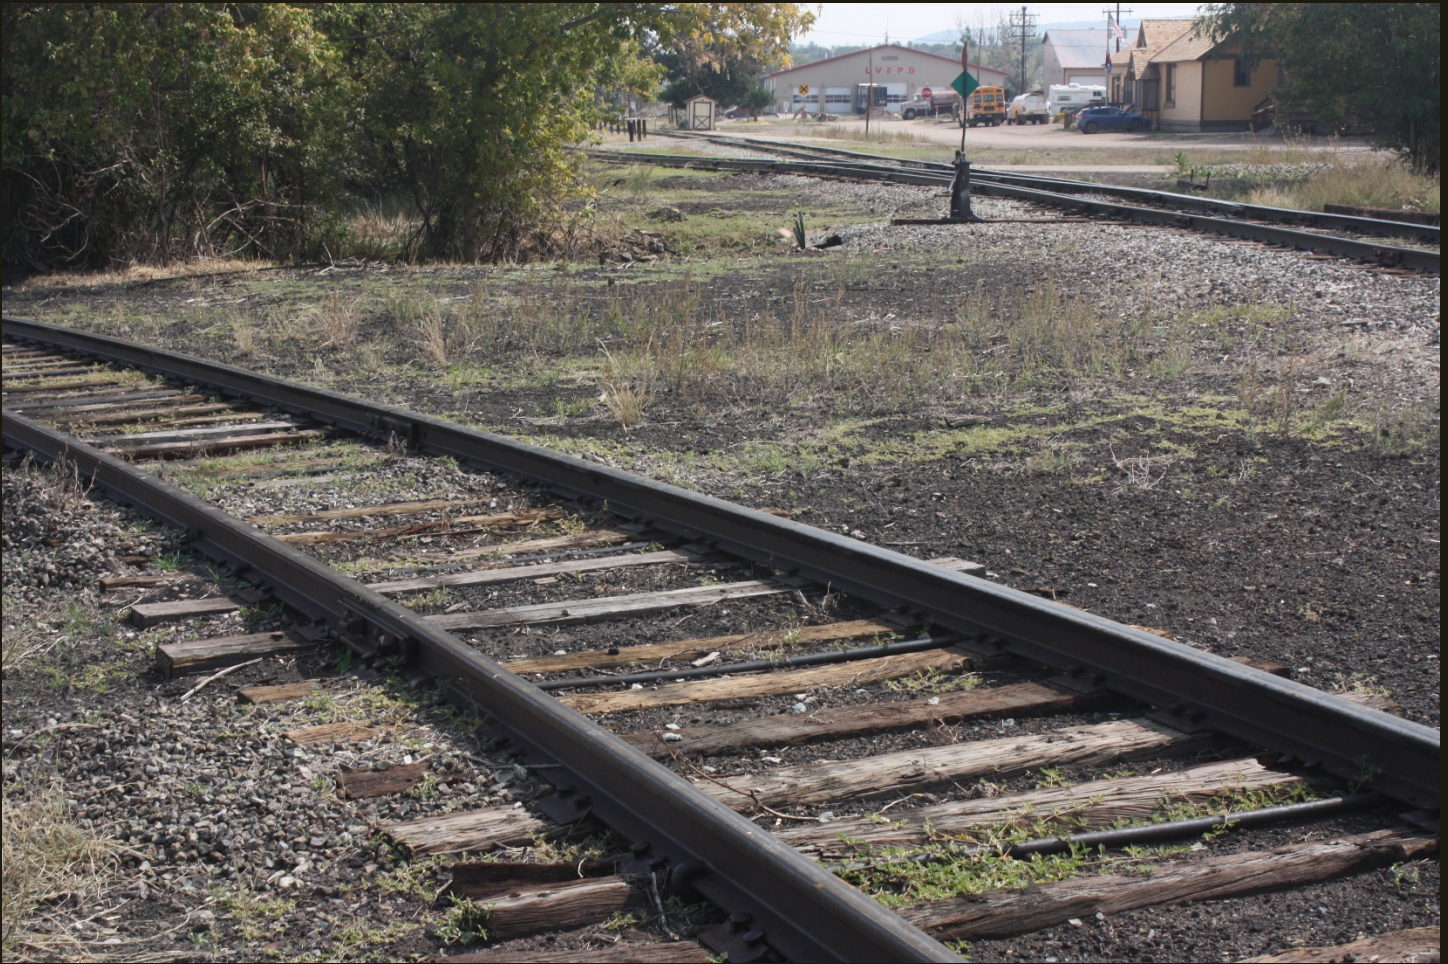
Southeastward view of the west branch of the wye (foreground), the track that emerges from the upper right edge of the photo is the D&RG San Juan Extension (1878n) mainline, the switch connects the mainline to the siding, and the depot is in the upper right.

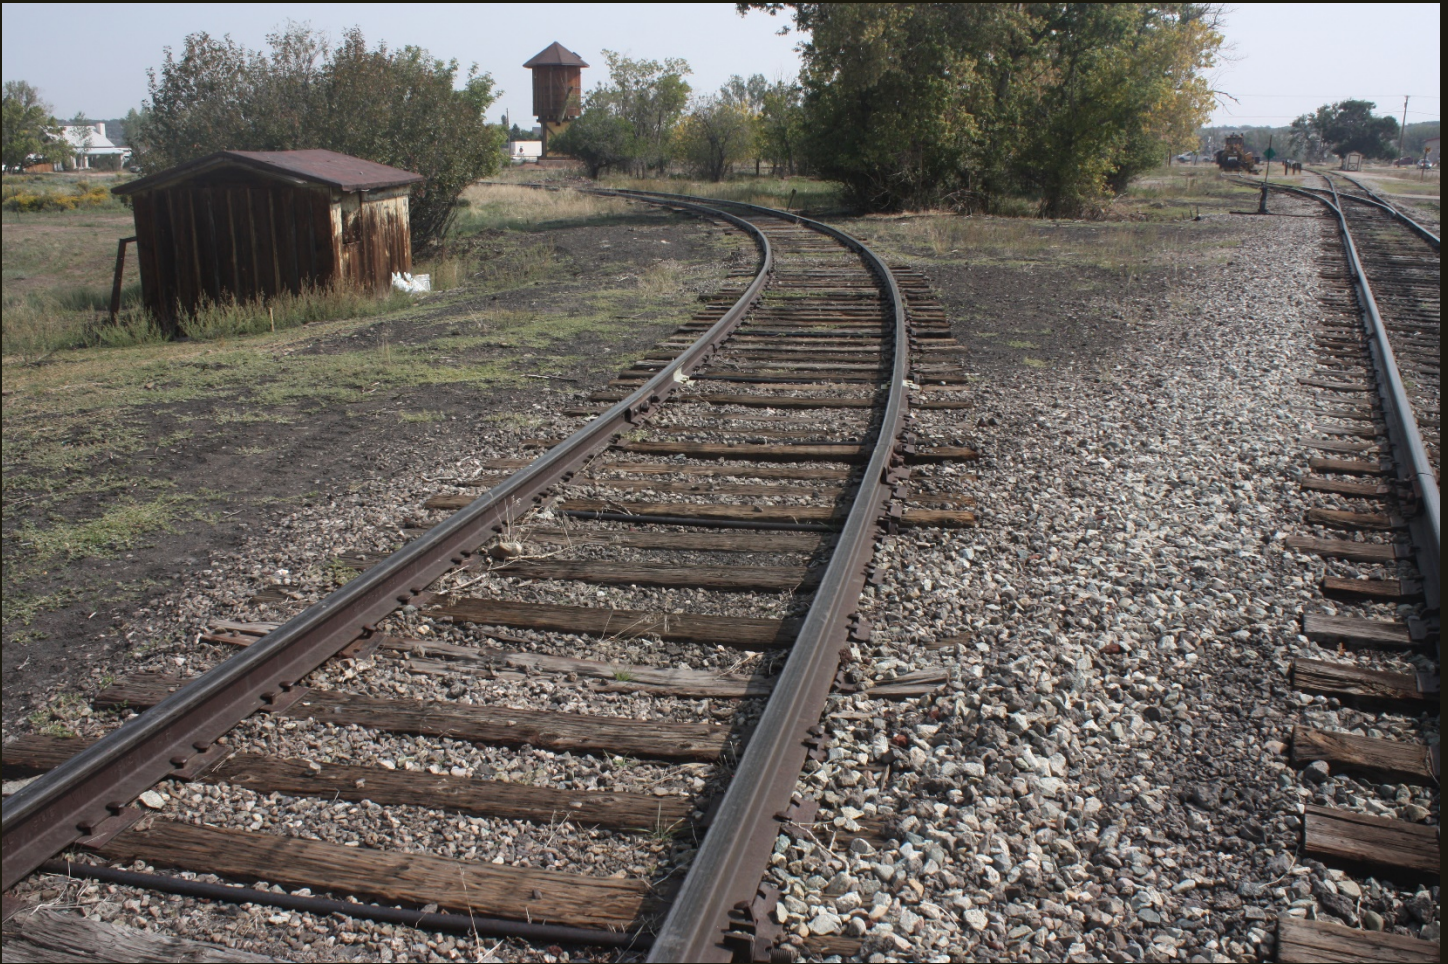
Eastward view a few steps south of the previous location. The track to the left is the west branch of the wye, the track on the right is the D&RG San Juan Extension (1878n) mainline, switch in the upper right connects the mainline to the siding, and the depot is just out of sight to the right of the photo. Note that the west branch of the wye connects directly to the mainline at a switch behind the viewer whereas the east branch connects to the siding (as seen in earlier photos).

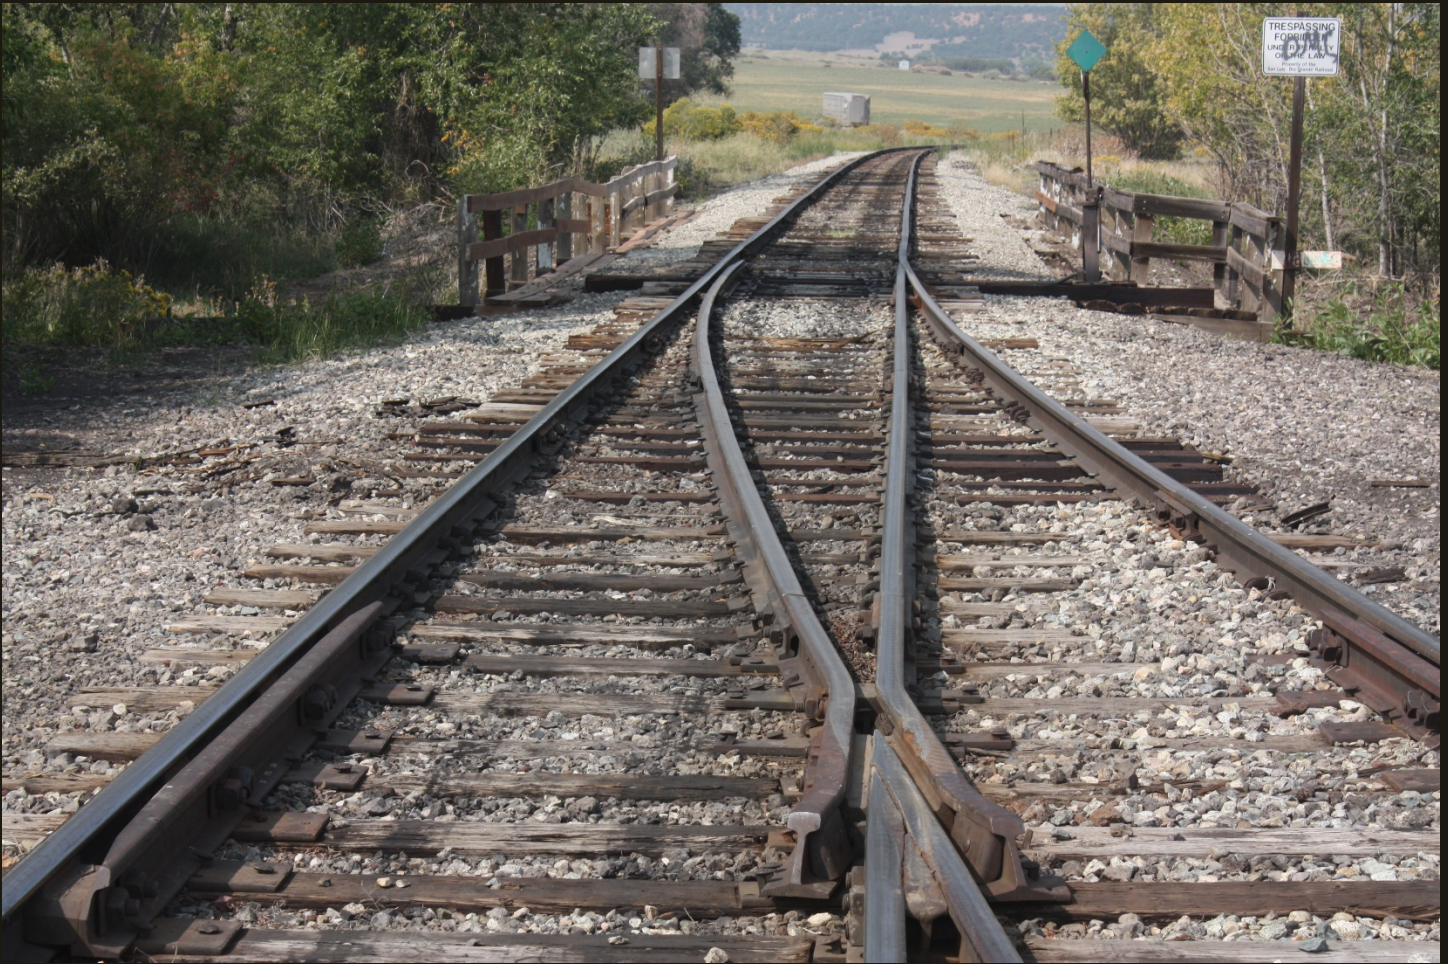
Westward view at the same location as previous, showing the connection of the west branch of the wye (on the right) with the D&RG San Juan Extension (1878n) mainline, which heads out of town after crossing the small bridge over the Cucharas River.

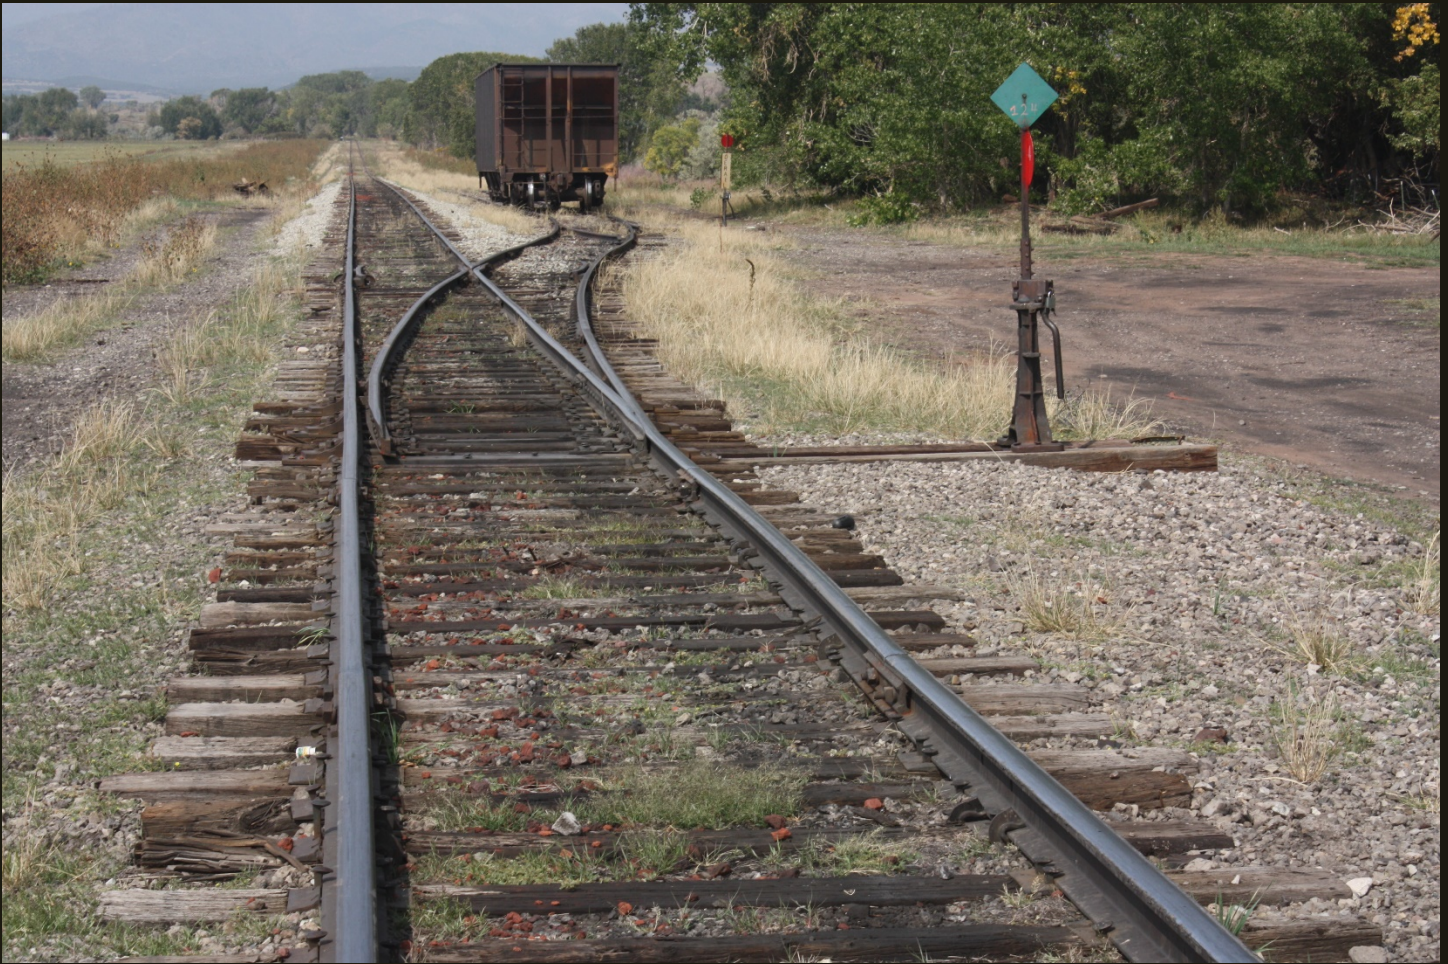
Westward view of the D&RG San Juan Extension (1878n) at the same location as previous. Historical topo maps indicate that the alignment of the original narrow gauge route over the Sangre de Cristo Range (La Veta Pass route) diverges from the alignment of the 1899 standard gauge route (Veta Pass route) one mile in the distance (farther west), just west of the other end of the siding that starts here. However, all evidence of the narrow gauge route is obliterated around the divergence point.

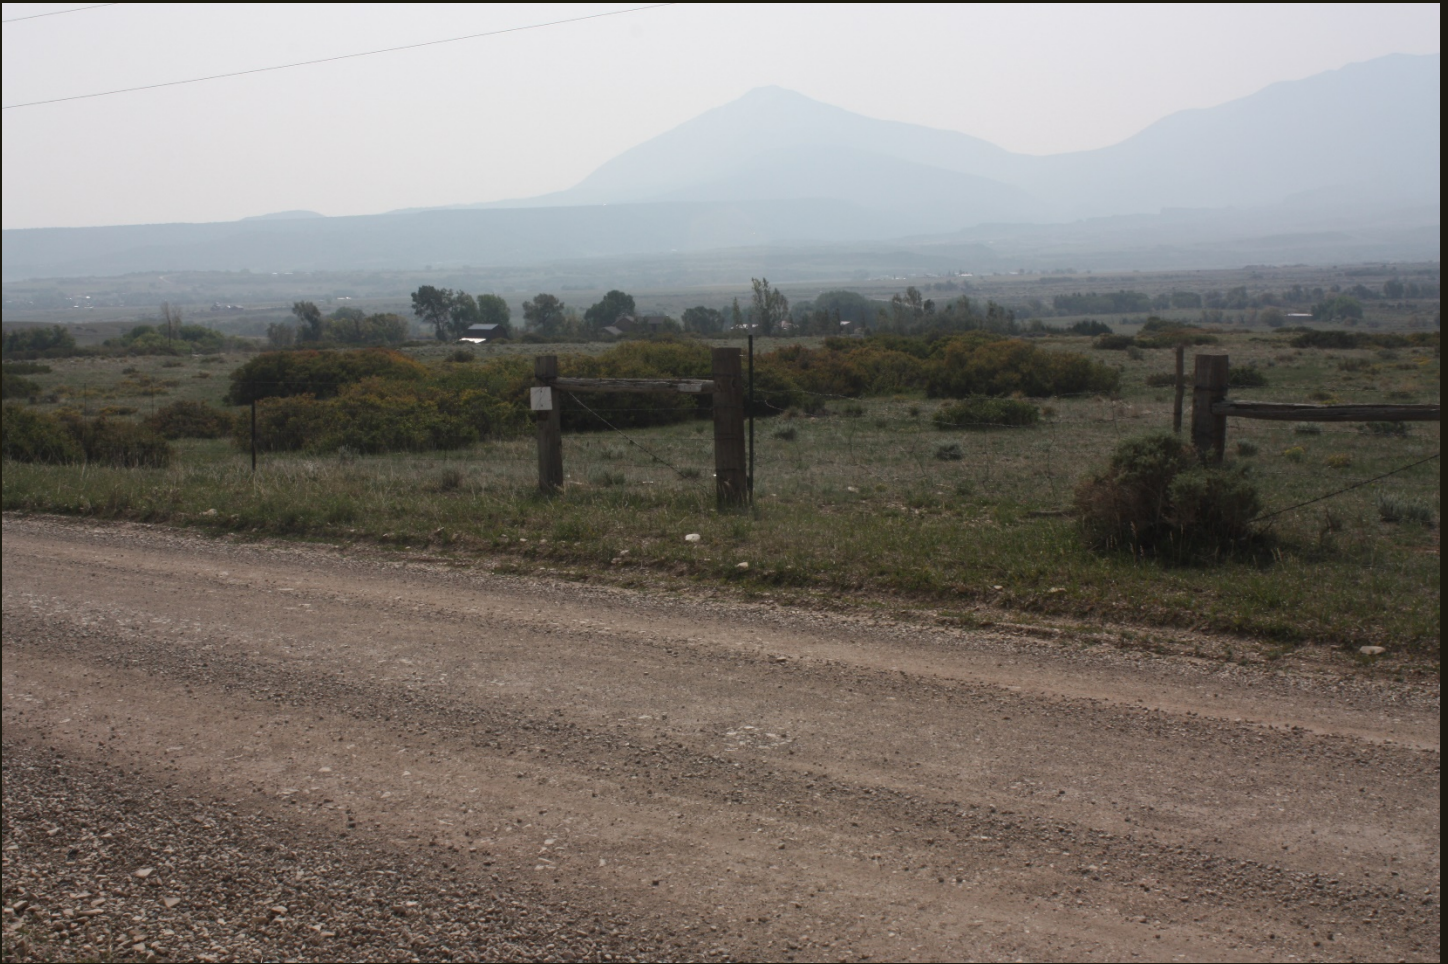
Southeastward view of the D&RG San Juan Extension (1878n), 2 miles west-northwest of the previous location and 1 mile northwest of the point where the original narrow gauge route over the Sangre de Cristo Range (La Veta Pass route) diverges from the alignment of the 1899 standard gauge route (Veta Pass route). The San Juan Extension (1878n), which was abandoned in 1900, ran through this location, but I could find no evidence of the narrow gauge grade in this view or anywhere between here and the standard gauge route (which is 1,500 feet south of this location but is not visible in this view).

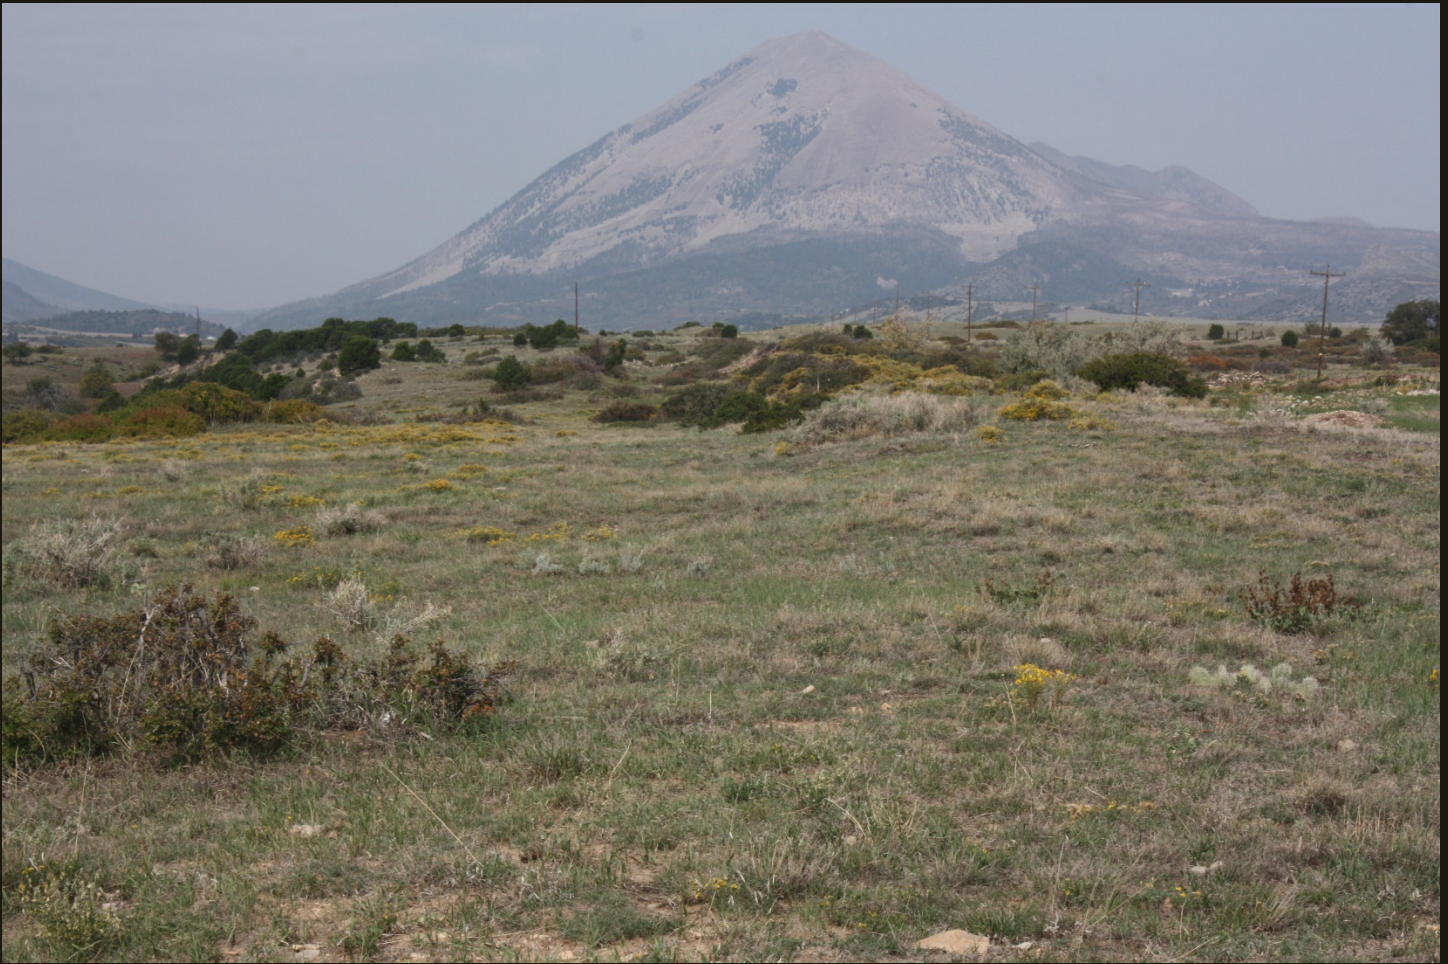
Northwestward view of the D&RG San Juan Extension (1878n) at the same location as previous. The peak in the distance is 11,569-foot Mount Maestas, and directly below the peak is a fill grade that heads almost directly away from the viewer; this is the first remnant of the abandoned San Juan Extension (1878n) west of La Veta. The tracks were removed from this grade in 1900.

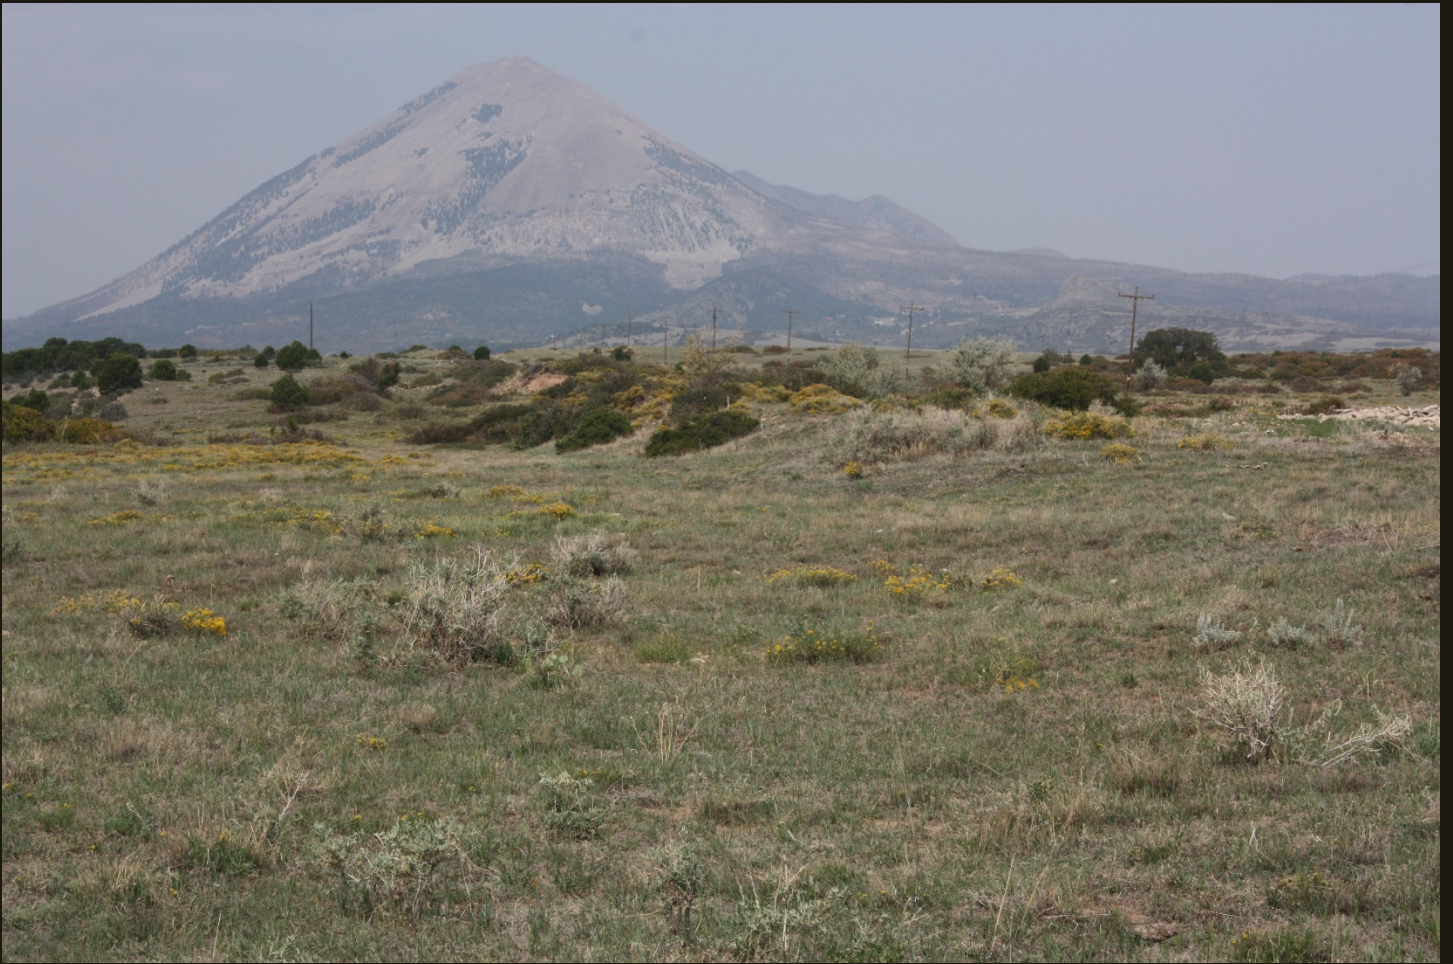
Closer northwestward view of the D&RG San Juan Extension (1878n) fill grade. A 1963 topo map shows this as the southeastern end of an "Old Railroad Grade."

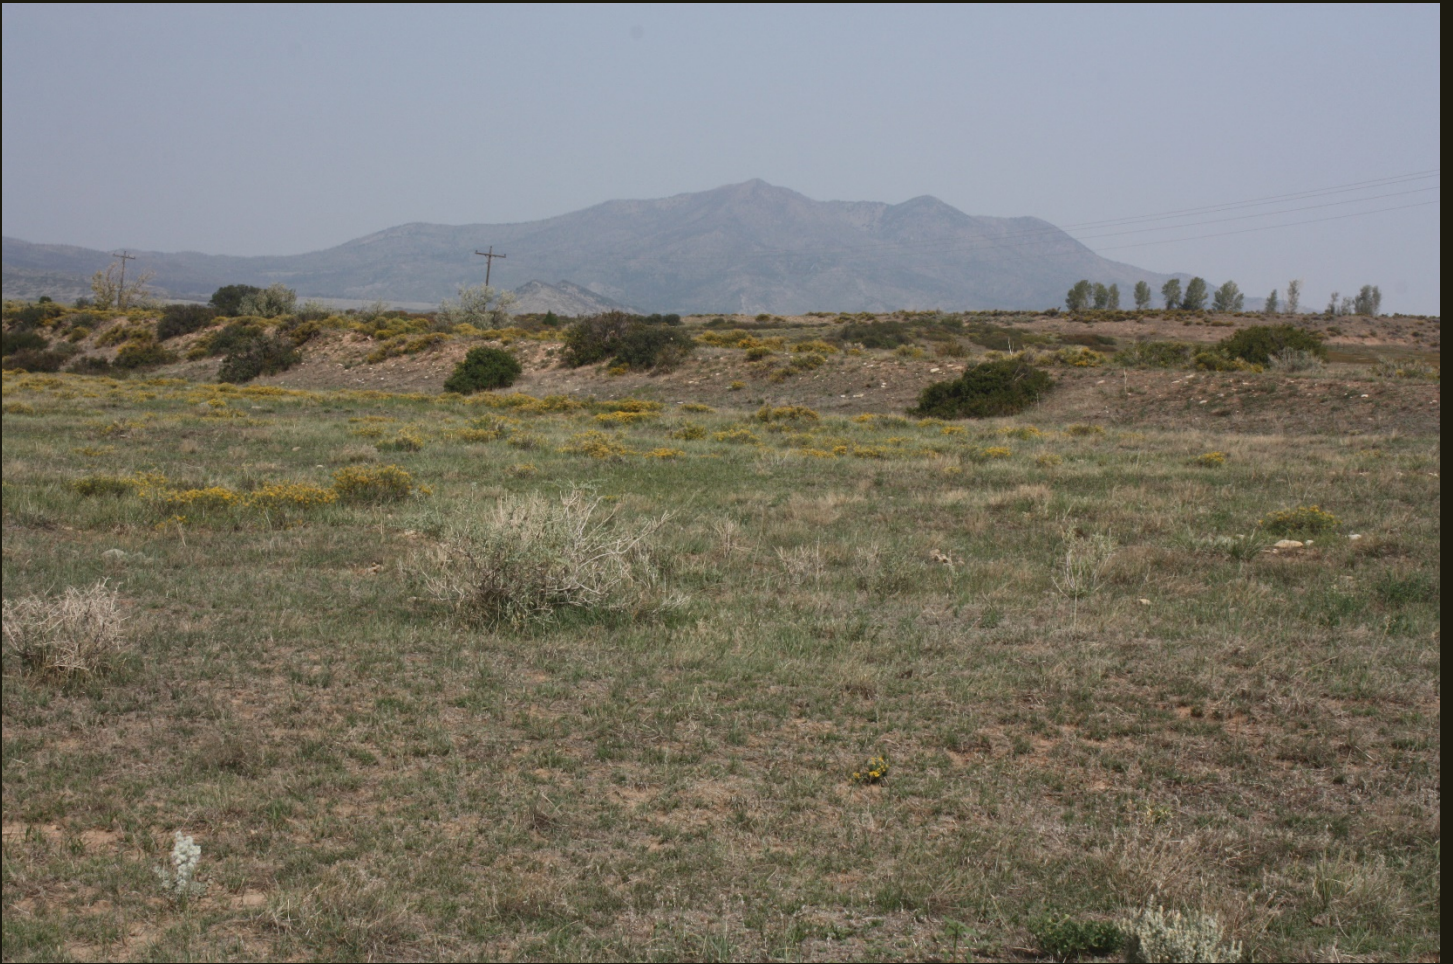
Northward view of the abandoned D&RG San Juan Extension (1878n) fill grade, an "Old Railroad Grade" on topo maps, taken a few steps west of the previous location.
