In 1881, the Denver & Rio Grande Railroad's narrow gauge San Juan Extension reached Durango, Colorado (this location) on the Animas River and was completed to its final terminus at Silverton in 1882. The route of the D&RG San Juan Extension encounters the Animas River 4 miles south of Durango then turns north along the east bank of the river through Durango (this location), where the Silverton branch continues north along the Animas River to Silverton. In 1887, D&RG built its narrow gauge Ouray Branch, the terminus of which was only 15 miles as the crow flies north of Silverton, but the San Juan Mountains between Ouray and Silverton were too formidable to for a railroad directly connecting the two towns. To bridge this gap, in 1889 Otto Mears, who had built a toll road between Ouray and Silverton, founded the Rio Grande Southern Railroad to go around the most rugged part of the San Juan Mountains. Construction of the narrow gauge line began in 1890 from a connection with the D&RG Ouray Branch (1887n) at Ridgway and ran southwest then southeast to a connection with the D&RG San Juan Extension (1881n) at Durango (this location); the RGS was completed and began operation in 1891 and e

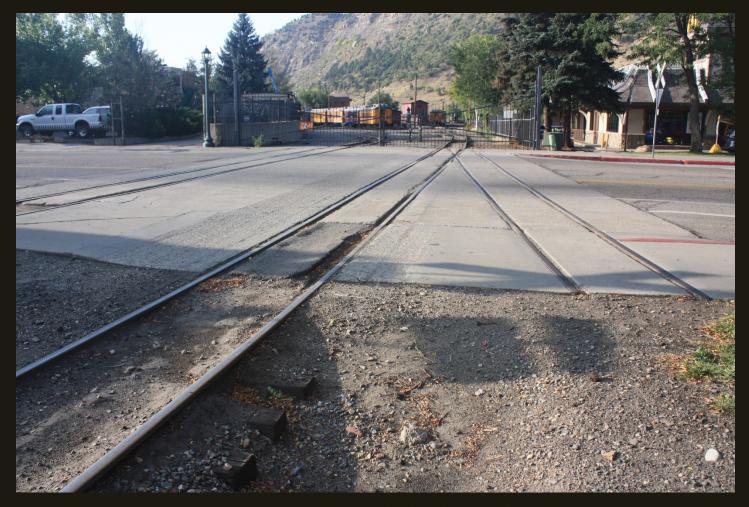
Southward view at the same location as previous, showing the mainline on the far left, the first branch off the mainline going into the D&SNGRR railyard in the middle, and an abandoned spur on the right. An 1898 topo map shows that the mainline is on the original D&RG Silverton Branch (1882n) alignment, including the curve to the left (east) on the other side of West College Drive. The topo map does not show either of the two spurs visible here.

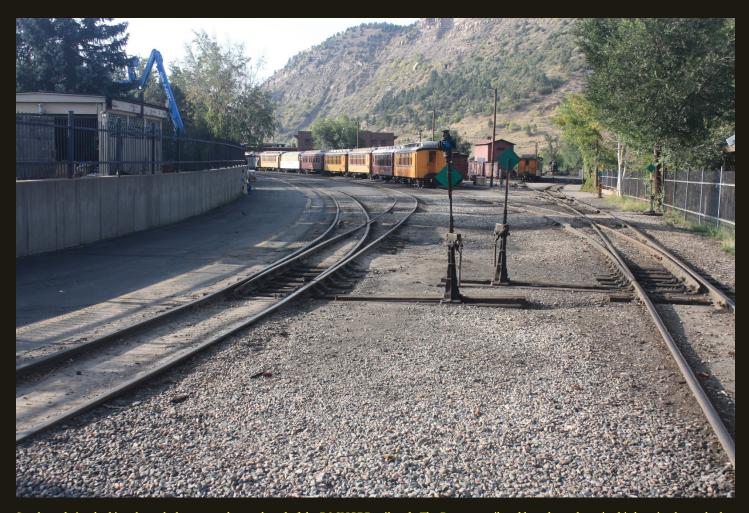
Southward view looking through the gate at the north end of the D&SNGRR railyard. The Durango railyard has always been in this location but only the mainline -- the track on the far left -- is in the same location that it was on the 1898 topo map and presumably in its original 1881 location. In a 1963 topo map, spurs and a turnaround loop are present that were not on the 1898 or 1907 topo maps (of the same scale) and are all different than the current configuration, which presumably was built by the D&SNGRR. If you look down the right-hand (west) track as far as you can see in this view, that is just about the location where the RGS (1891n) came into the railyard from the right (west) and connected to the D&RG San Juan Extension (1881n) mainline farther south, according to the 1898 and 1907 topo maps.

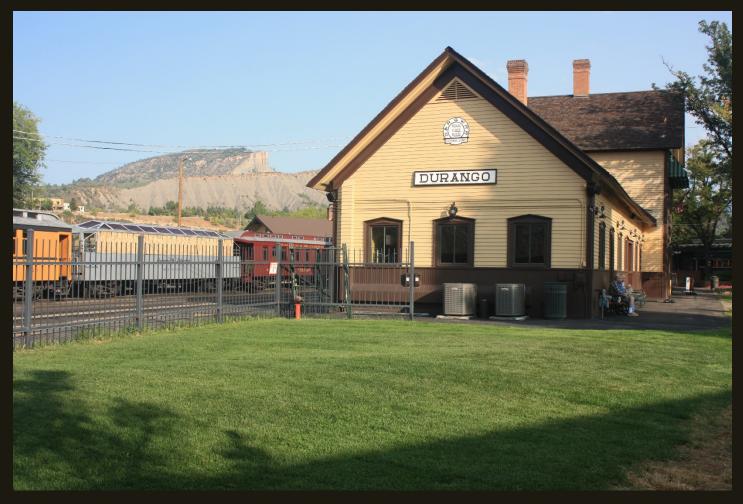
Northward view of the D&RG Durango Depot, 600 feet south of the previous location. The Durango Depot was built in 1882 and has been preserved in its original form and original location adjacent to the D&RG San Juan Extension (1881n) mainline.

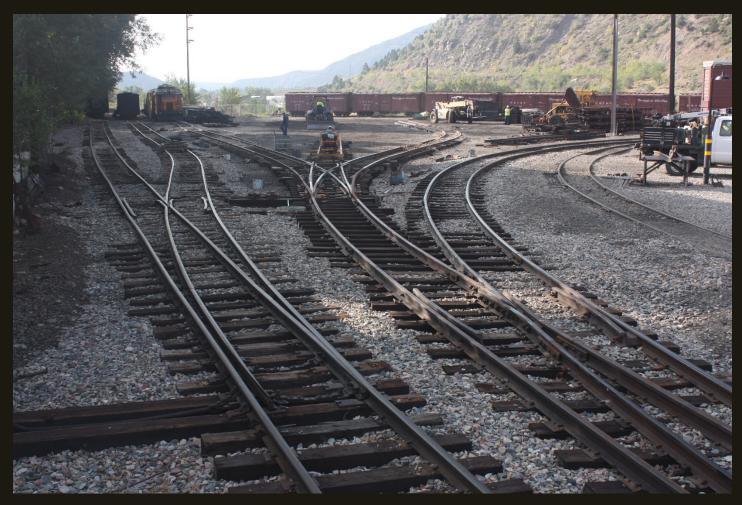
Southward view of the south end of the D&SNGRR railyard, 300 feet south of the previous location. The D&RG San Juan Extension (1881n) mainline is on the far left and ends just beyond the stored car. South from there, the grade disappears. The Animas River is 300 feet beyond the line of stored box cars. The RGS (1891n) entered the area of the current railyard to the left (west) of this location and turned southeastward to join the D&RG San Juan Extension (1881n) about 400 feet south of the current end of track, according to historical topo maps. The curved track on the far right is a turnaround loop; as far as I can tell, the turnaround loop and all tracks in the railyard except the mainline were built by the D&SNGRR and are not historic.

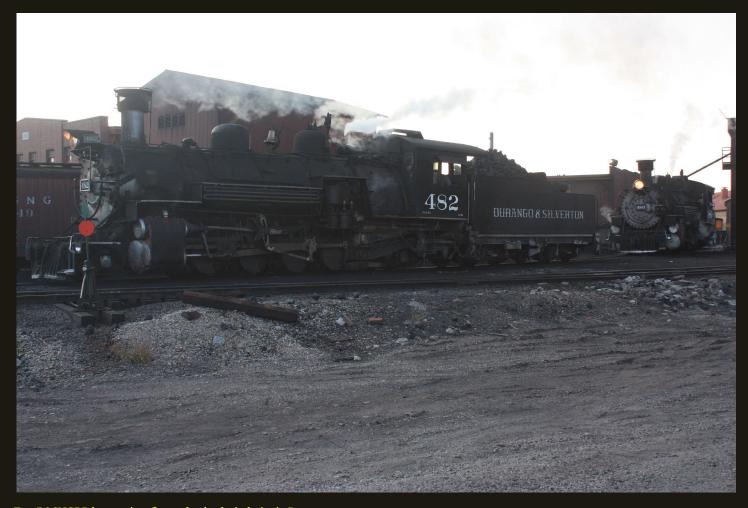
Two D&SNGRR locomotives fire up for the day's duties in Durango.
